Appendix B
Tree Inventory & Protection Plan

**755 Jarvis Drive
Tree Inventory & Protection Plan**

755 Jarvis Drive
Morgan Hill, California

Prepared by:
Samuel Oakley
ISA Board Certified Master Arborist WE-9474B
ASCA Registered Consulting Arborist #556

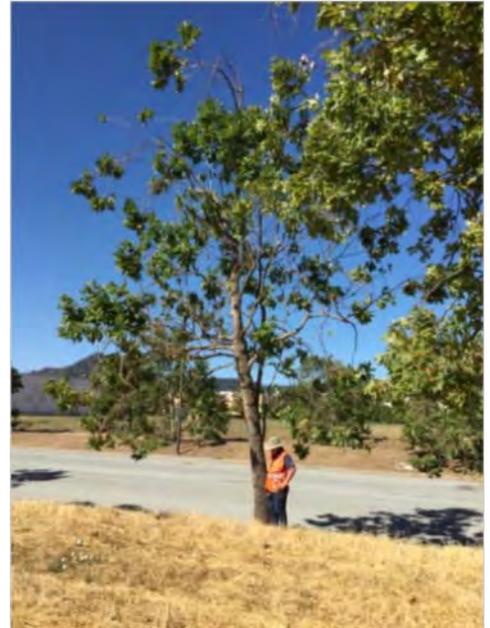
London Plane Tree ID# 2
 London Plane Tree Tag# 102
 Height: DBH: 13"-18"
 Health: 80% - Good

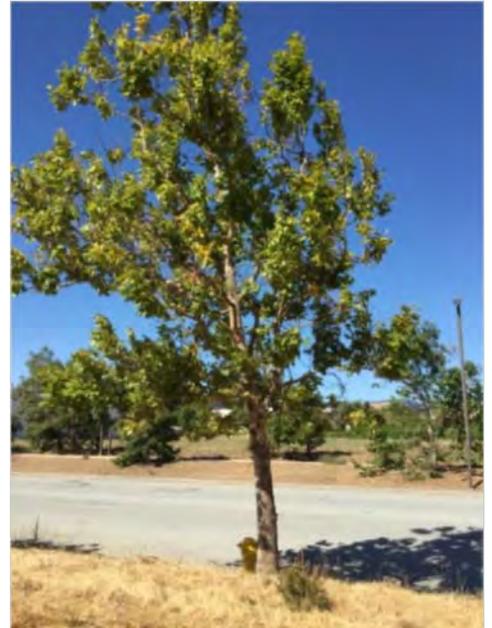
London Plane Tree ID# 5
London Plane Tree Tag# 105
Height:
Health: 60% - Fair
DBH: 7"-12"

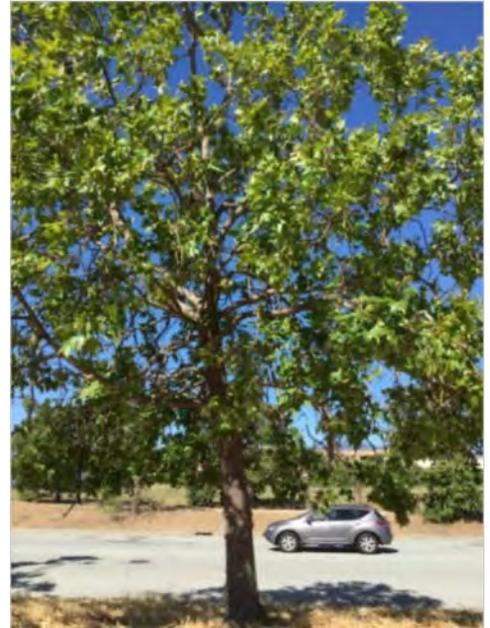
London Plane Tree ID# 8
London Plane Tree Tag# 108
Height: DBH: 7"-12"
Health: 60% - Fair

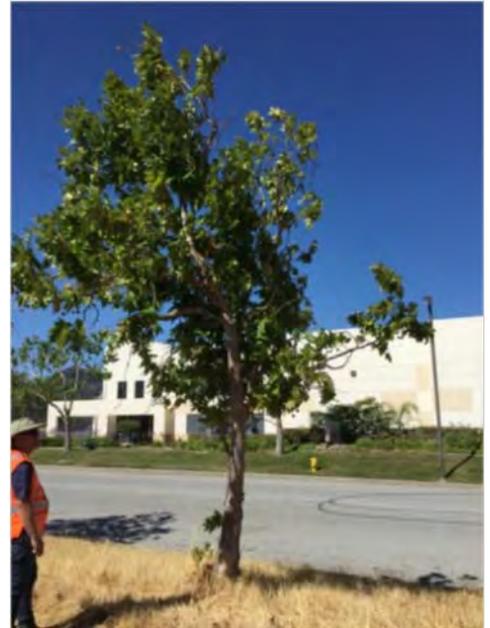
London Plane Tree ID# 14
 London Plane Tree Tag# 114
 Height:
 Health: 60% - Fair
 DBH: 7"-12"

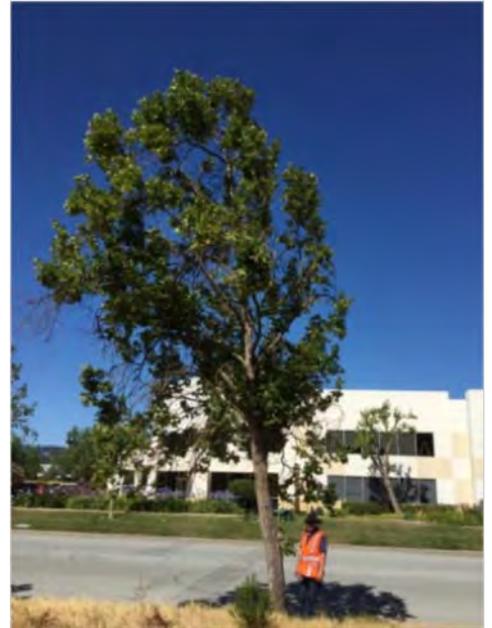
London Plane Tree ID# 17
 London Plane Tree Tag# 117
 Height: DBH: 7"-12"
 Health: 60% - Fair

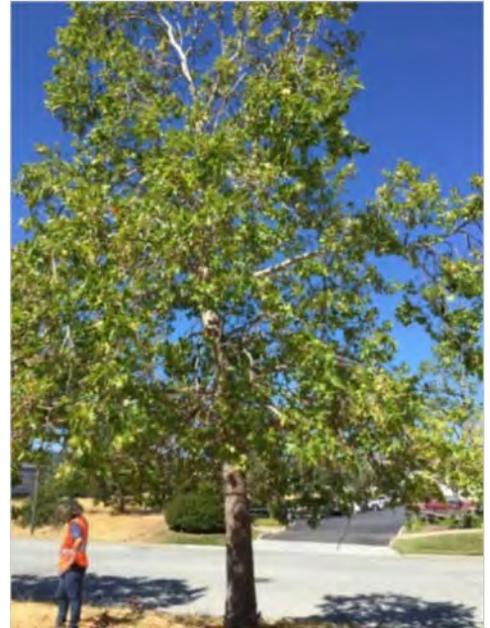
London Plane Tree ID# 20
 London Plane Tree Tag# 120
 Height:
 Health: 60% - Fair
 DBH: 7"-12"

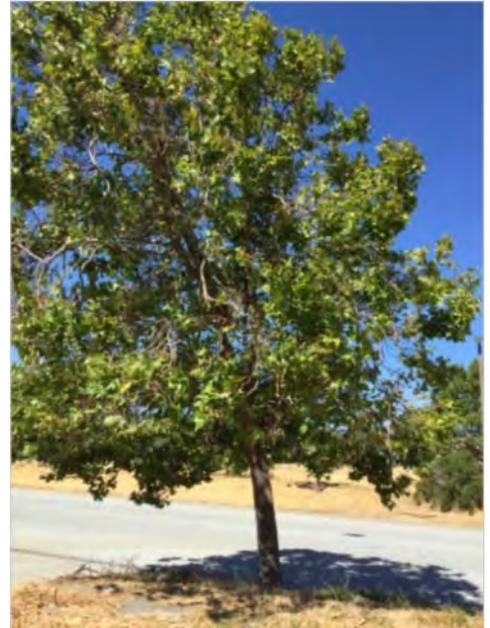
London Plane Tree ID# 23
London Plane Tree Tag# 123
Height:
Health: 60% - Fair
DBH: 1"-6"

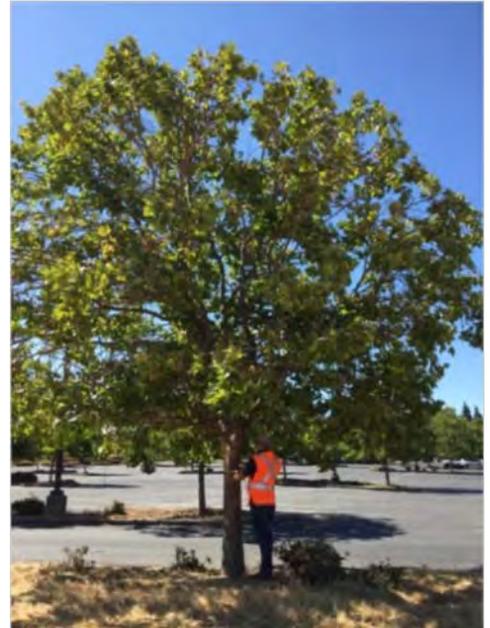
London Plane Tree ID# 29
 London Plane Tree Tag# 128
 Height:
 Health: 80% - Good
 DBH: 7"-12"

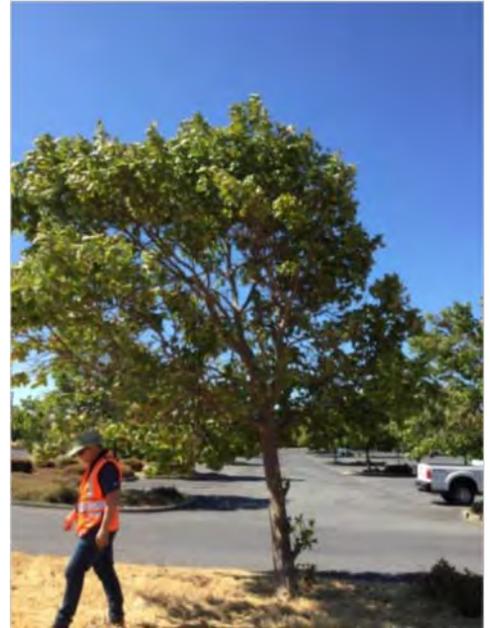
London Plane Tree ID# 32
 London Plane Tree Tag# 131
 Height: DBH: 7"-12"
 Health: 80% - Good

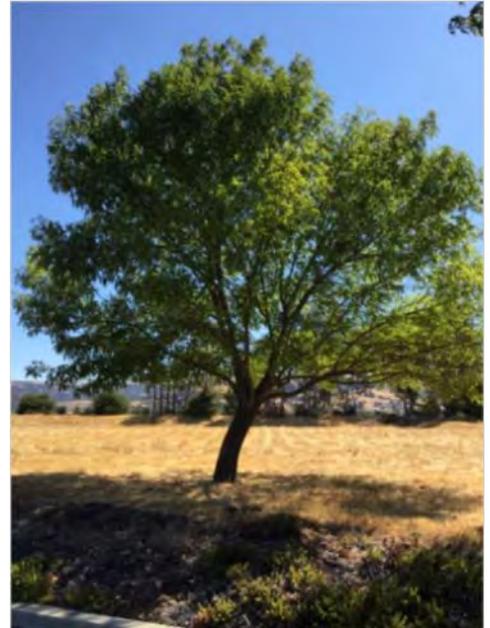
fraxinus uhdei ID# 35
 fraxinus uhdei Tag# 134
 Height: DBH: 7"-12"
 Health: 80% - Good

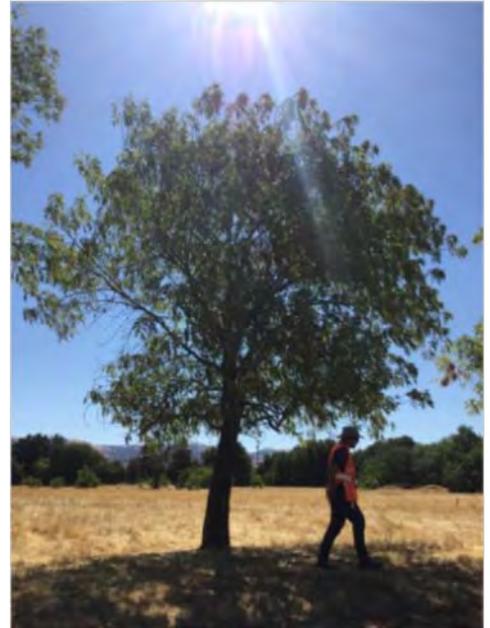
fracsinus uhdei ID# 41
 fracsinus uhdei Tag# 140
 Height: DBH: 7"-12"
 Health: 60% - Fair

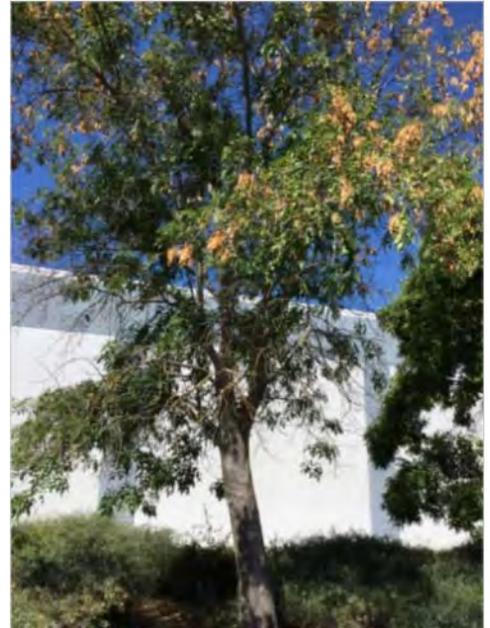
fracsinus uhdei ID# 44
fracsinus uhdei Tag# 143
Height: DBH: 7"-12"
Health: 20% - Critical

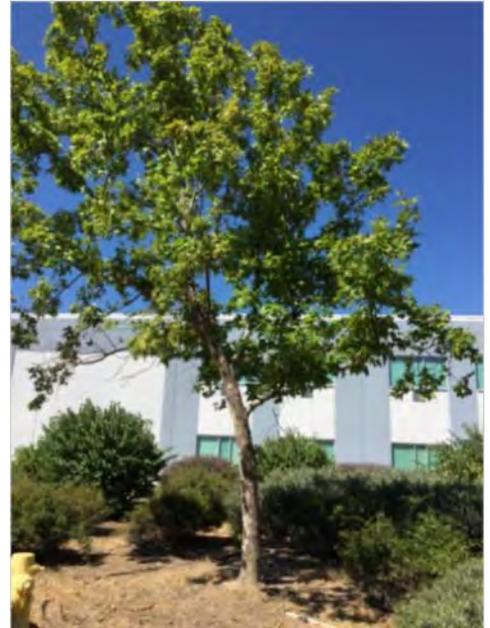
fracsinus uhdei ID# 47
fracsinus uhdei Tag# 146
Height: DBH: 13"-18"
Health: 40% - Poor

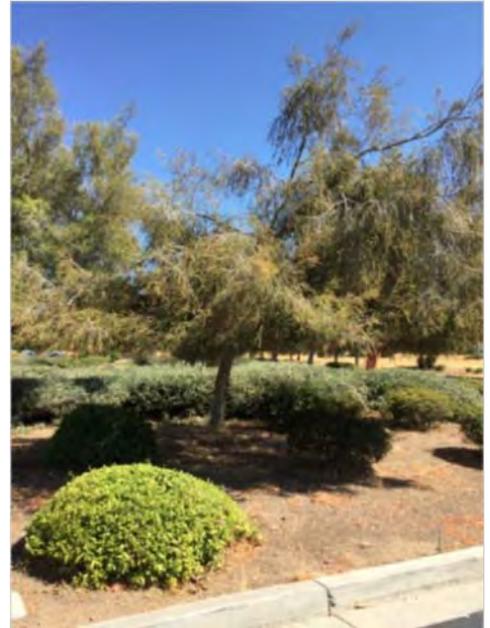
London Plane Tree ID# 50
 London Plane Tree Tag# 149
 Height: DBH: 7"-12"
 Health: 40% - Poor

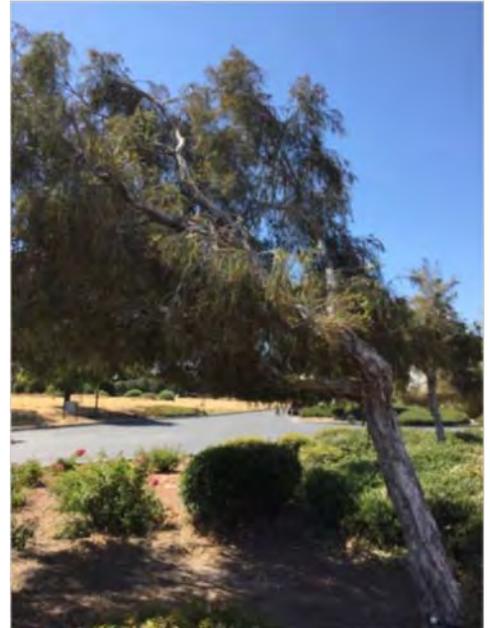
Melaleuca, Flaxleaf Paperb... ID# 53
 Melaleuca, Flaxleaf Paperb... Tag# 152
 Height: DBH: 1"-6"
 Health: 40% - Poor

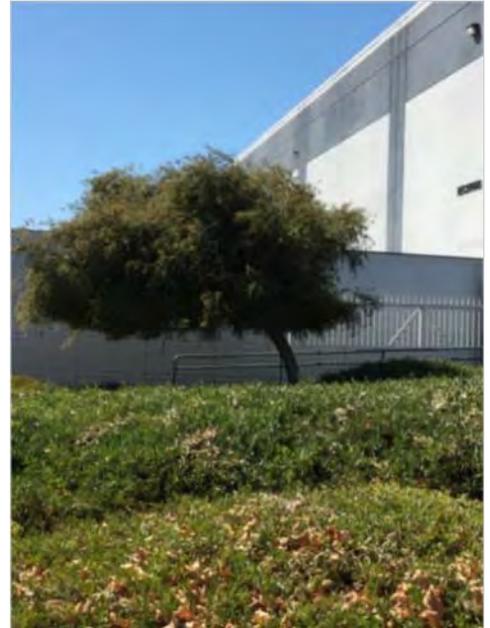
Melaleuca, Flaxleaf Paperb... ID# 56
 Melaleuca, Flaxleaf Paperb... Tag# 155
 Height: DBH: 1"-6"
 Health: 40% - Poor

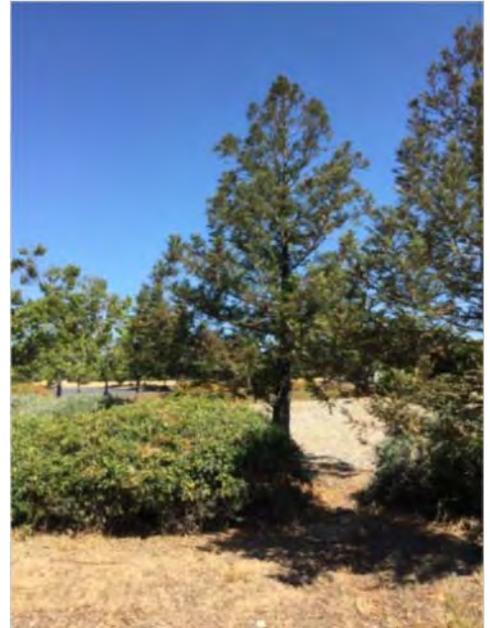
sequoia sempervivans ID# 59
sequoia sempervivans Tag# 158
Height: DBH: 1"-6"
Health: 60% - Fair

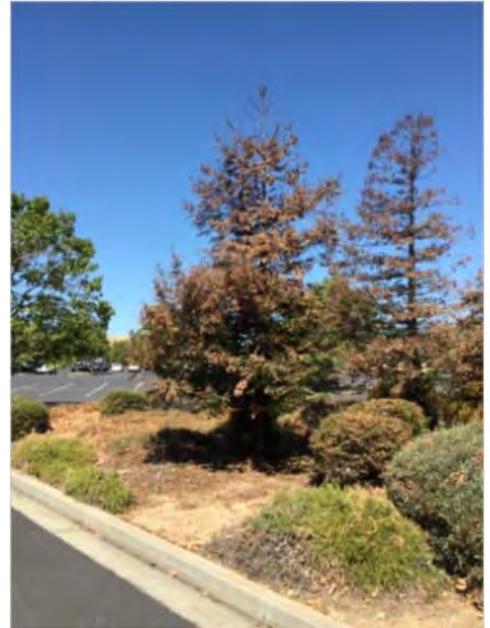
sequoia sempervivans ID# 62
sequoia sempervivans Tag# 161
Height:
Health: 20% - Critical
DBH: 7"-12"

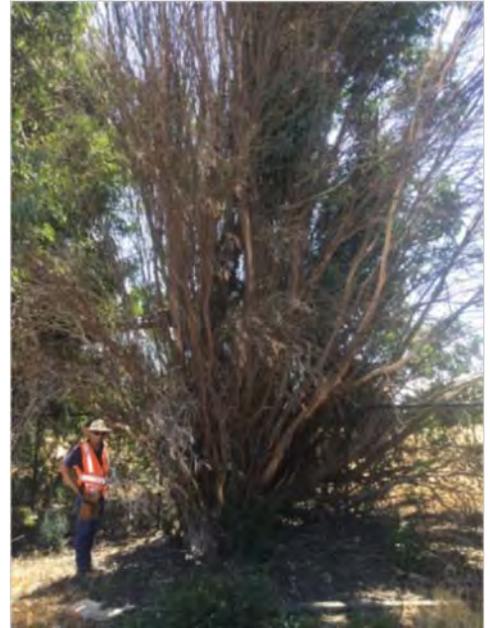
Eucalyptus ID# 91
Eucalyptus Tag# 226
Height: DBH: 10"/8"/7"
Health: 0% - Dead

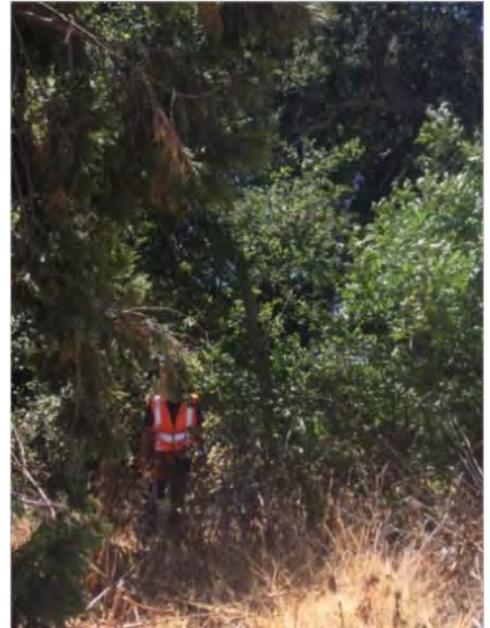
Oak, Coast Live ID# 110
Oak, Coast Live Tag# 343
Height: DBH: 1"-6"
Health: 20% - Critical

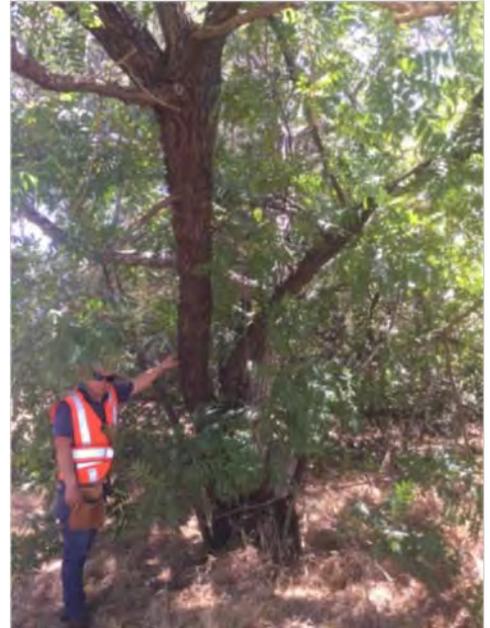
Juglans nigra ID# 129
eastern black walnut Tag# 249
Height: DBH: 11"/12...
Health: 20% - Critical

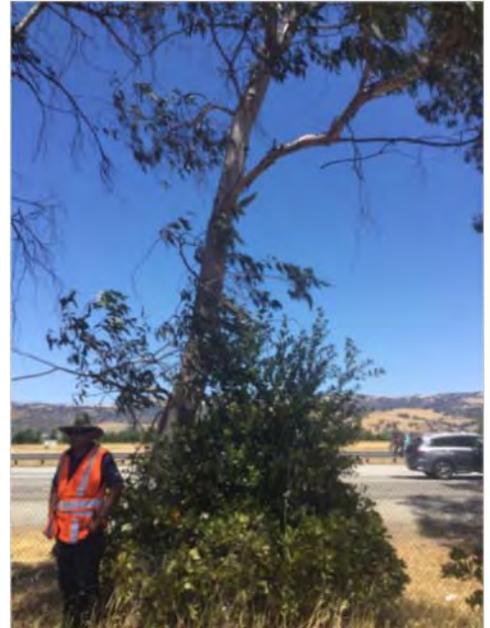
Eucalyptus ID# 188
Eucalyptus Tag# 303
Height: DBH: 32"
Health: 20% - Critical
