Appendix B
Tree Inventory & Protection Plan

**755 Jarvis Drive
Tree Inventory & Protection Plan**

755 Jarvis Drive
Morgan Hill, California

Prepared by:
Samuel Oakley
ISA Board Certified Master Arborist WE-9474B
ASCA Registered Consulting Arborist #556

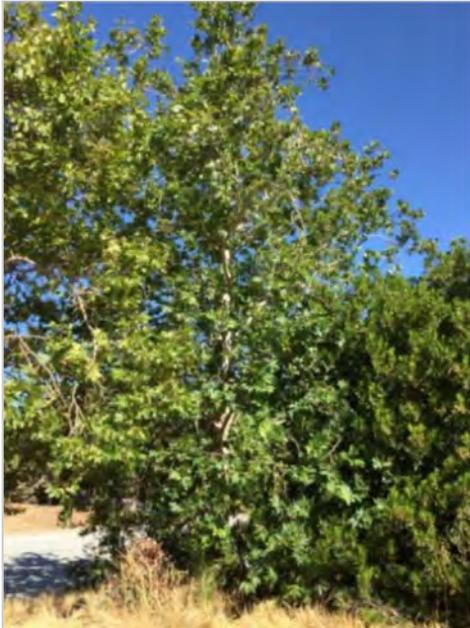
London Plane Tree ID# 1
 London Plane Tree Tag# 101
 Height: DBH: 13"-18"
 Health: 80% - Good

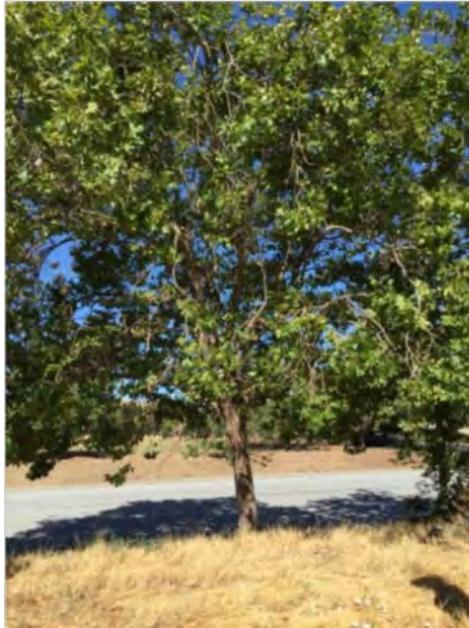
London Plane Tree ID# 2
 London Plane Tree Tag# 102
 Height: DBH: 13"-18"
 Health: 80% - Good

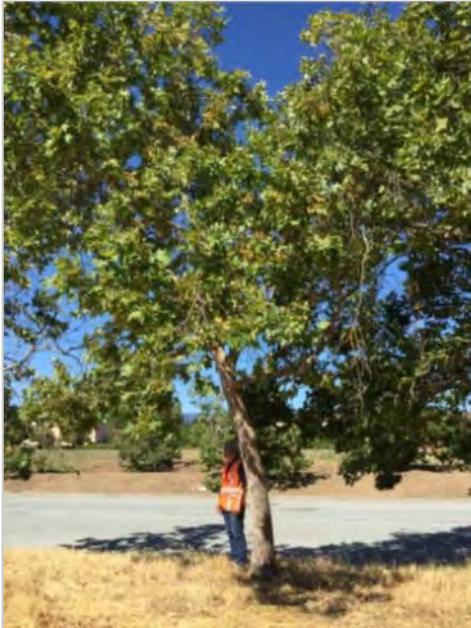
London Plane Tree ID# 3
London Plane Tree Tag# 104
Height:
Health: 60% - Fair
DBH: 7"-12"

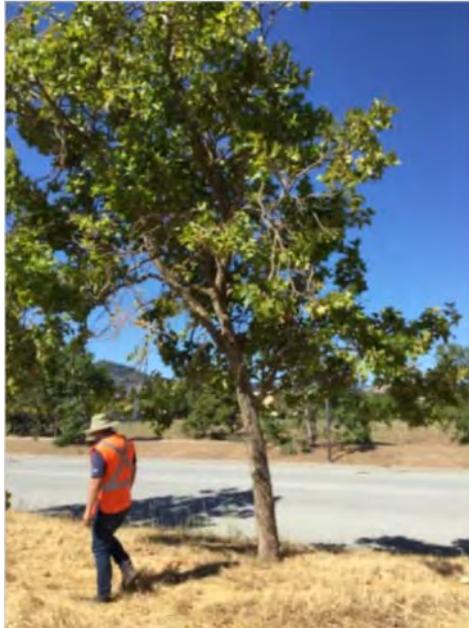
London Plane Tree ID# 5
London Plane Tree Tag# 105
Height:
Health: 60% - Fair
DBH: 7"-12"

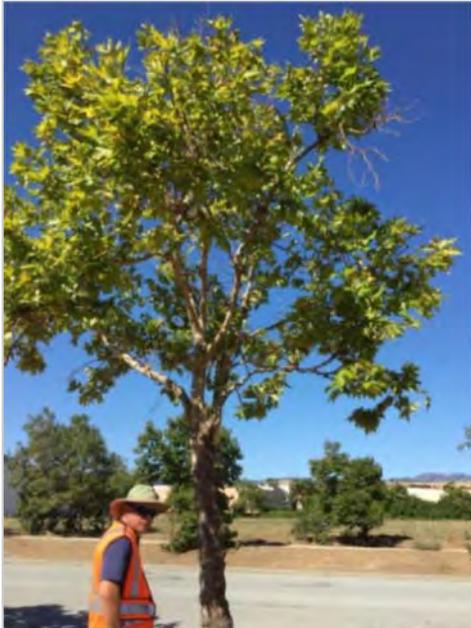
London Plane Tree ID# 7
London Plane Tree Tag# 107
Height: DBH: 7"-12"
Health: 60% - Fair

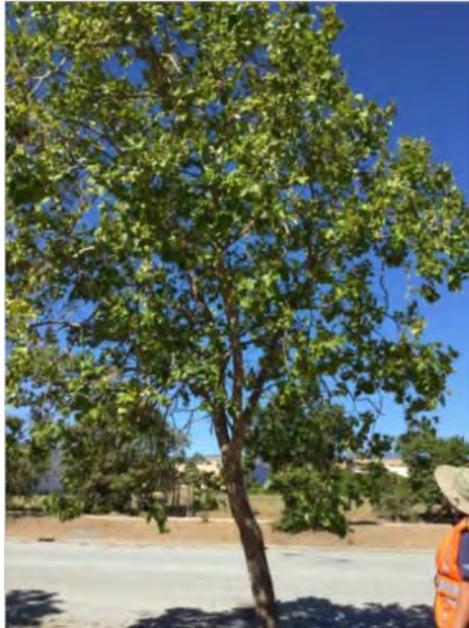
London Plane Tree ID# 8
London Plane Tree Tag# 108
Height: DBH: 7"-12"
Health: 60% - Fair

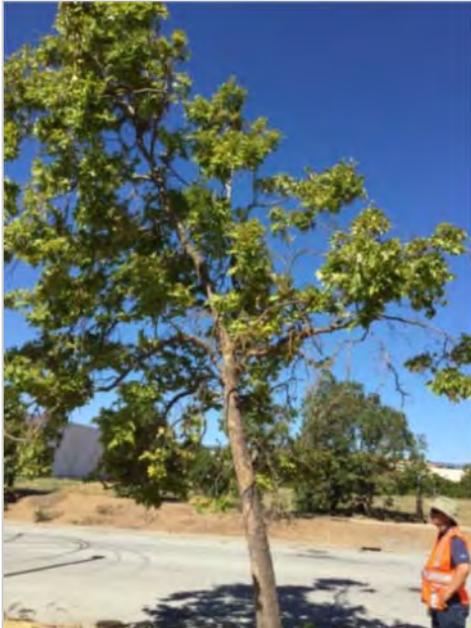
London Plane Tree ID# 10
 London Plane Tree Tag# 110
 Height: DBH: 7"-12"
 Health: 60% - Fair

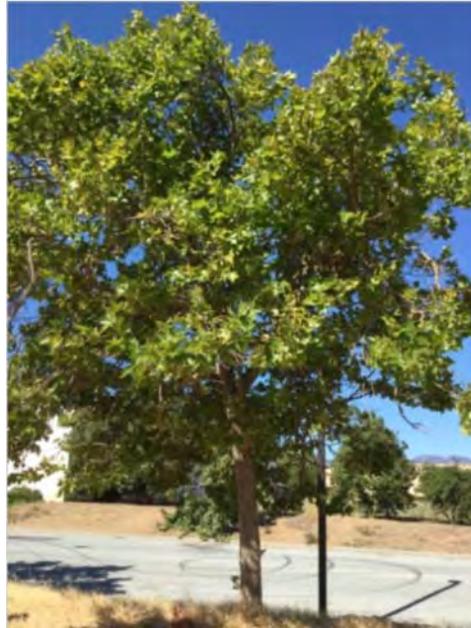
London Plane Tree ID# 11
 London Plane Tree Tag# 111
 Height: DBH: 7"-12"
 Health: 80% - Good

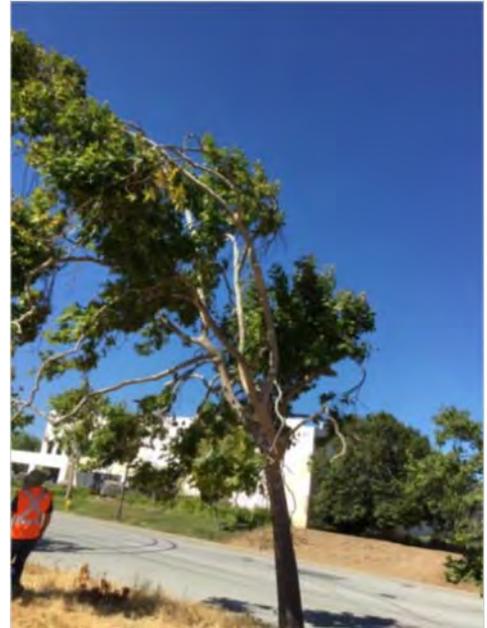
London Plane Tree ID# 12
 London Plane Tree Tag# 112
 Height: DBH: 7"-12"
 Health: 60% - Fair

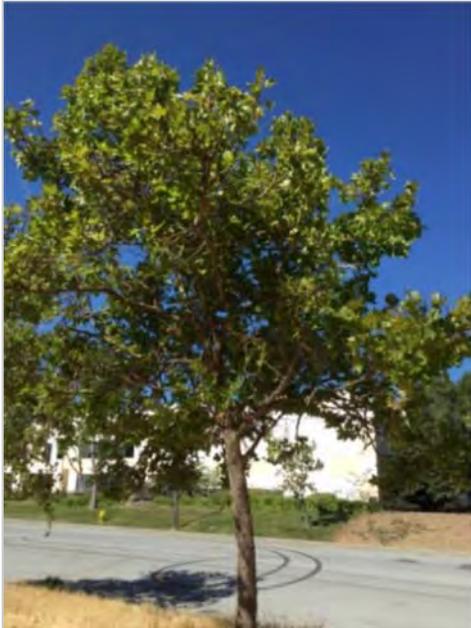
London Plane Tree ID# 13
 London Plane Tree Tag# 113
 Height:
 Health: 60% - Fair
 DBH: 7"-12"

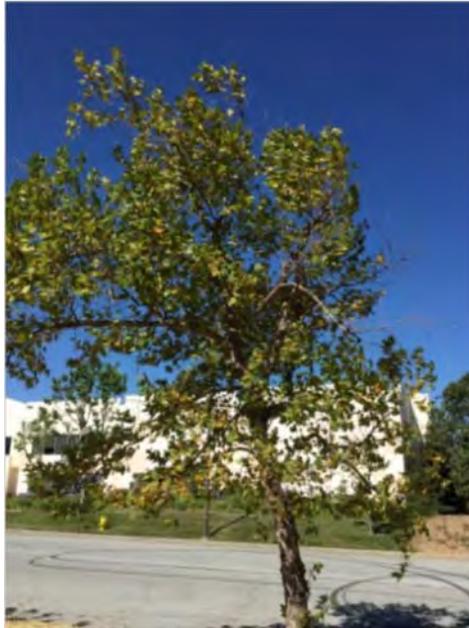
London Plane Tree ID# 14
 London Plane Tree Tag# 114
 Height:
 Health: 60% - Fair
 DBH: 7"-12"

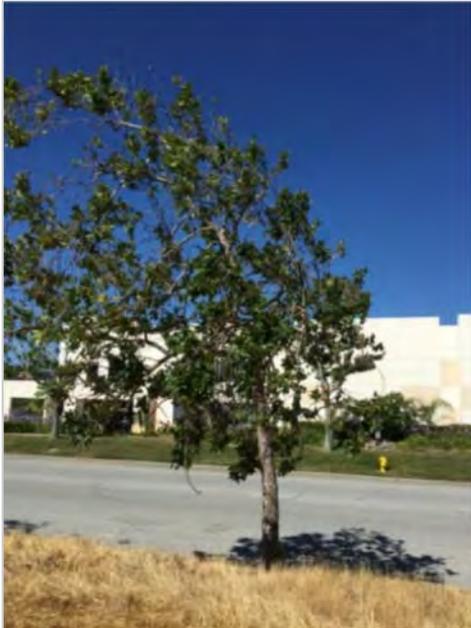
London Plane Tree ID# 16
 London Plane Tree Tag# 116
 Height: DBH: 7"-12"
 Health: 60% - Fair

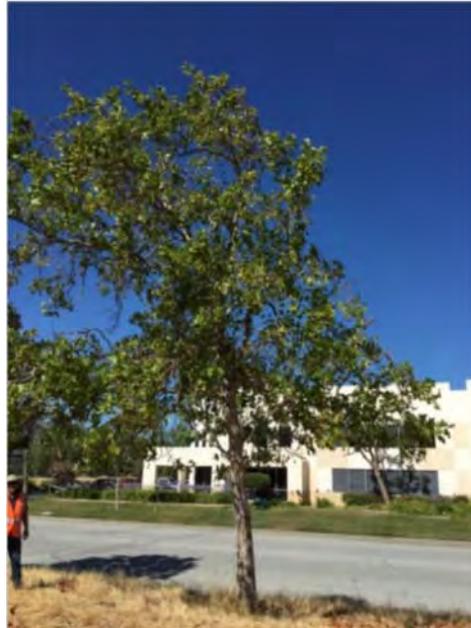
London Plane Tree ID# 17
 London Plane Tree Tag# 117
 Height: DBH: 7"-12"
 Health: 60% - Fair

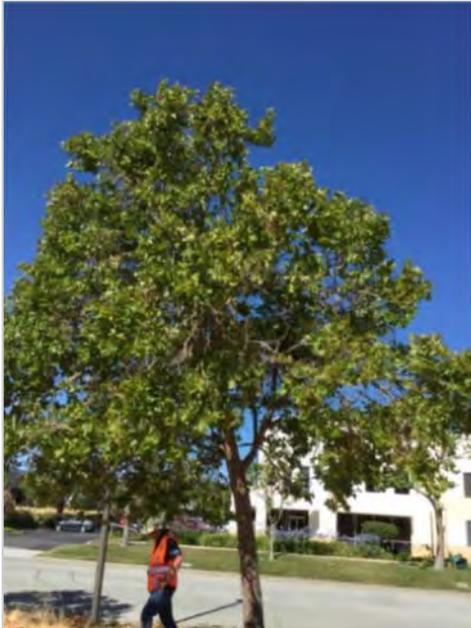
London Plane Tree ID# 19
 London Plane Tree Tag# 119
 Height:
 Health: 80% - Good
 DBH: 7"-12"

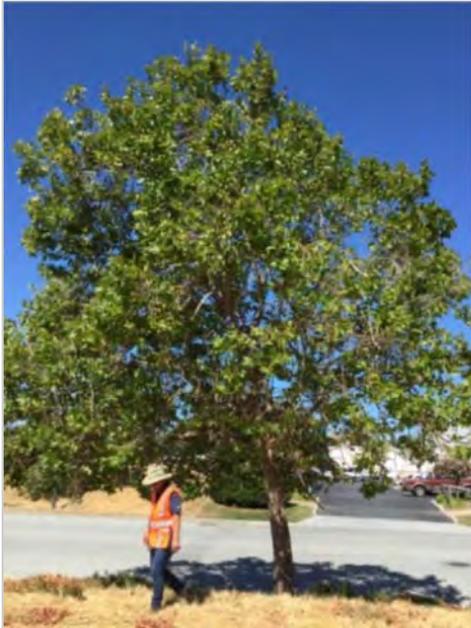
London Plane Tree ID# 22
London Plane Tree Tag# 122
Height:
Health: 80% - Good
DBH: 7"-12"

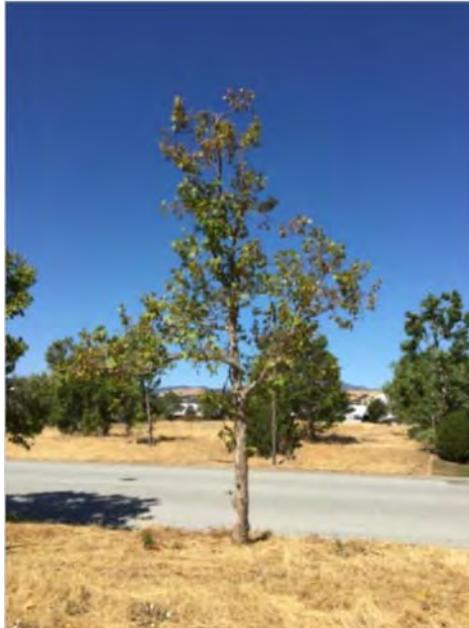
London Plane Tree ID# 23
London Plane Tree Tag# 123
Height:
Health: 60% - Fair
DBH: 1"-6"

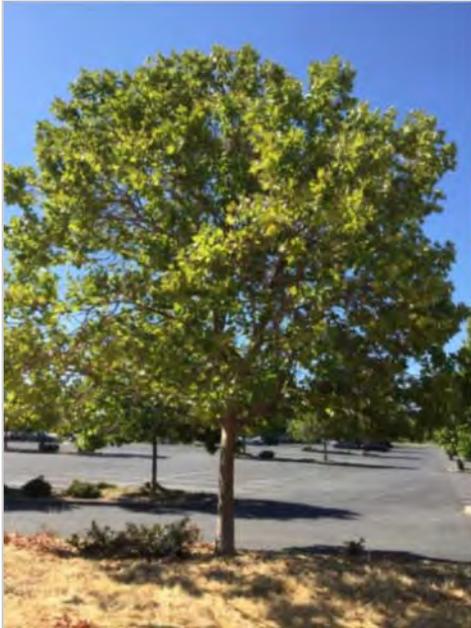
London Plane Tree ID# 25
 London Plane Tree Tag# 125
 Height: DBH: 7"-12"
 Health: 80% - Good

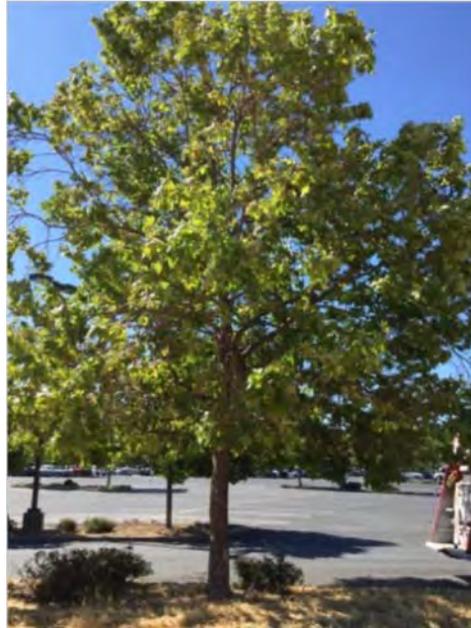
London Plane Tree ID# 26
 London Plane Tree Tag# 126
 Height: DBH: 7"-12"
 Health: 80% - Good

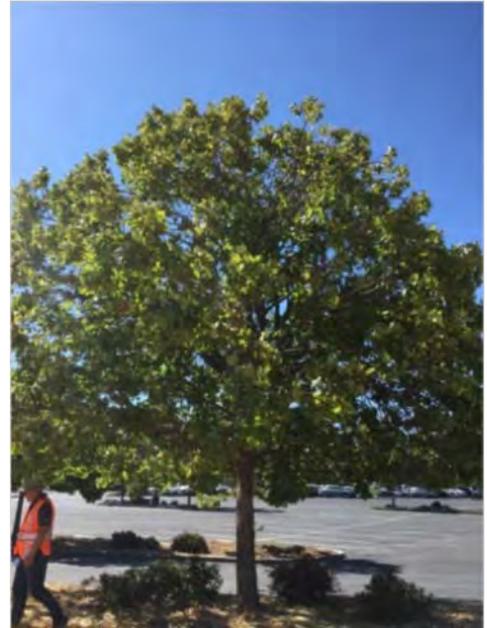
London Plane Tree ID# 27
 London Plane Tree Tag# 127
 Height: DBH: 7"-12"
 Health: 80% - Good

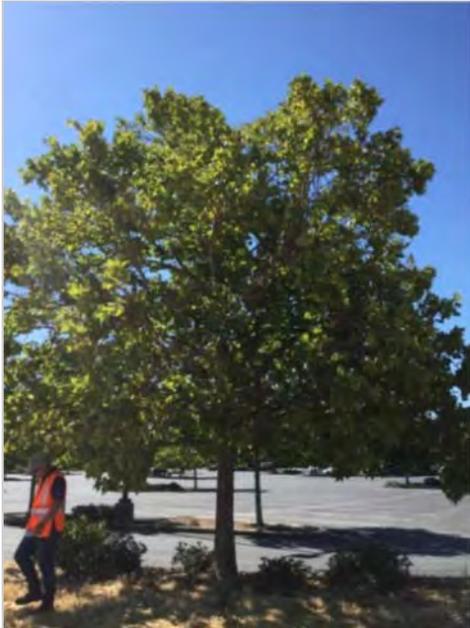
London Plane Tree ID# 28
 London Plane Tree Tag# 201
 Height:
 Health: 80% - Good
 DBH: 7"-12"

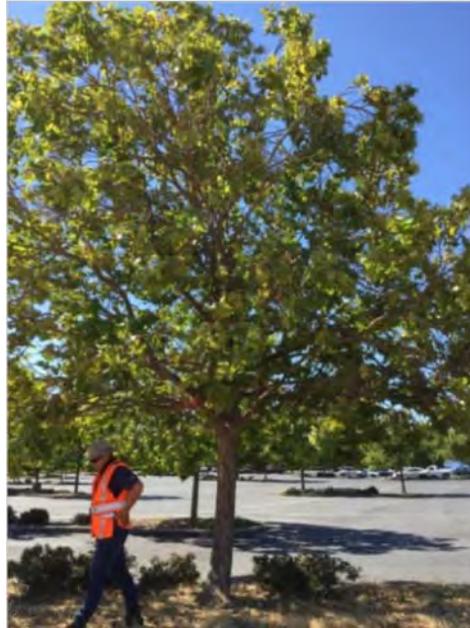
London Plane Tree ID# 29
 London Plane Tree Tag# 128
 Height:
 Health: 80% - Good
 DBH: 7"-12"

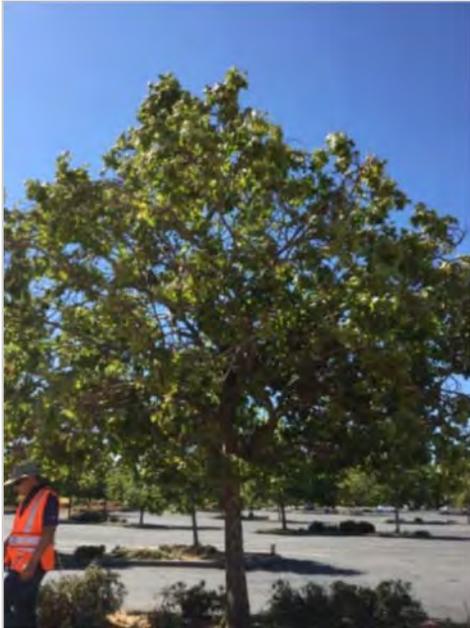
London Plane Tree ID# 31
 London Plane Tree Tag# 130
 Height: DBH: 7"-12"
 Health: 80% - Good

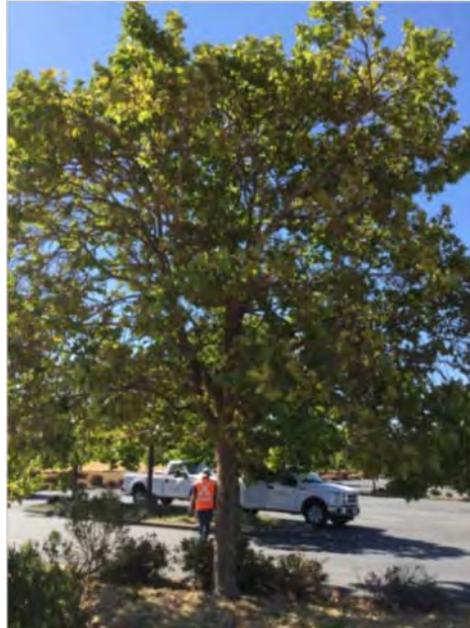
London Plane Tree ID# 32
 London Plane Tree Tag# 131
 Height: DBH: 7"-12"
 Health: 80% - Good

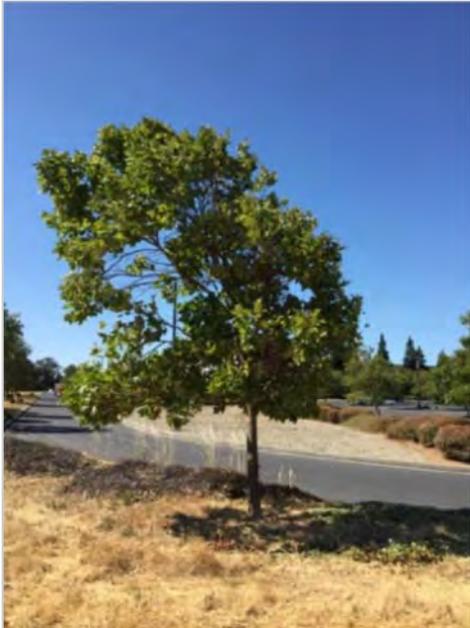
London Plane Tree ID# 34
 London Plane Tree Tag# 133
 Height: DBH: 1"-6"
 Health: 80% - Good

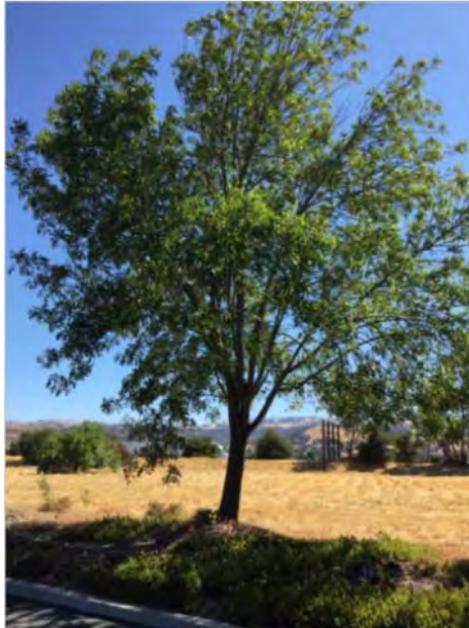
fraxinus uhdei ID# 35
 fraxinus uhdei Tag# 134
 Height: DBH: 7"-12"
 Health: 80% - Good

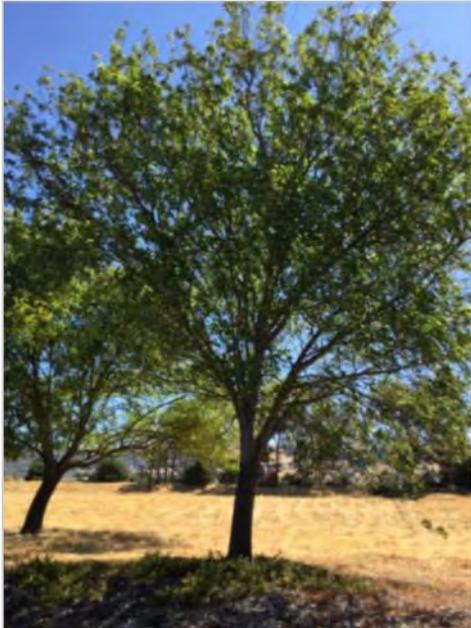
fracsinus uhdei ID# 37
fracsinus uhdei Tag# 136
Height: DBH: 7"-12"
Health: 60% - Fair

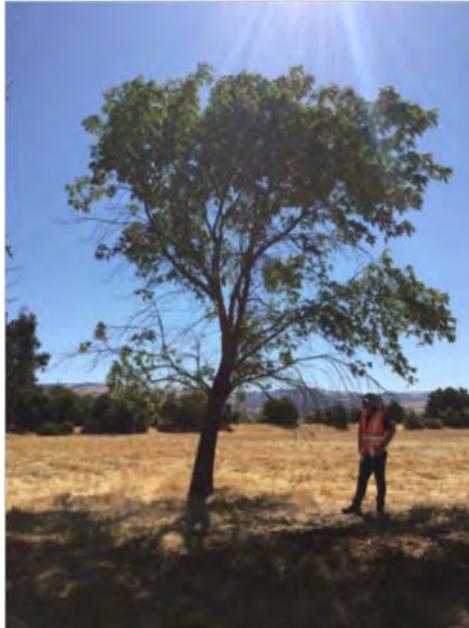
fracsinus uhdei ID# 38
fracsinus uhdei Tag# 137
Height: DBH: 7"-12"
Health: 40% - Poor

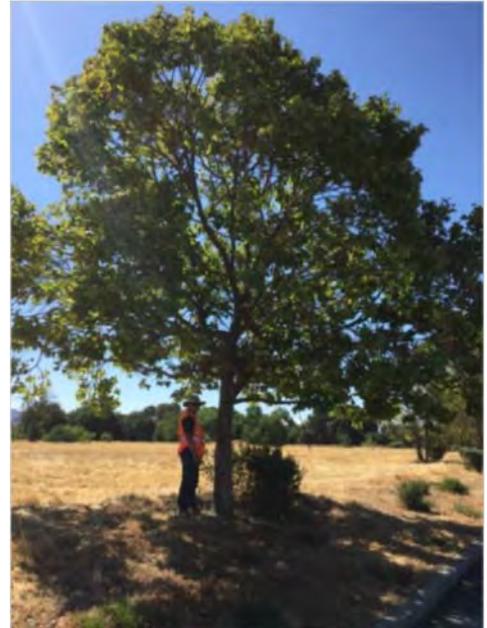
London Plane Tree ID# 39
London Plane Tree Tag# 138
Height: DBH: 7"-12"
Health: 80% - Good

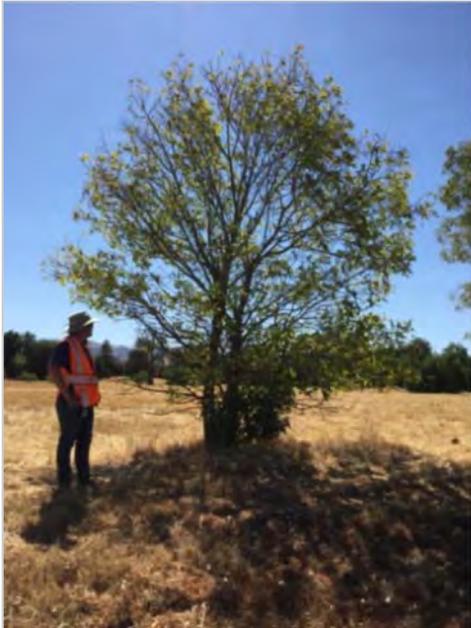
fracsinus uhdei ID# 40
 fracsinus uhdei Tag# 139
 Height: DBH: multi s...
 Health: 40% - Poor

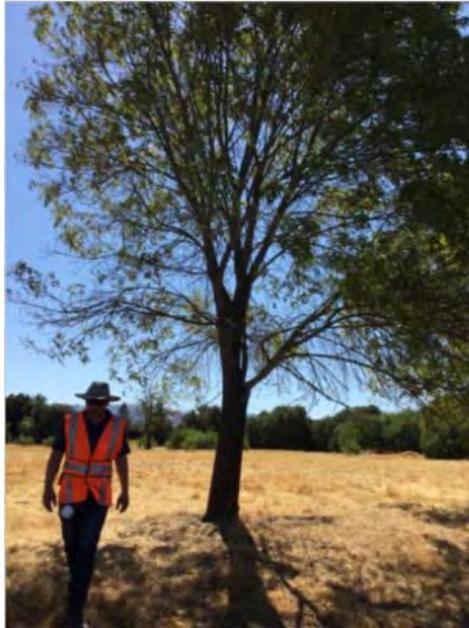
fracsinus uhdei ID# 41
 fracsinus uhdei Tag# 140
 Height: DBH: 7"-12"
 Health: 60% - Fair

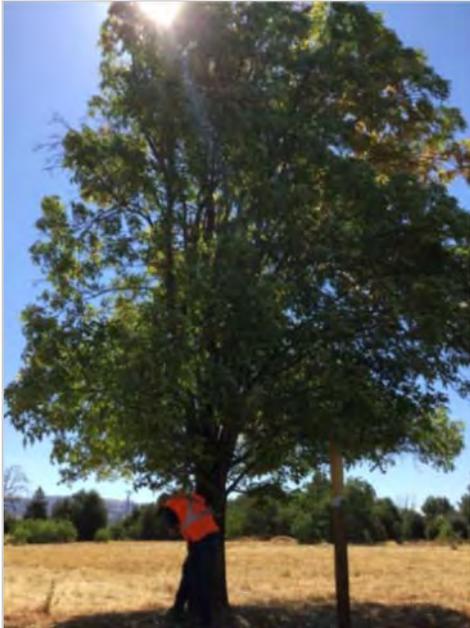
fracsinus uhdei ID# 43
fracsinus uhdei Tag# 142
Height: DBH: 13"-18"
Health: 60% - Fair

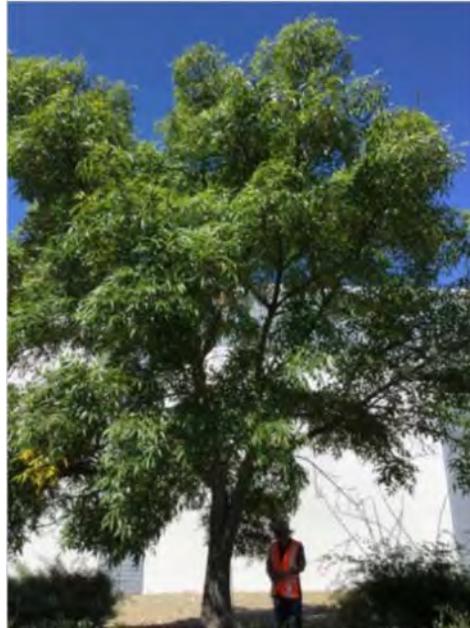
fracsinus uhdei ID# 44
fracsinus uhdei Tag# 143
Height: DBH: 7"-12"
Health: 20% - Critical

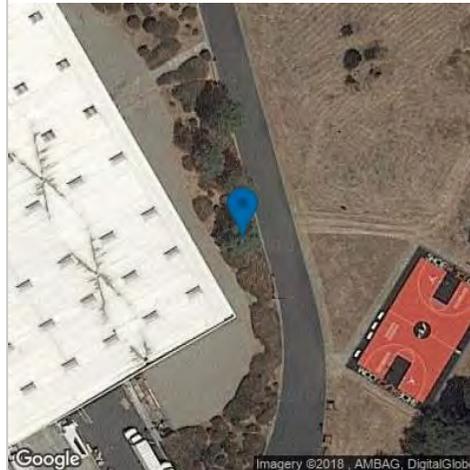
755 Jarvis Dr
gurdled root

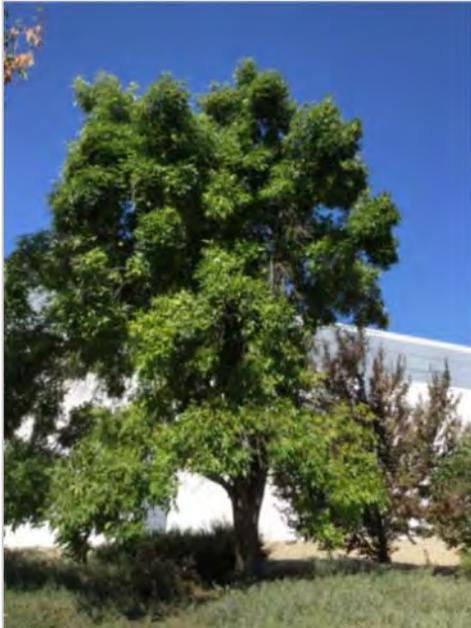
fracsinus uhdei ID# 46
fracsinus uhdei Tag# 145
Height: DBH: 13"-18"
Health: 20% - Critical

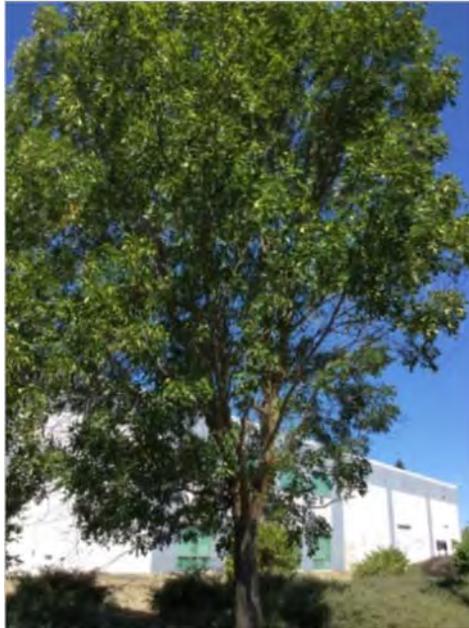
fracsinus uhdei ID# 47
fracsinus uhdei Tag# 146
Height: DBH: 13"-18"
Health: 40% - Poor

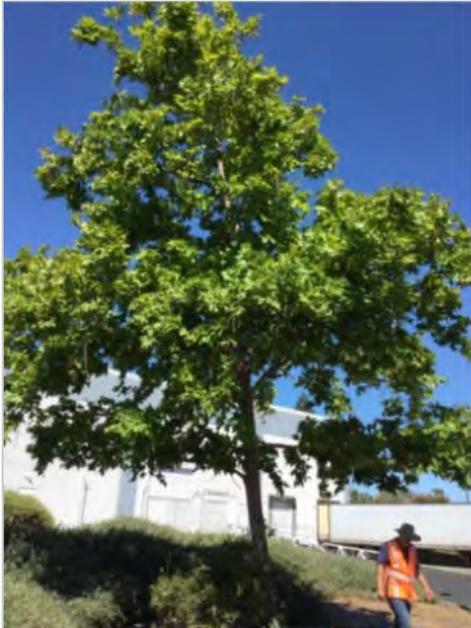
London Plane Tree ID# 49
 London Plane Tree Tag# 148
 Height: DBH: 7"-12"
 Health: 80% - Good

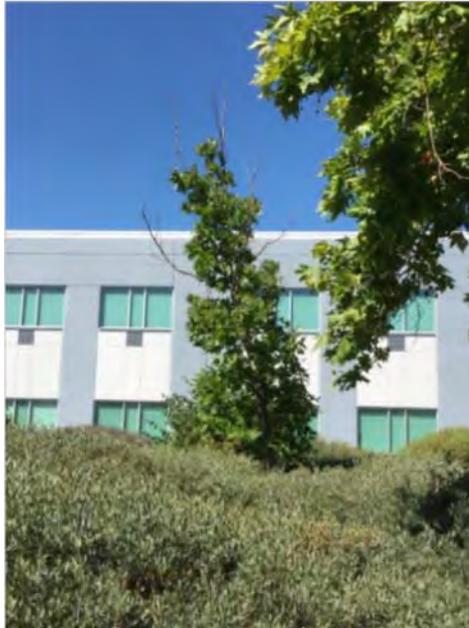
London Plane Tree ID# 50
 London Plane Tree Tag# 149
 Height: DBH: 7"-12"
 Health: 40% - Poor

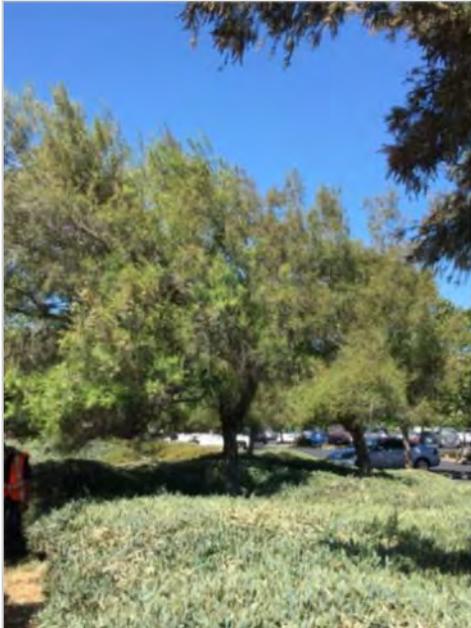
Melaleuca, Flaxleaf Paperb... ID# 52
 Melaleuca, Flaxleaf Paperb... Tag# 151
 Height: DBH: 7"-12"
 Health: 40% - Poor

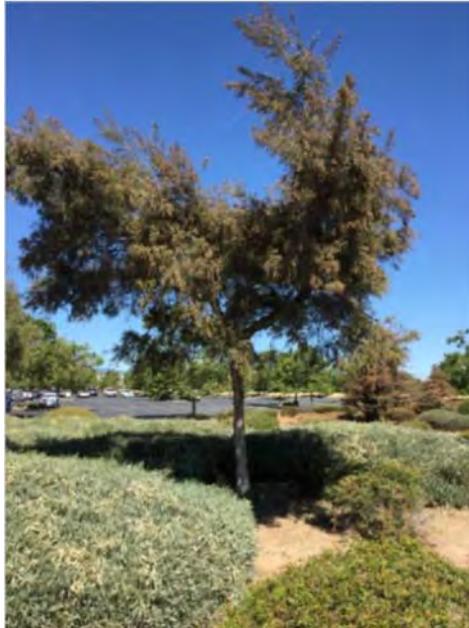
Melaleuca, Flaxleaf Paperb... ID# 53
 Melaleuca, Flaxleaf Paperb... Tag# 152
 Height: DBH: 1"-6"
 Health: 40% - Poor

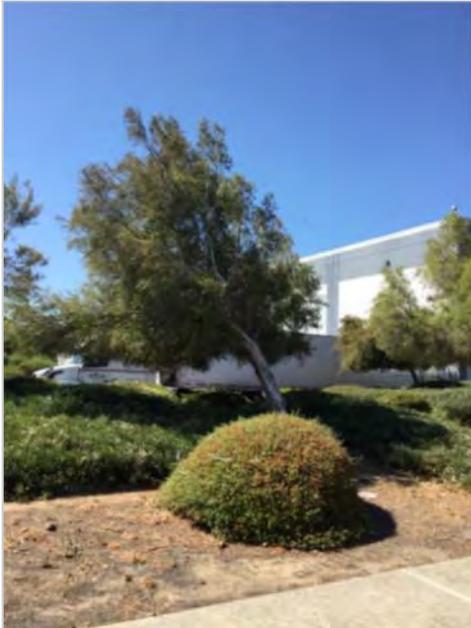
Melaleuca, Flaxleaf Paperb... ID# 55
 Melaleuca, Flaxleaf Paperb... Tag# 154
 Height: DBH: 7"-12"
 Health: 40% - Poor

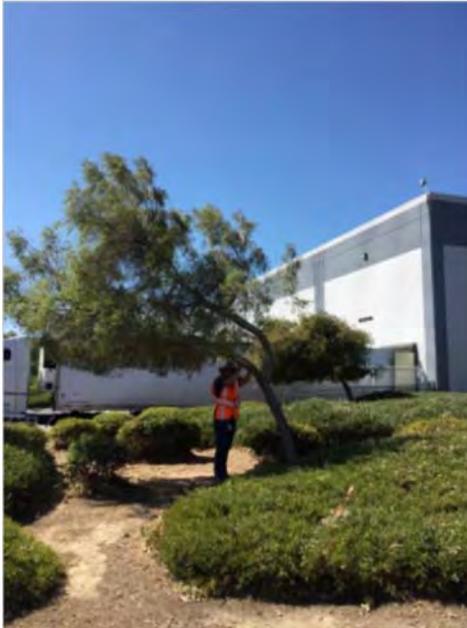
Melaleuca, Flaxleaf Paperb... ID# 56
 Melaleuca, Flaxleaf Paperb... Tag# 155
 Height: DBH: 1"-6"
 Health: 40% - Poor

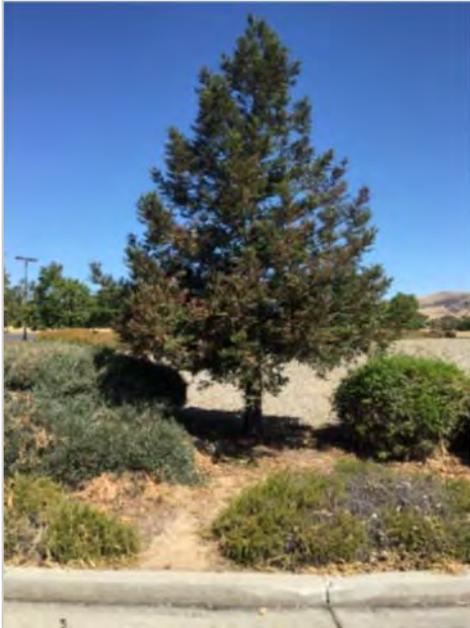
sequoia sempervivans ID# 58
sequoia sempervivans Tag# 157
Height: DBH: 7"-12"
Health: 60% - Fair

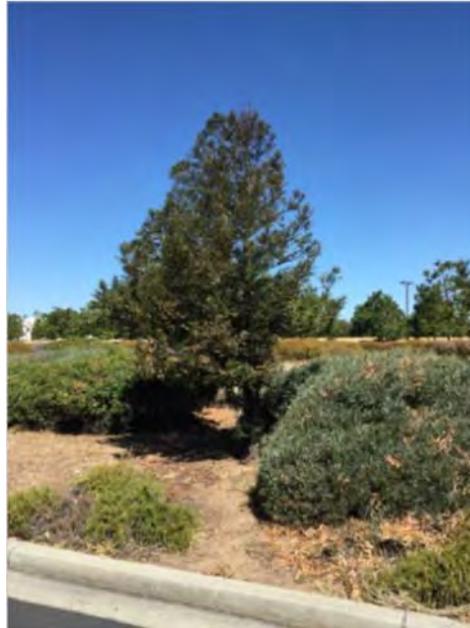
sequoia sempervivans ID# 59
sequoia sempervivans Tag# 158
Height: DBH: 1"-6"
Health: 60% - Fair

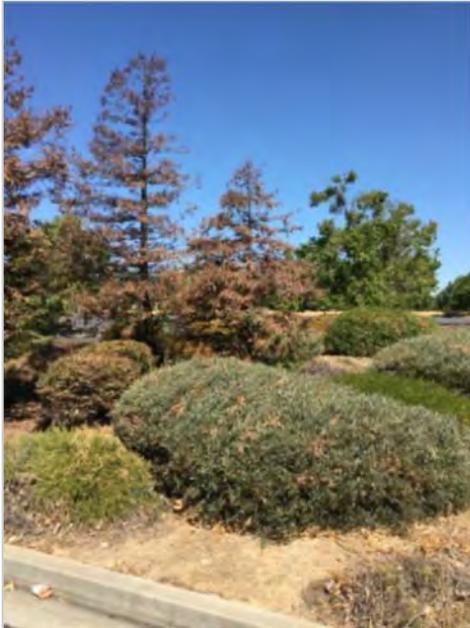
sequoia sempervivans ID# 61
sequoia sempervivans Tag# 160
Height:
Health: 20% - Critical
DBH: 7"-12"

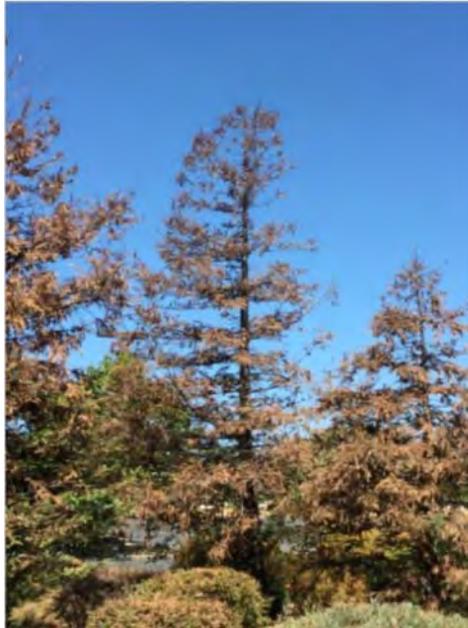
sequoia sempervivans ID# 62
sequoia sempervivans Tag# 161
Height:
Health: 20% - Critical
DBH: 7"-12"

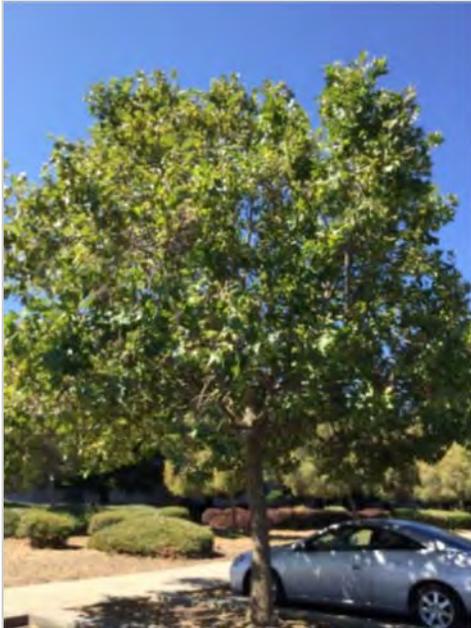
London Plane Tree ID# 64
London Plane Tree Tag# 163
Height: DBH: 7"-12"
Health: 80% - Good

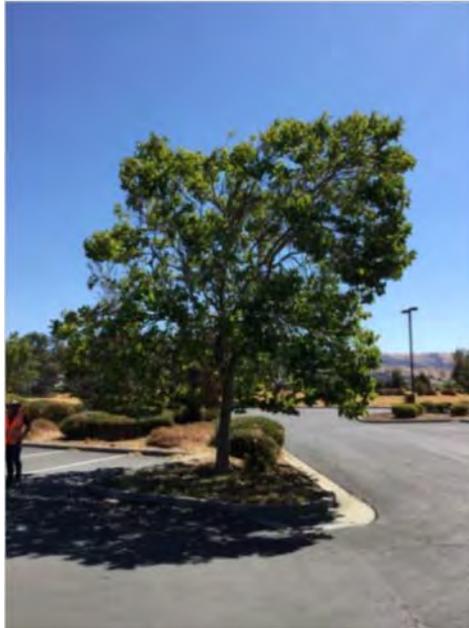
London Plane Tree ID# 65
London Plane Tree Tag# 164
Height: DBH: 7"-12"
Health: 80% - Good

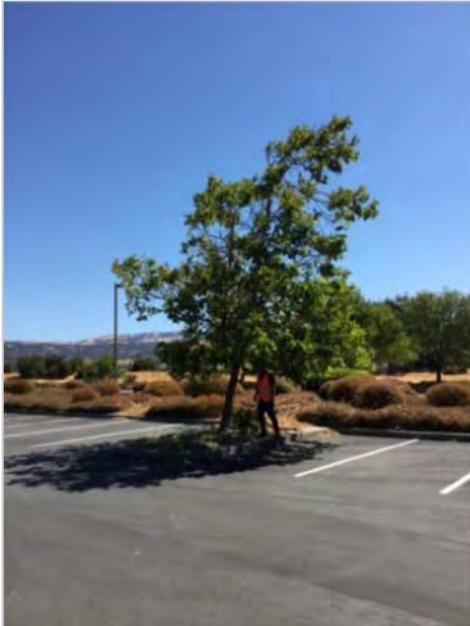
London Plane Tree ID# 67
 London Plane Tree Tag# 166
 Height:
 Health: 80% - Good
 DBH: 7"-12"

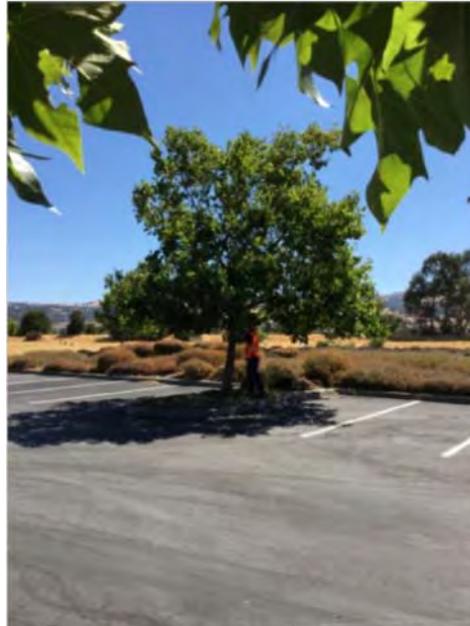
London Plane Tree ID# 68
 London Plane Tree Tag# 167
 Height:
 Health: 80% - Good
 DBH: 7"-12"

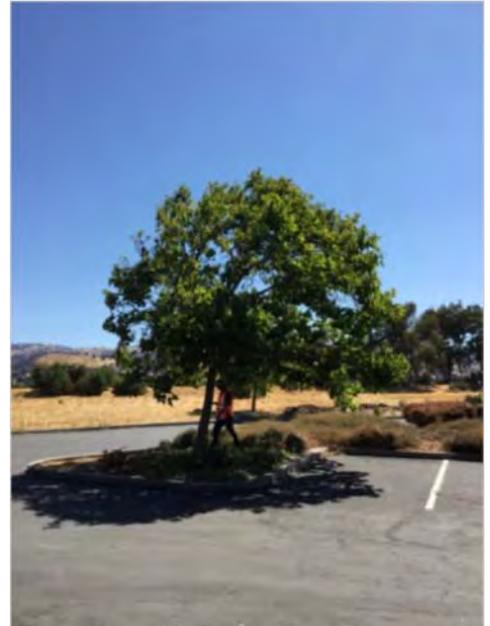
London Plane Tree ID# 69
 London Plane Tree Tag# 168
 Height:
 Health: 80% - Good
 DBH: 7"-12"

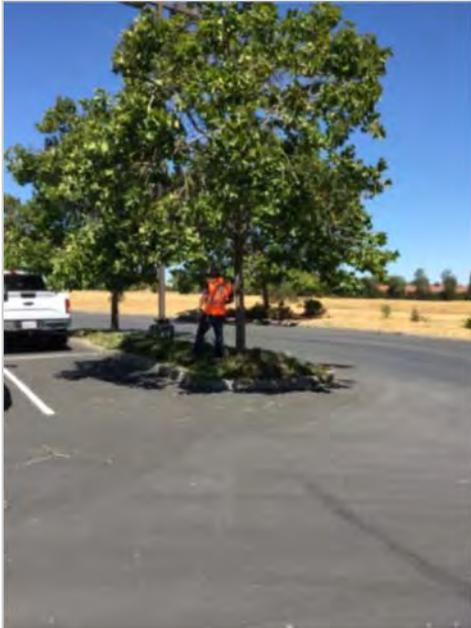
London Plane Tree ID# 70
 London Plane Tree Tag# 169
 Height: DBH: 7"-12"
 Health: 80% - Good

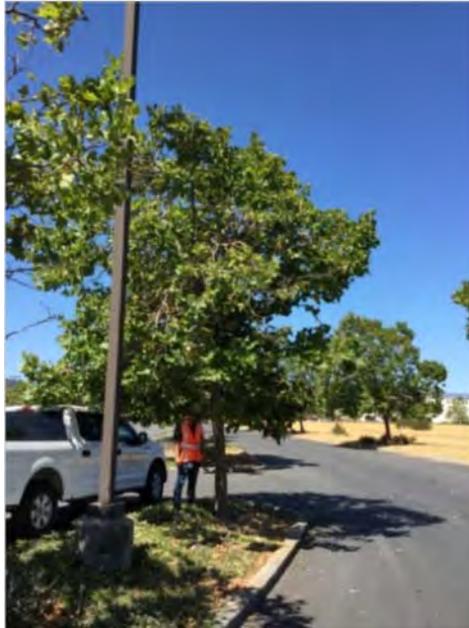
London Plane Tree ID# 71
 London Plane Tree Tag# 170
 Height: DBH: 7"-12"
 Health: 80% - Good

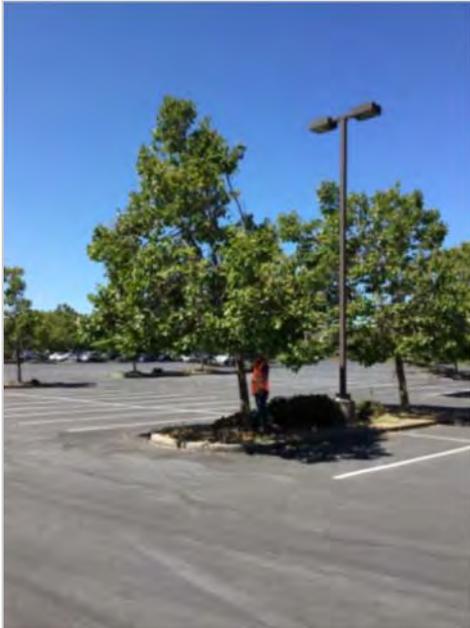
London Plane Tree ID# 73
London Plane Tree Tag# 172
Height: DBH: 1"-6"
Health: 80% - Good

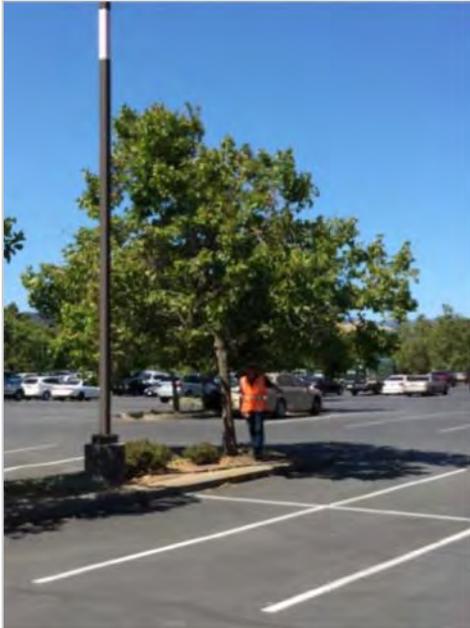
London Plane Tree ID# 76
London Plane Tree Tag# 175
Height:
Health: 80% - Good
DBH: 7"-12"

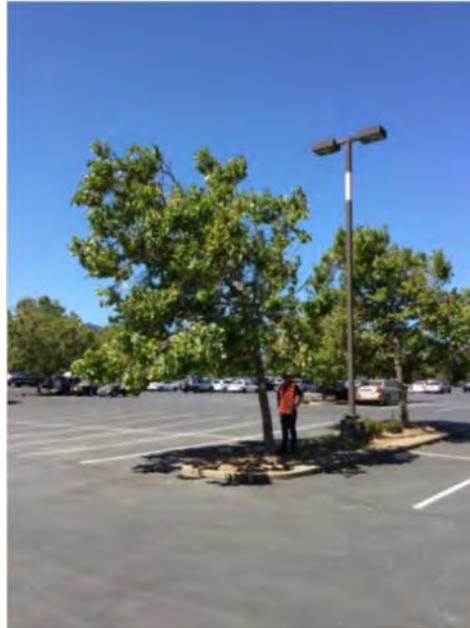
London Plane Tree ID# 77
London Plane Tree Tag# 176
Height:
Health: 80% - Good
DBH: 7"-12"

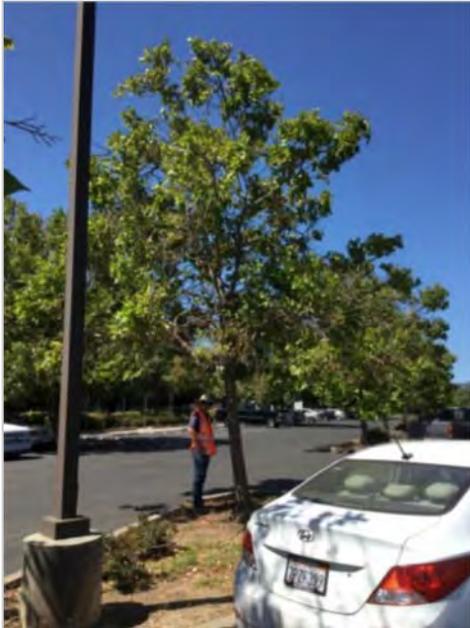
London Plane Tree ID# 79
 London Plane Tree Tag# 178
 Height: DBH: 7"-12"
 Health: 80% - Good

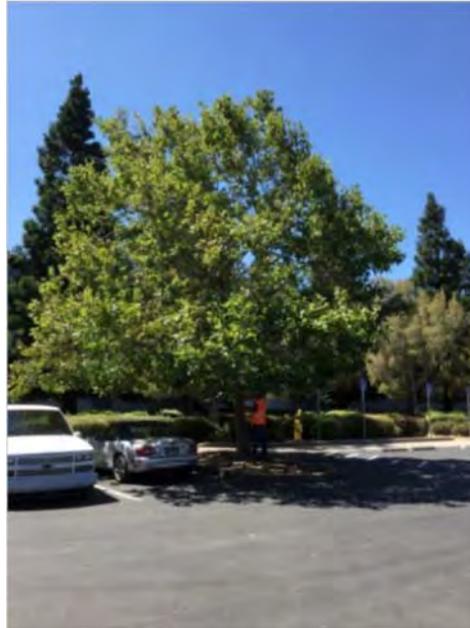
London Plane Tree ID# 80
 London Plane Tree Tag# 179
 Height: DBH: 7"-12"
 Health: 80% - Good

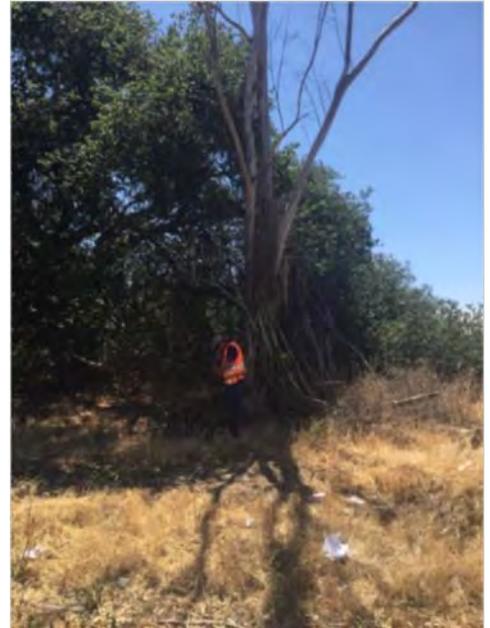
Eucalyptus ID# 81
 Eucalyptus Tag# 216
 Height: DBH: 19"-24"
 Health: 0% - Dead

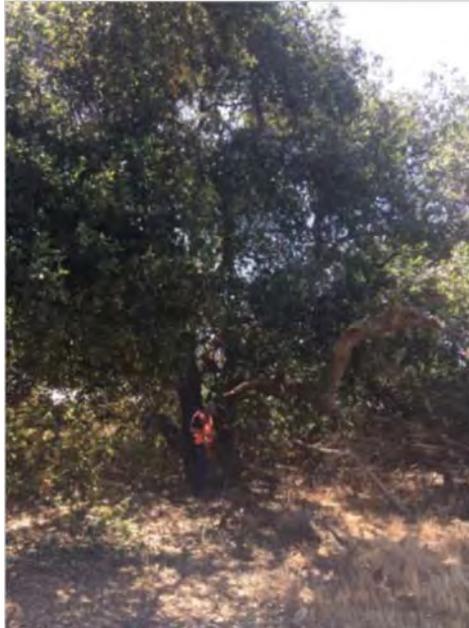
Oak, Coast Live ID# 82
Oak, Coast Live Tag# 217
Height:
Health: 60% - Fair

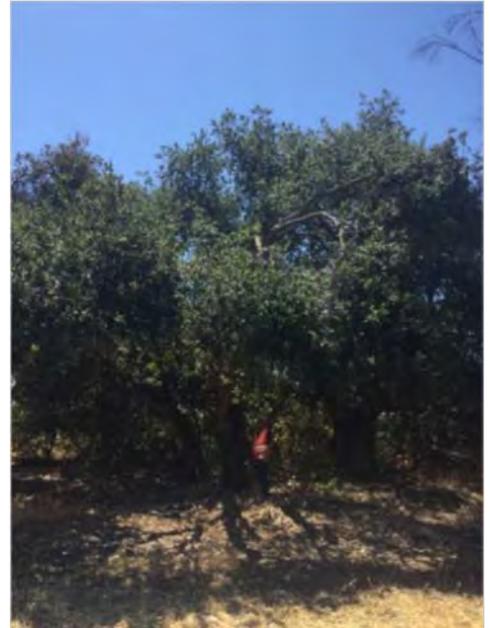
Oak, Coast Live ID# 83
Oak, Coast Live Tag# 218
DBH: 31"-36"

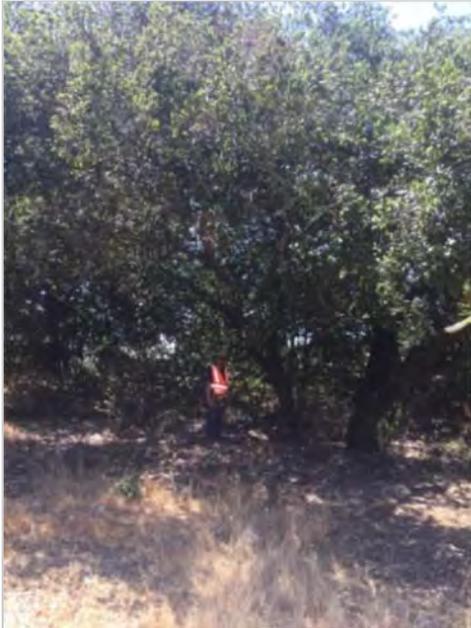
Oak, Coast Live ID# 85
Oak, Coast Live Tag# 219
DBH: 19"-24"

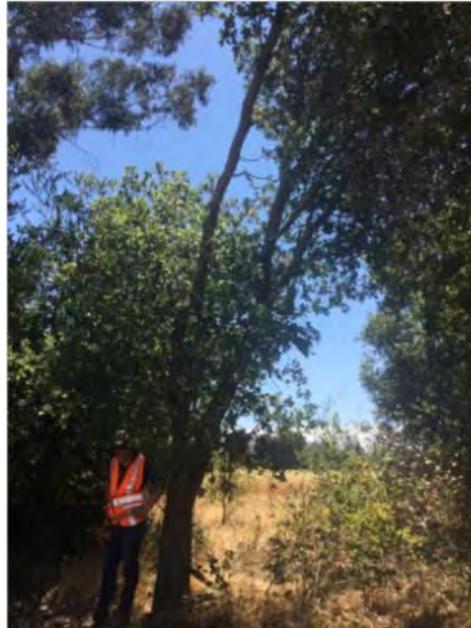
Oak, Coast Live ID# 86
Oak, Coast Live Tag# 221
DBH: 7"-12"

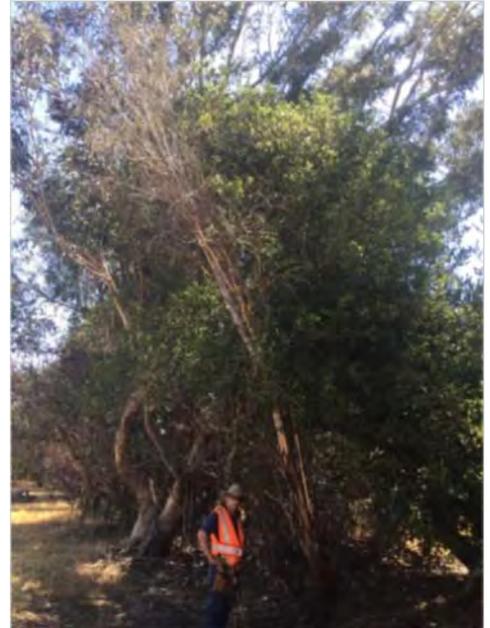
Eucalyptus ID# 87
Eucalyptus Tag# 222
Height:
Health: 0% - Dead DBH: 7"-12"

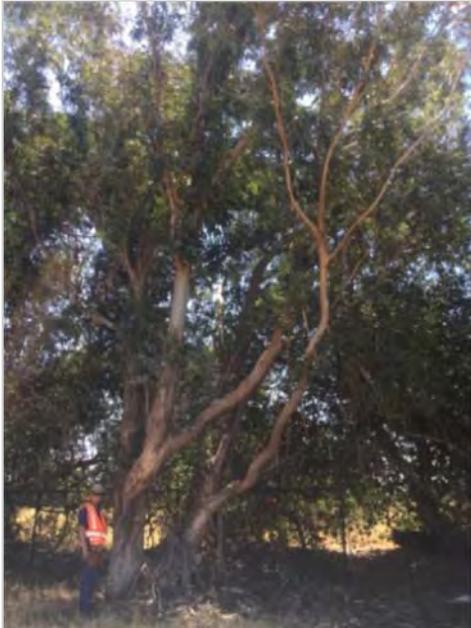
Eucalyptus ID# 88
Eucalyptus Tag# 223
Height: DBH: 31"-36"
Health: 40% - Poor

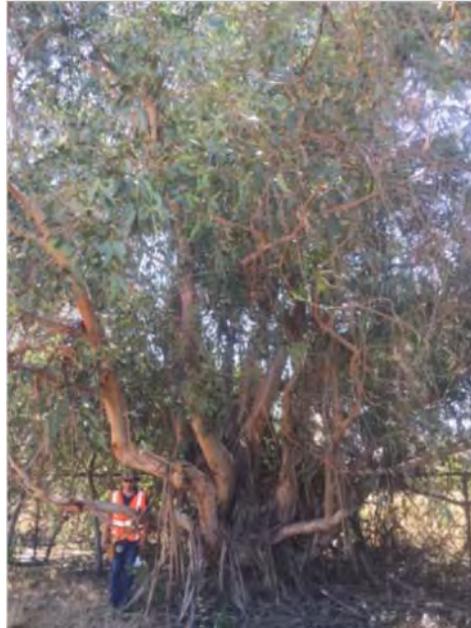
Eucalyptus ID# 89
Eucalyptus Tag# 224
Height: DBH: 43"-48"
Health: 40% - Poor

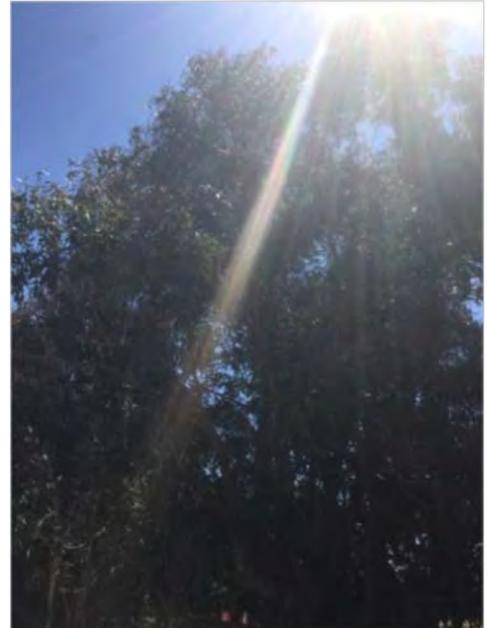
Eucalyptus ID# 89
Eucalyptus Tag# 224
Height: DBH: 43"-48"
Health: 40% - Poor

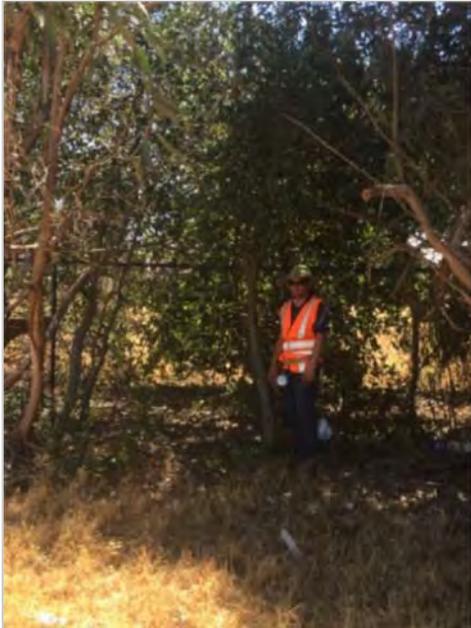
Oak, Coast Live ID# 90
Oak, Coast Live Tag# 225
Height: DBH: 1"-6"
Health: 60% - Fair

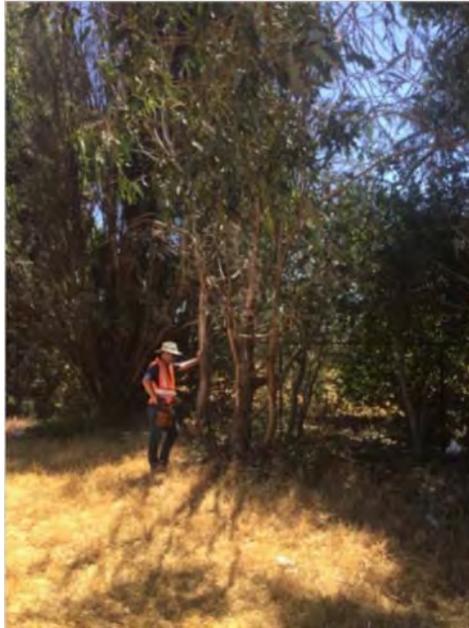
Eucalyptus ID# 91
Eucalyptus Tag# 226
Height: DBH: 10"/8"/7"
Health: 0% - Dead

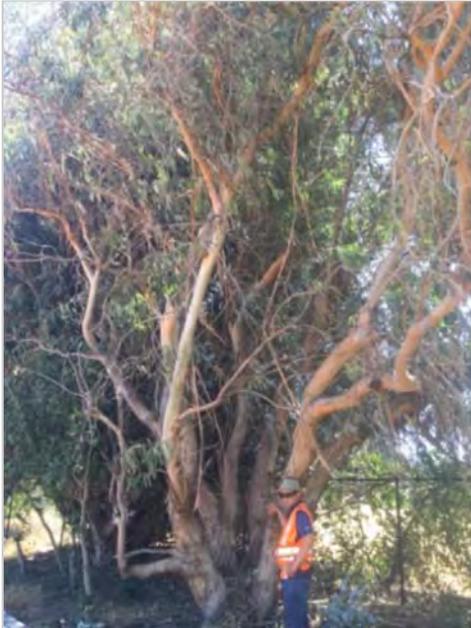
Eucalyptus ID# 93
Eucalyptus Tag# 228
Height:
DBH: 16"/15...
Health: 40% - Poor

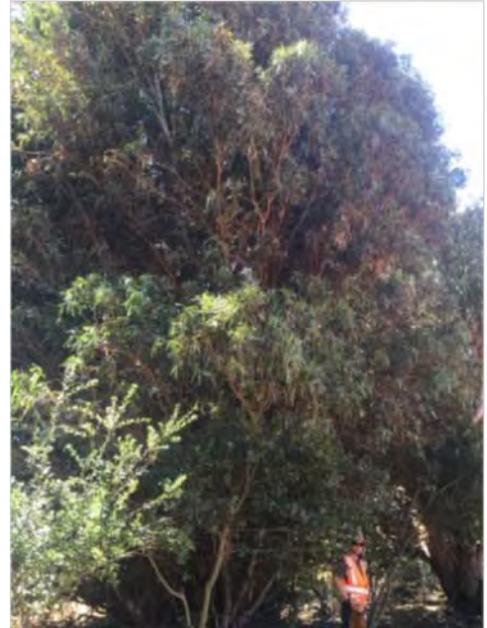
Eucalyptus ID# 94
Eucalyptus Tag# 229
Height:
DBH: 60"
Health: 40% - Poor

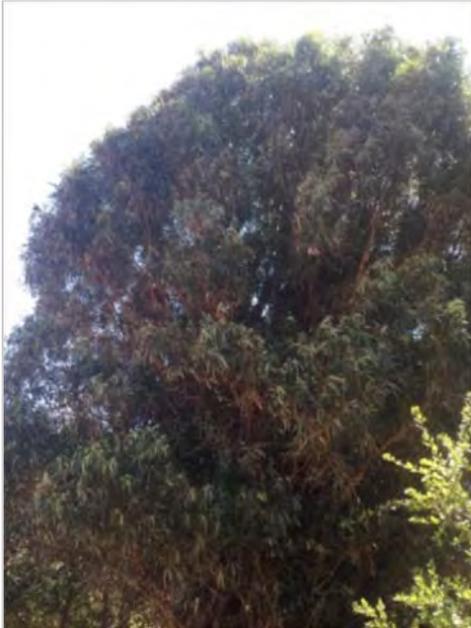
Eucalyptus ID# 95
Eucalyptus Tag# 230
Height:
Health: 40% - Poor

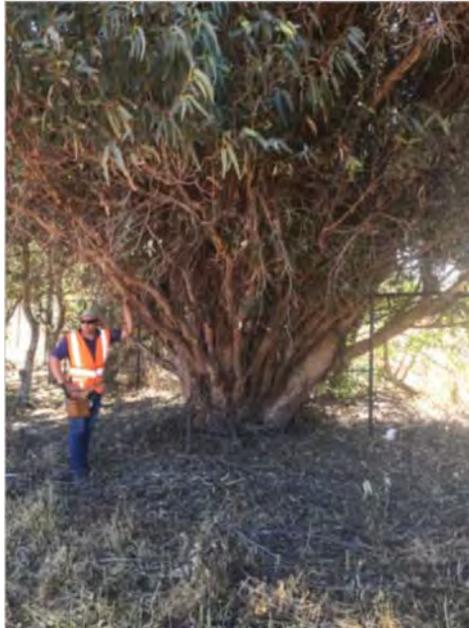
Eucalyptus ID# 95
Eucalyptus Tag# 230
Height:
Health: 40% - Poor
