Appendix B
Tree Inventory & Protection Plan

**755 Jarvis Drive
Tree Inventory & Protection Plan**

755 Jarvis Drive
Morgan Hill, California

Prepared by:
Samuel Oakley
ISA Board Certified Master Arborist WE-9474B
ASCA Registered Consulting Arborist #556

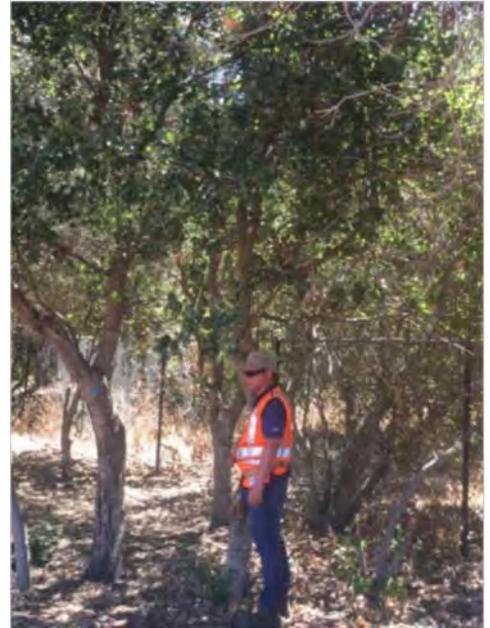
Oak, Coast Live ID# 96
Oak, Coast Live Tag# 232
Height:
Health: 40% - Poor

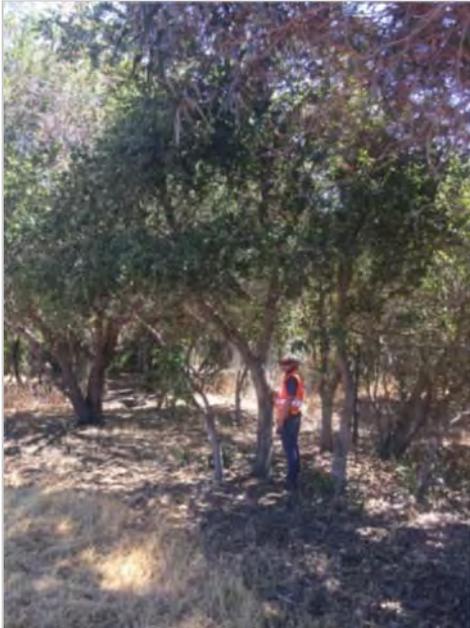
Oak, Coast Live ID# 97
Oak, Coast Live Tag# 231
Height: DBH: 7"-12"
Health: 60% - Fair

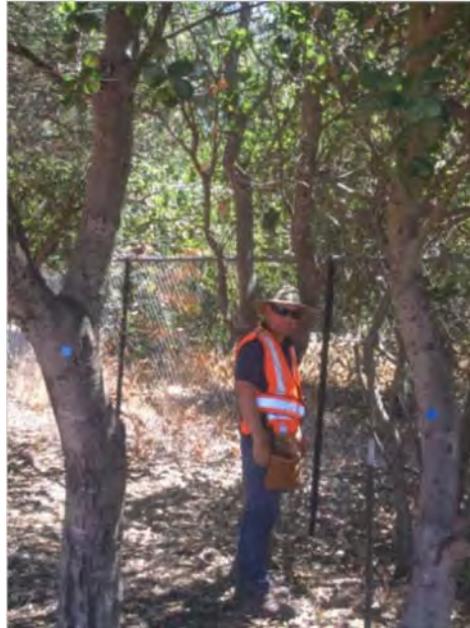
Oak, Coast Live ID# 98
Oak, Coast Live Tag# 233
Height: DBH: 1"-6"
Health: 60% - Fair

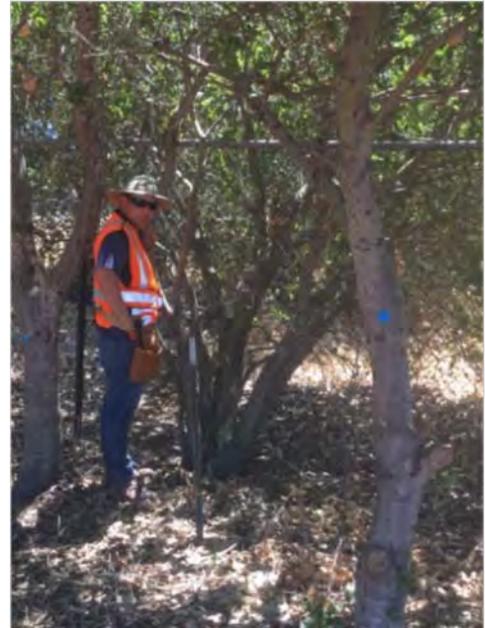
Oak, Coast Live ID# 99
Oak, Coast Live Tag# 342
Height: DBH: 5"/6"/3...
Health: 60% - Fair

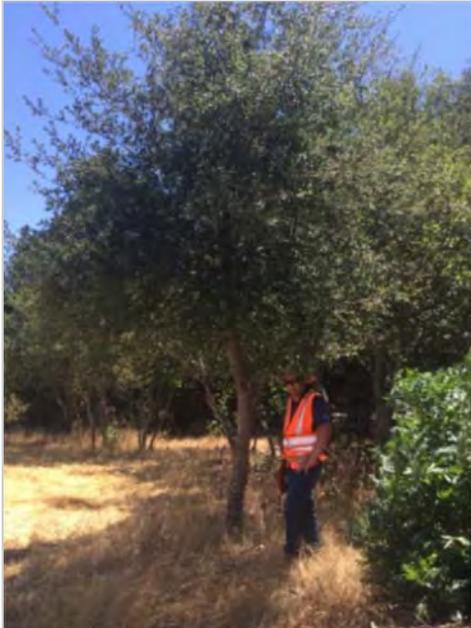
Oak, Coast Live ID# 102
Oak, Coast Live Tag# 236
Height: DBH: 5"/3"
Health: 60% - Fair

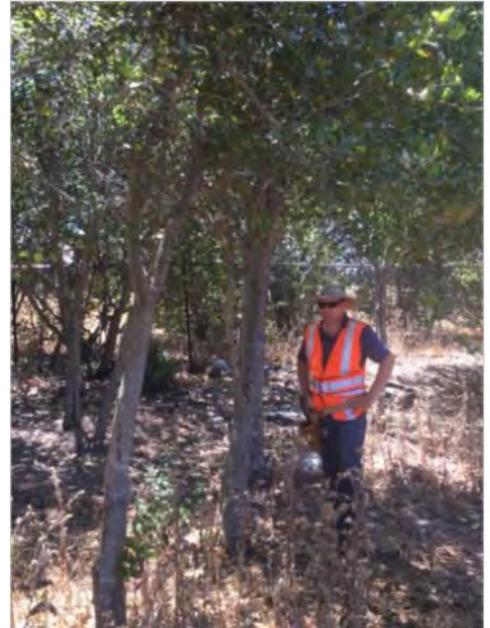
Oak, Coast Live ID# 104
Oak, Coast Live Tag# 238
Height: DBH: 1"-6"
Health: 60% - Fair

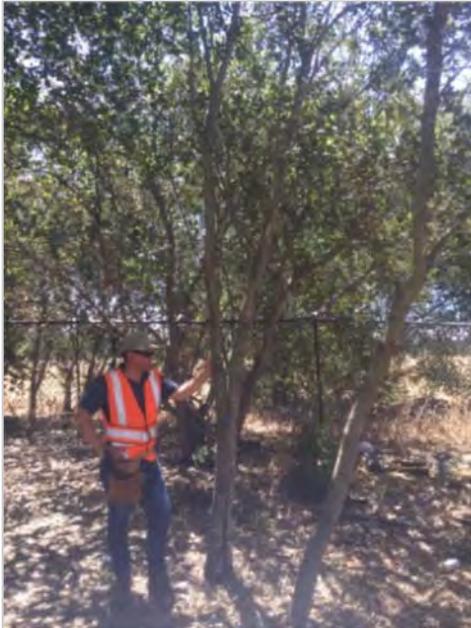
Oak, Coast Live ID# 105
 Oak, Coast Live Tag# 239
 Height: DBH: 6"/4"
 Health: 60% - Fair

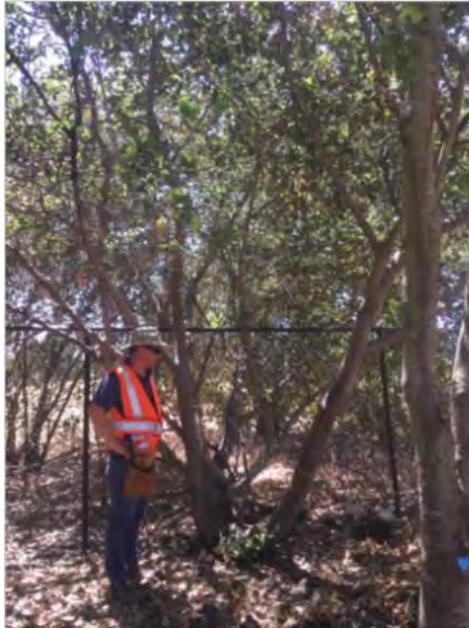
Oak, Coast Live ID# 106
 Oak, Coast Live Tag# 240
 Height: DBH: 5"/7"/6"
 Health: 40% - Poor

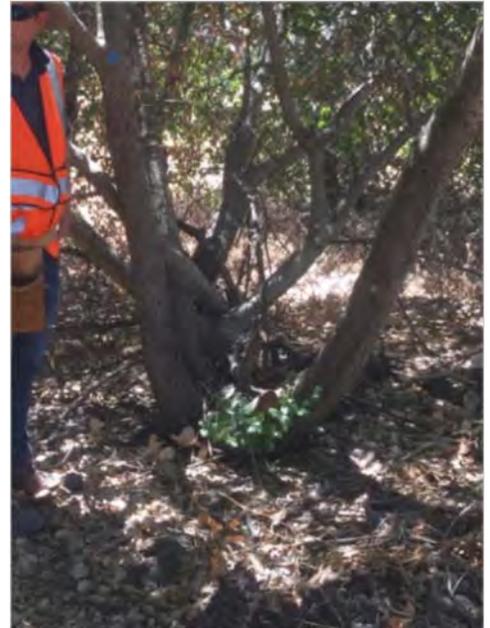
Oak, Coast Live ID# 106
 Oak, Coast Live Tag# 240
 Height: DBH: 5"/7"/6"
 Health: 40% - Poor

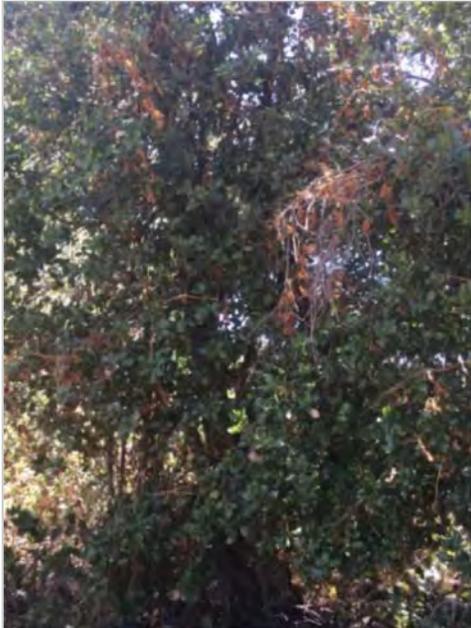
Oak, Coast Live ID# 110
Oak, Coast Live Tag# 343
Height: DBH: 1"-6"
Health: 20% - Critical

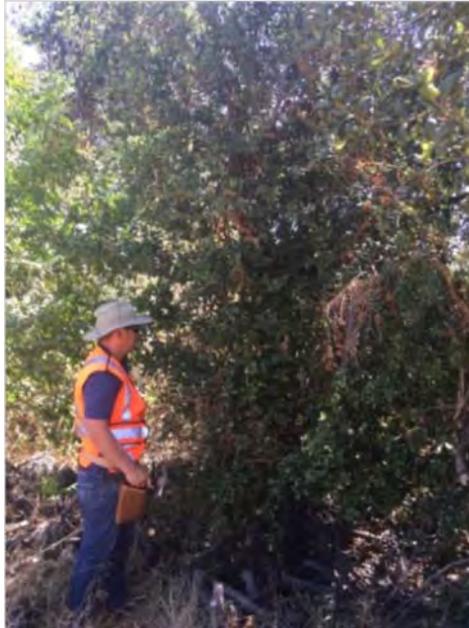
Oak, Coast Live ID# 110
Oak, Coast Live Tag# 343
Height: DBH: 1"-6"
Health: 20% - Critical

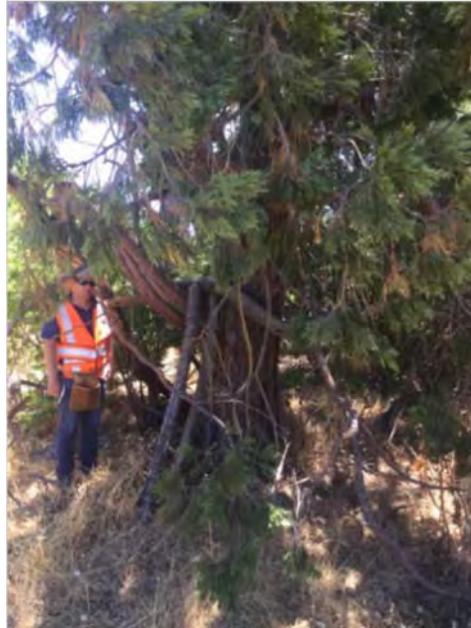
Cedar, Incense ID# 112
Cedar, Incense Tag# 245
Height: DBH: 31"-36"
Health: 20% - Critical

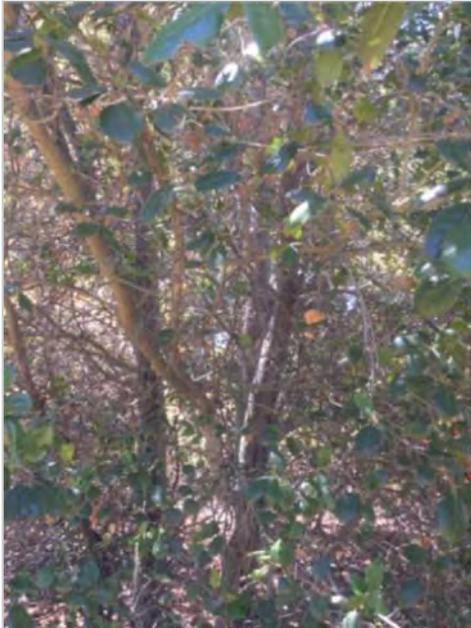
Oak, Coast Live ID# 114
Oak, Coast Live Tag# 345
Height: DBH: 9"/9"/10"
Health: 40% - Poor

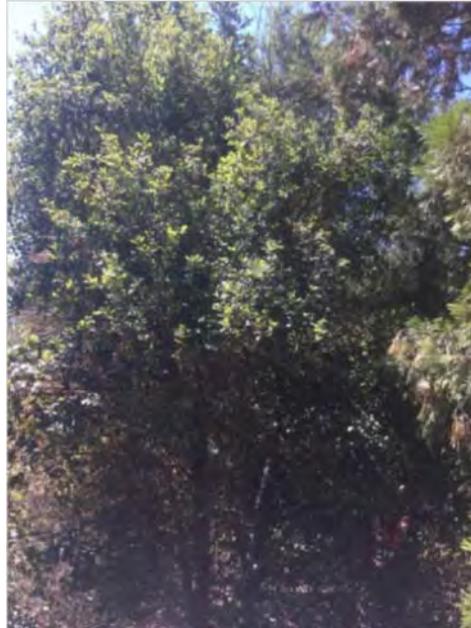
Oak, Coast Live ID# 114
Oak, Coast Live Tag# 345
Height: DBH: 9"/9"/10"
Health: 40% - Poor

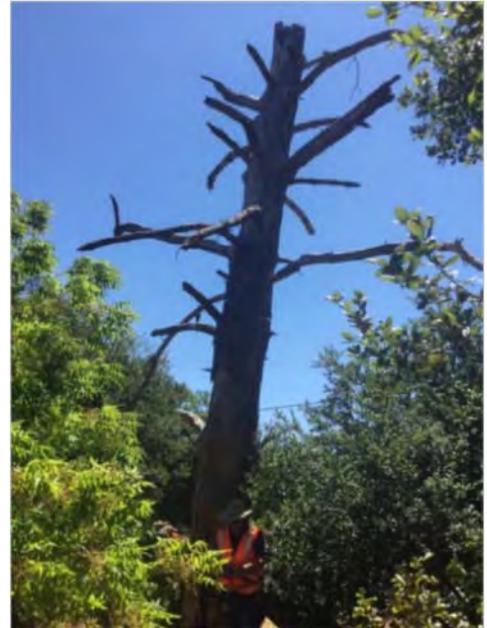
Pine, Monterey ID# 115
Pine, Monterey Tag# 346
Height: DBH: 25"-30"
Health: 0% - Dead

115	346	Monterey Pine	Pinus radiata	25"-30"	0% - Dead	Remove Based on Conflicts with Design Plans & Condition	No	Yes	No
116	347	Coast Live Oak	Quercus agrifolia	5"	40% - Poor	Remove Based on Conflicts with Design Plans & Condition	Yes	No	No
117	348	Coast Live Oak	Quercus agrifolia	5"	40% - Poor	Remove Based on Conflicts with Design Plans & Condition	Yes	No	No
118	349	Coast Live Oak	Quercus agrifolia	7"-12"	40% - Poor	Remove Based on Conflicts with Design Plans & Condition	Yes	Yes	No
119	350	Coast Live Oak	Quercus agrifolia	5 1/6"	40% - Poor	Remove Based on Conflicts with Design Plans & Condition	Yes	Yes	No
120	351	Coast Live Oak	Quercus agrifolia	5"	40% - Poor	Remove Based on Conflicts with Design Plans & Condition	Yes	No	No
121	258	Coast Live Oak	Quercus agrifolia	10"	60% - Fair	Remove Based on Conflicts with Design Plans	Yes	Yes	No
122	259	Peruvian Pepper	Schinus molle	7 1/4"	40% - Poor	Remove Based on Conflicts with Design Plans & Condition	No	No	No

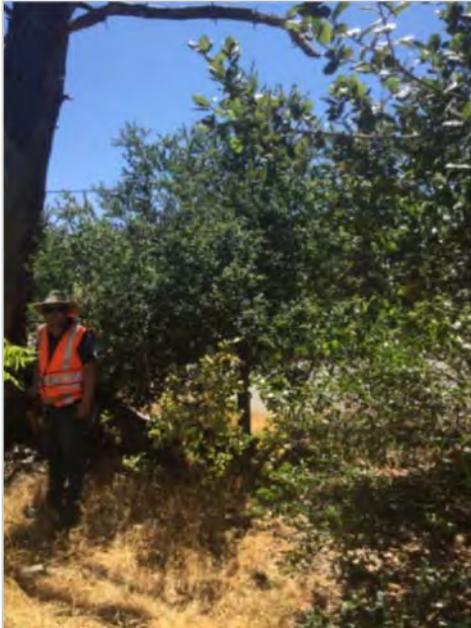
Oak, Coast Live ID# 116
Oak, Coast Live Tag# 347
Height: DBH: 1"-6"
Health: 40% - Poor

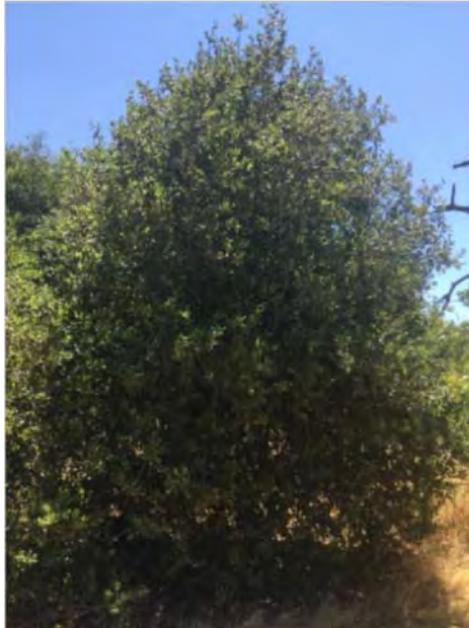
Oak, Coast Live ID# 117
Oak, Coast Live Tag# 348
Height: DBH: 1"-6"
Health: 40% - Poor

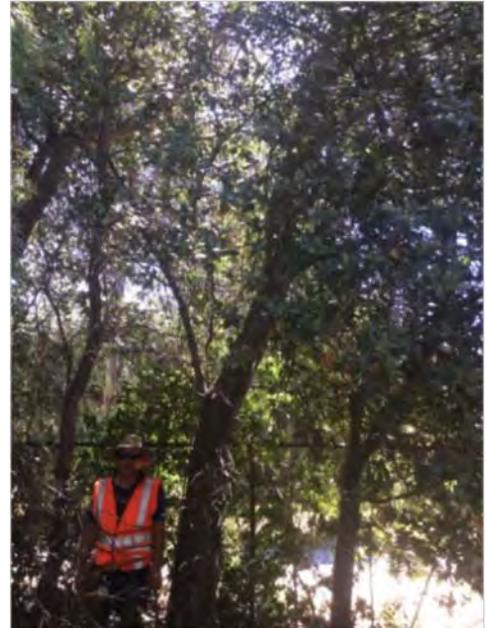
Oak, Coast Live ID# 121
Oak, Coast Live Tag# 258
Height: DBH: 10"
Health: 60% - Fair

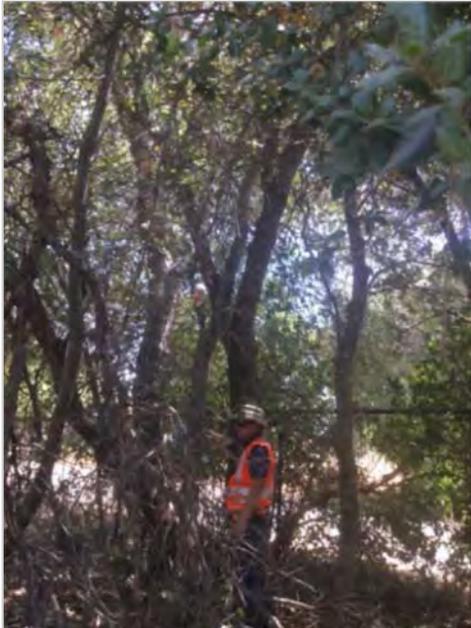
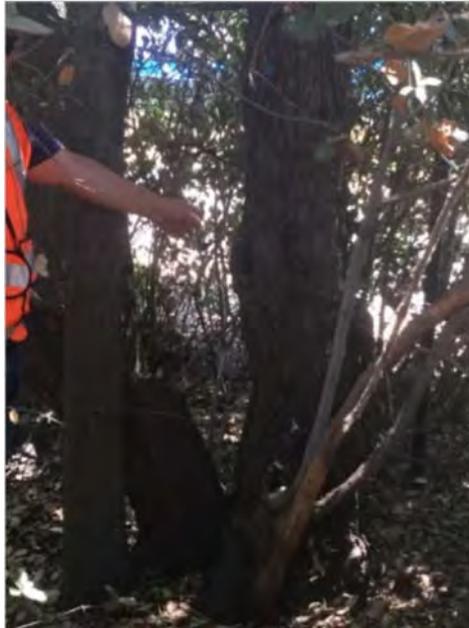
Schinus molle ID# 122
California pepper tree Tag# 259
Height: DBH: 7"/14"
Health: 40% - Poor

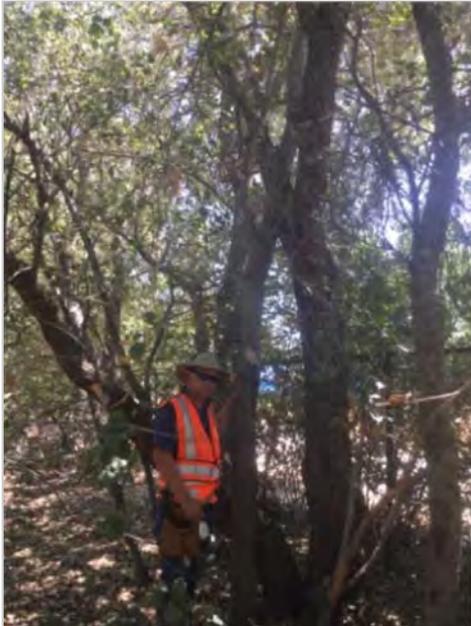
123	352	Coast Live Oak	Quercus agrifolia	7"	60% - Fair	Remove Based on Conflicts with Design Plans	Yes	Yes	No
124	353	Coast Live Oak	Quercus agrifolia	5"	40% - Poor	Remove Based on Conflicts with Design Plans & Condition	Yes	No	No
125	354	Prunus spp.	Prunus spp.	14 1/8"	0% - Dead	Remove Based on Conflicts with Design Plans & Condition	No	Yes	No
126	355	Coast Live Oak	Quercus agrifolia	9"	40% - Poor	Remove Based on Conflicts with Design Plans & Condition	Yes	Yes	No
127	247	Black Walnut	Juglans nigra	7 9/16"	40% - Poor	Remove Based on Conflicts with Design Plans & Condition	No	No	No
128	356	Coast Live Oak	Quercus agrifolia	7"	40% - Poor	Remove Based on Conflicts with Design Plans & Condition	Yes	Yes	No
129	249	Black Walnut	Juglans nigra	11 1/2"	20% - Critical	Remove Based on Conflicts with Design Plans & Condition	No	No	No
130	250	Black Walnut	Juglans nigra	12 1/2"	20% - Critical	Remove Based on Conflicts with Design Plans & Condition	No	No	No

Oak, Coast Live ID# 123
Oak, Coast Live Tag# 352
Height: DBH: 7"
Health: 60% - Fair

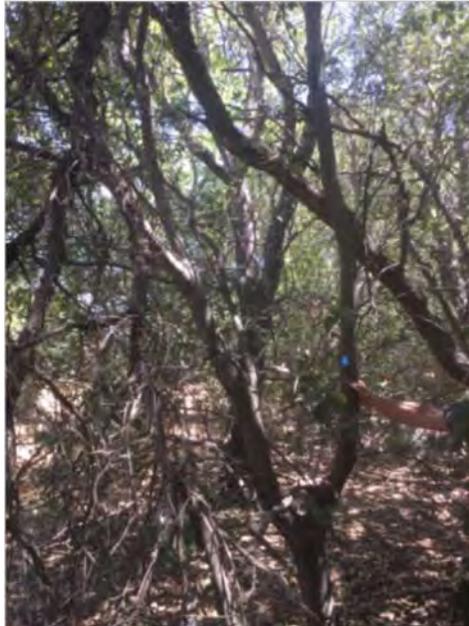
Oak, Coast Live ID# 124
Oak, Coast Live Tag# 353
Height: DBH: 5"
Health: 40% - Poor

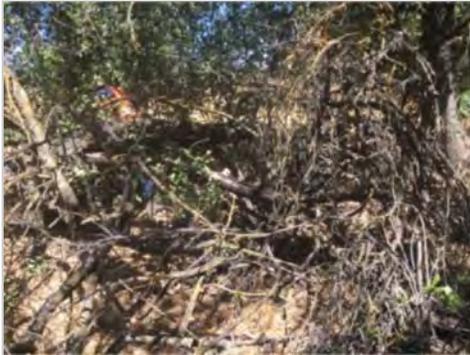
Prunus c. "Thundercloud" ID# 125
Prunus c. "Thundercloud" Tag# 354
Height: DBH: 14"14
Health: 0% - Dead

Prunus c. "Thundercloud" ID# 125
 Prunus c. "Thundercloud" Tag# 354
 Height:
 Health: 0% - Dead

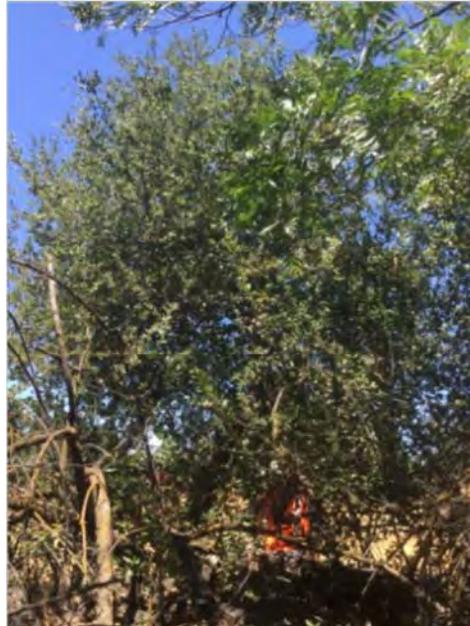
Oak, Coast Live ID# 126
 Oak, Coast Live Tag# 355
 Height:
 Health: 40% - Poor

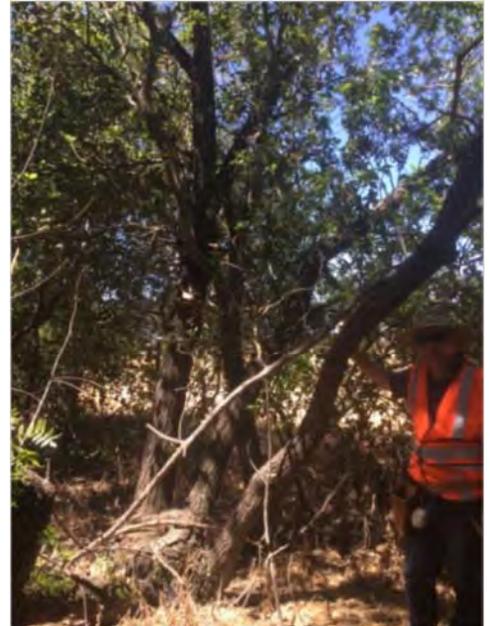
Juglans nigra ID# 127
 eastern black walnut Tag# 247
 Height:
 Health: 40% - Poor

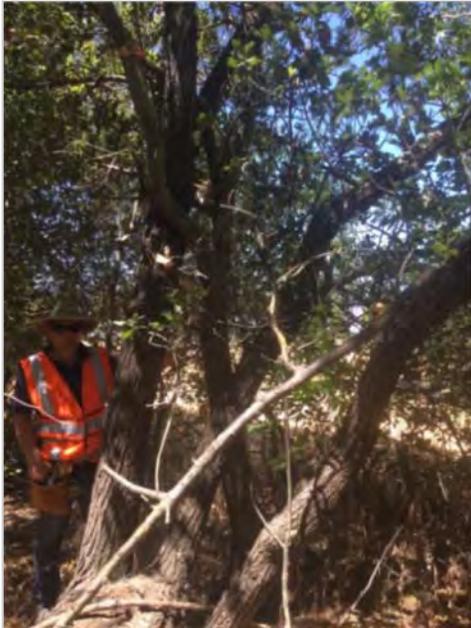
Oak, Coast Live ID# 128
Oak, Coast Live Tag# 356
Height: DBH: 7"
Health: 40% - Poor

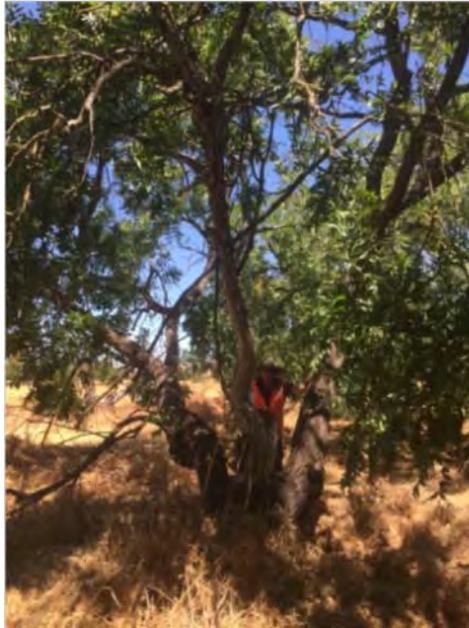
Juglans nigra ID# 129
eastern black walnut Tag# 249
Height: DBH: 11"/12...
Health: 20% - Critical

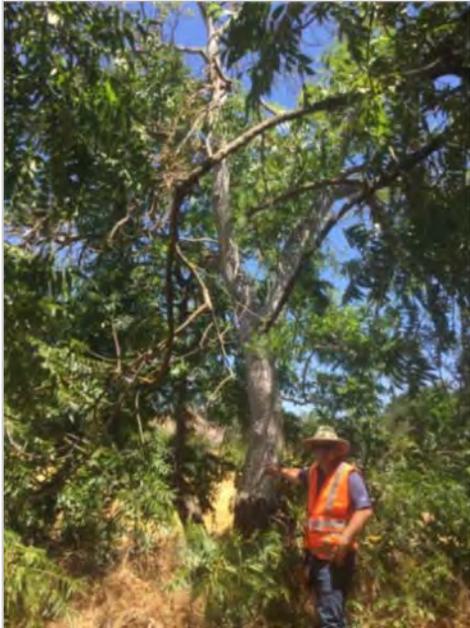
131	252	Black Walnut	Juglans nigra	16 1/10"	20% - Critical	Remove Based on Conflicts with Design Plans & Condition	No	Yes	No
132	254	Black Walnut	Juglans nigra	36"	20% - Critical	Remove Based on Conflicts with Design Plans & Condition	No	Yes	No
133	253	Coast Live Oak	Quercus agrifolia	5"	60% - Fair	Remove Based on Conflicts with Design Plans	Yes	No	No
134	251	Coast Live Oak	Quercus agrifolia	18 1/10"	60% - Fair	Remove Based on Conflicts with Design Plans	Yes	Yes	No

Juglans nigra ID# 131
eastern black walnut Tag# 252
Height: DBH: 16"/10"
Health: 20% - Critical

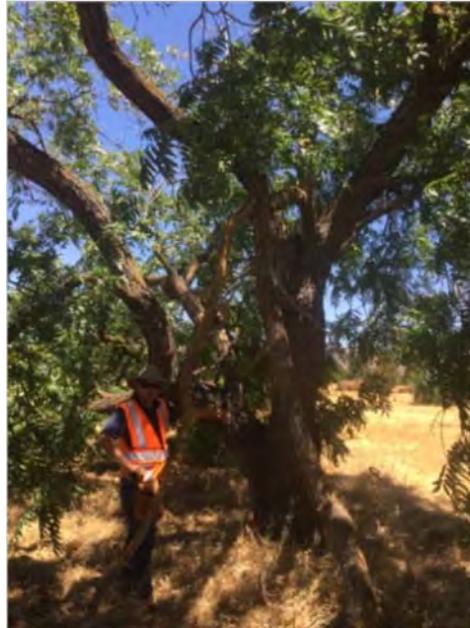
Juglans nigra ID# 132
eastern black walnut Tag# 254
Height: DBH: 36"
Health: 20% - Critical

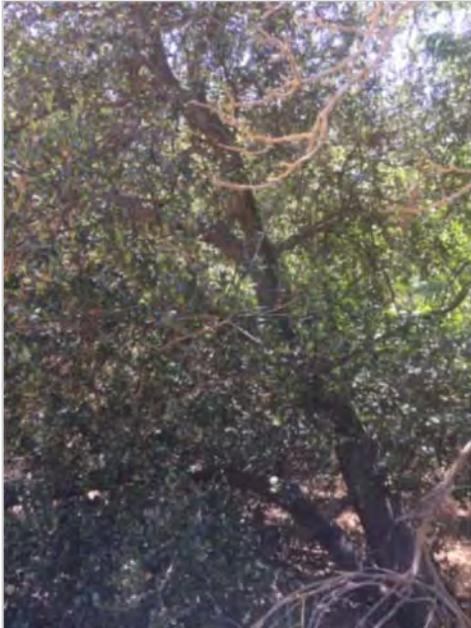
Oak, Coast Live ID# 134
 Oak, Coast Live Tag# 251
 Height: DBH: 18"/10"
 Health: 60% - Fair

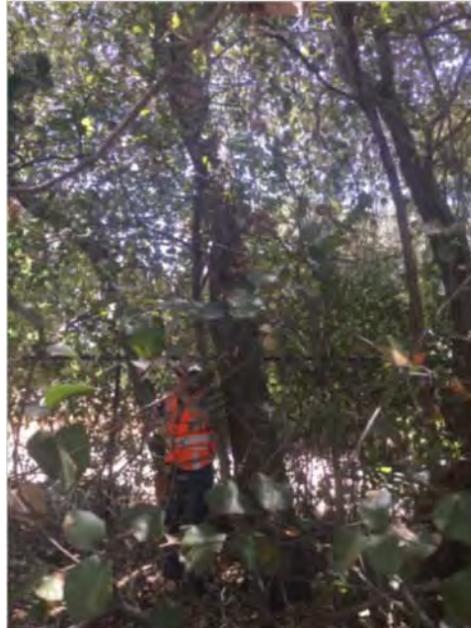
Map ID	Tag ID	Common Name	Species	DBH (inches)	Condition	Recommended Action	Indigenous Tree?	Ordinance Tree?	Street Tree?
135	257	Coast Live Oak	Quercus agrifolia	15"	60% - Fair	Remove Based on Conflicts with Design Plans	Yes	Yes	No
136	357	Coast Live Oak	Quercus agrifolia	6"	40% - Poor	Remove Based on Conflicts with Design Plans & Condition	Yes	Yes	No
137	256	Coast Live Oak	Quercus agrifolia	14"	60% - Fair	Remove Based on Conflicts with Design Plans	Yes	Yes	No
138	244	Coast Live Oak	Quercus agrifolia	15"	60% - Fair	Remove Based on Conflicts with Design Plans	Yes	Yes	No
139	255	Coast Live Oak	Quercus agrifolia	12 1/4"	40% - Poor	Remove Based on Conflicts with Design Plans & Condition	Yes	Yes	No
140	248	Black Walnut	Juglans nigra	12 1/10"	20% - Critical	Remove Based on Conflicts with Design Plans & Condition	No	No	No
141	358	Coast Live Oak	Quercus agrifolia	5"	60% - Fair	Remove Based on Conflicts with Design Plans	Yes	No	No

Oak, Coast Live ID# 135
 Oak, Coast Live Tag# 257
 Height: DBH: 15"
 Health: 60% - Fair

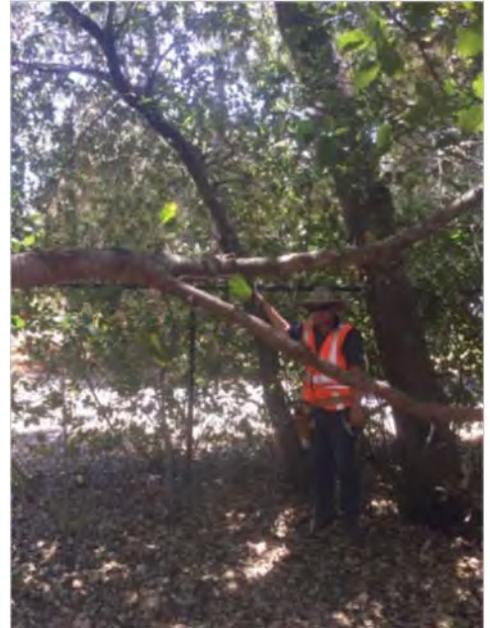
Oak, Coast Live ID# 136
 Oak, Coast Live Tag# 357
 Height: DBH: 6"
 Health: 40% - Poor

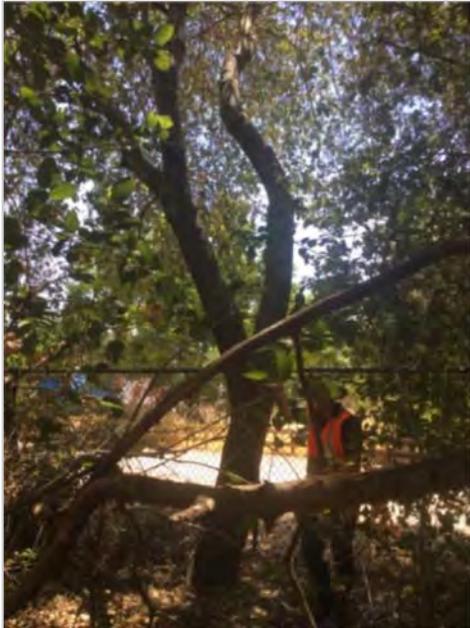
Oak, Coast Live ID# 137
Oak, Coast Live Tag# 256
Height: DBH: 14"
Health: 60% - Fair

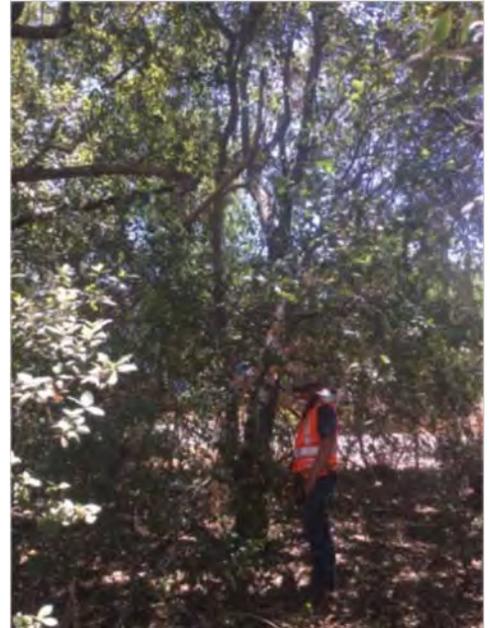
Oak, Coast Live ID# 139
Oak, Coast Live Tag# 255
Height: DBH: 12"/4"
Health: 40% - Poor

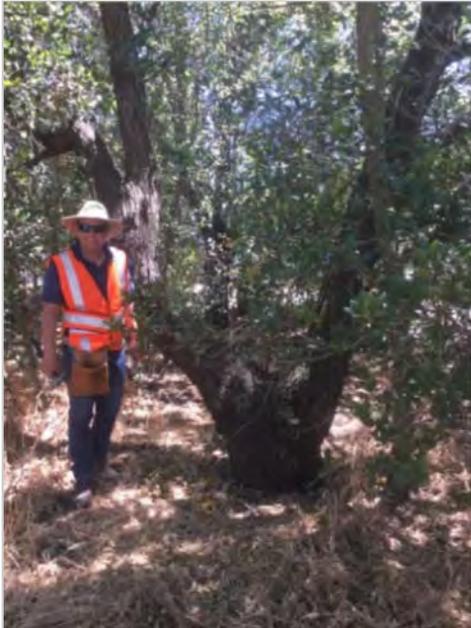
ID# 140
Tag# 248
DBH: 12"/10"

Juglans nigra
eastern black walnut
Height:
Health: 20% - Critical

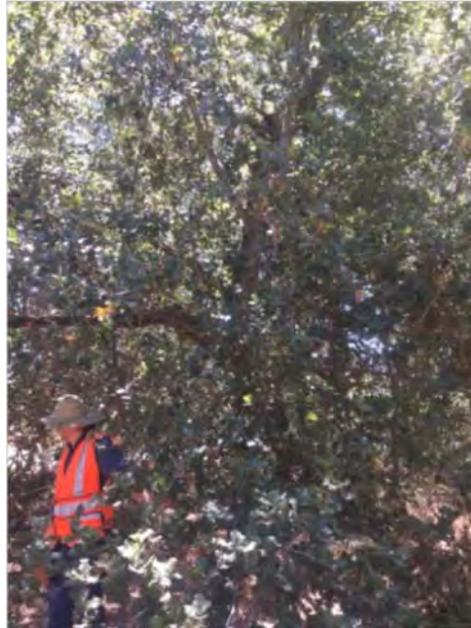
ID# 141
Tag# 358
DBH: 5"

Oak, Coast Live
Oak, Coast Live
Height:
Health: 60% - Fair

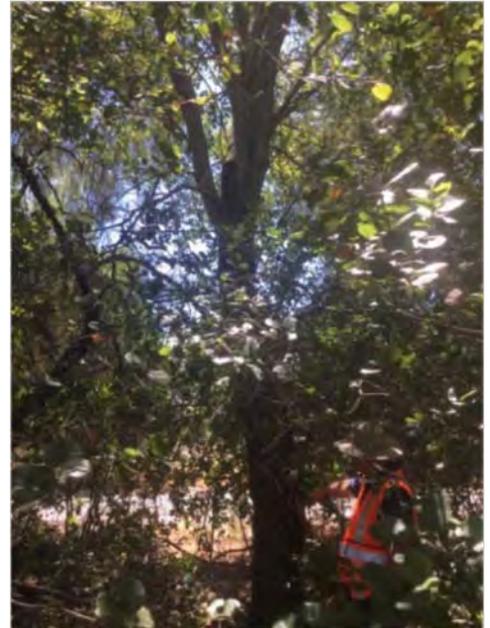
ID# 142
Tag# 359
DBH: 14"

142	359	Coast Live Oak	Quercus agrifolia	14"	60% - Fair	Remove Based on Conflicts with Design Plans	Yes	Yes	No
143	260	Peruvian Pepper	Schinus molle	18"	40% - Poor	Remove Based on Conflicts with Design Plans & Condition	No	Yes	No
144	261	Coast Live Oak	Quercus agrifolia	17"	60% - Fair	Remove Based on Conflicts with Design Plans	Yes	Yes	No
145	360	Peruvian Pepper	Schinus molle	11"	40% - Poor	Remove Based on Conflicts with Design Plans & Condition	No	No	No
146	262	Peruvian Pepper	Schinus molle	8 1/6"	40% - Poor	Remove Based on Conflicts with Design Plans & Condition	No	No	No
147	263	Coast Live Oak	Quercus agrifolia	17"	60% - Fair	Remove Based on Conflicts with Design Plans	Yes	Yes	No
148	264	Coast Live Oak	Quercus agrifolia	8 1/12"	20% - Critical	Remove Based on Conflicts with Design Plans & Condition	Yes	Yes	No
149	265	Coast Live Oak	Quercus agrifolia	13 1/14 1/10 1/7"	40% - Poor	Remove Based on Conflicts with Design Plans & Condition	Yes	Yes	No

Oak, Coast Live
Oak, Coast Live
Height:
Health: 60% - Fair

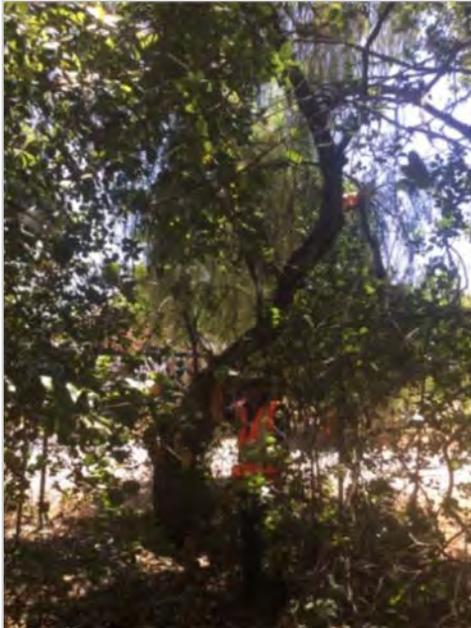
Schinus molle ID# 143
California pepper tree Tag# 260
Height: DBH: 18"
Health: 40% - Poor

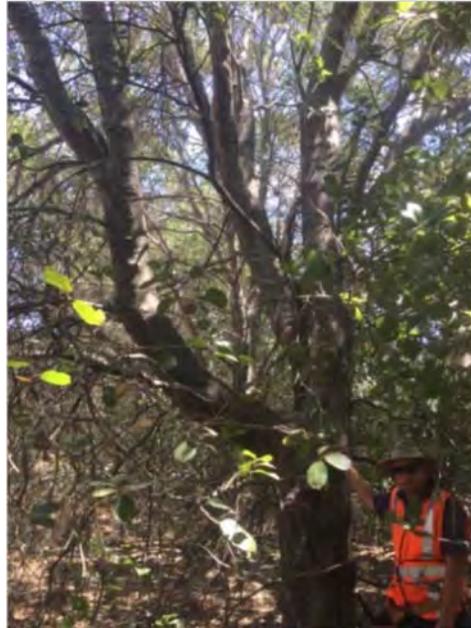
Oak, Coast Live ID# 144
Oak, Coast Live Tag# 261
Height: DBH: 17"
Health: 60% - Fair

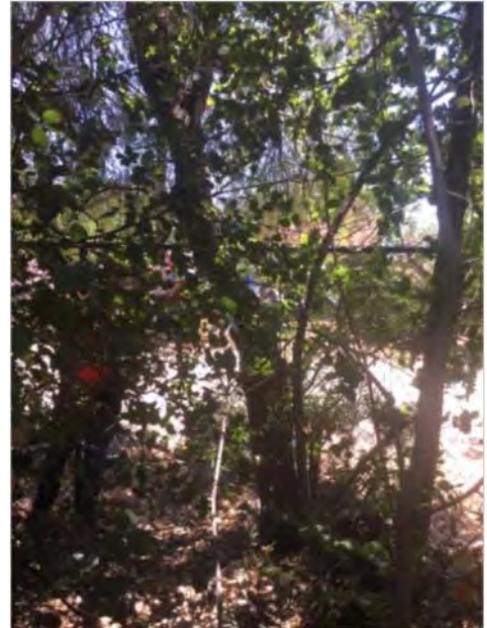
Schinus molle ID# 145
California pepper tree Tag# 360
Height: DBH: 11"
Health: 40% - Poor

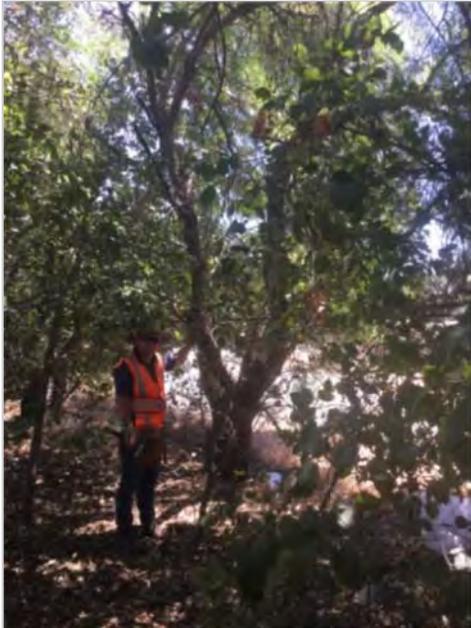
Schinus molle ID# 146
California pepper tree Tag# 262
Height: DBH: 8"/6"
Health: 40% - Poor

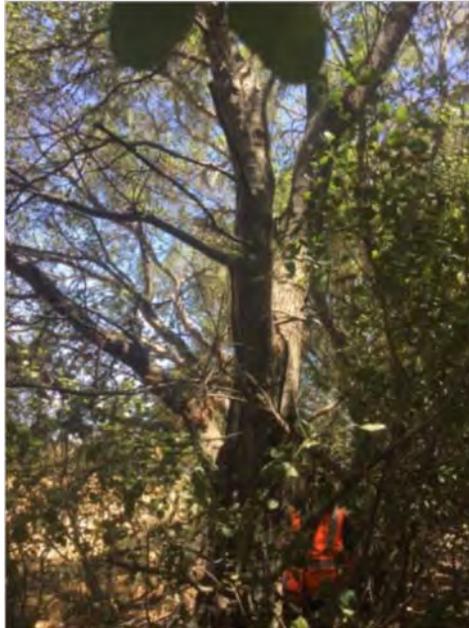
Oak, Coast Live ID# 147
Oak, Coast Live Tag# 263
Height: DBH: 17"
Health: 60% - Fair

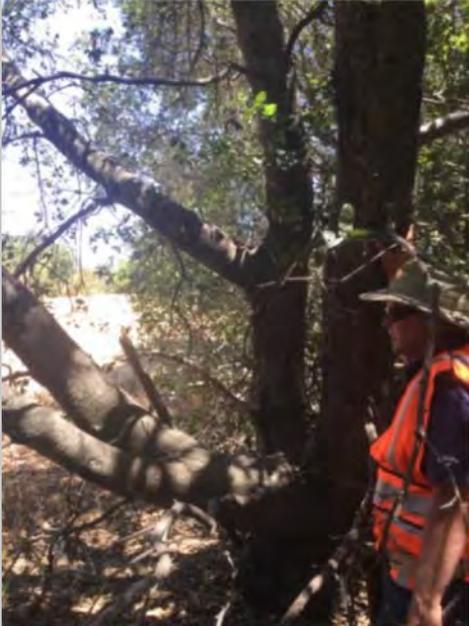
Oak, Coast Live	ID# 149
Oak, Coast Live	Tag# 265
Height:	DBH: 13"/14...
Health: 40% - Poor

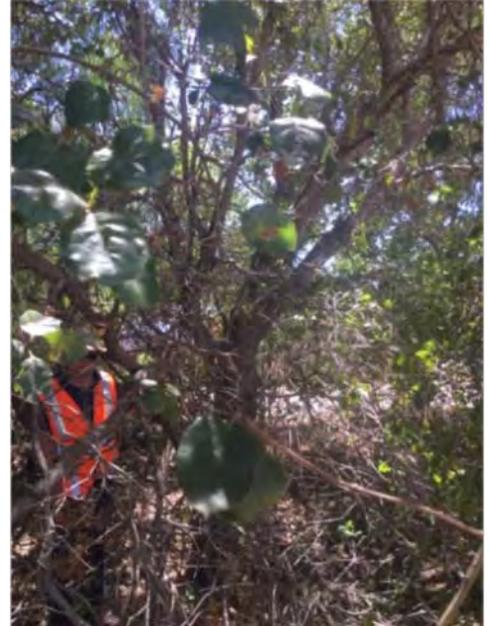
150	267	Peruvian Pepper	Schinus molle	9 7/13 1/4"	40% - Poor	Remove Based on Conflicts with Design Plans & Condition	No	No	No
151	266	Coast Live Oak	Quercus agrifolia	13 1/4"	40% - Poor	Remove Based on Conflicts with Design Plans & Condition	Yes	Yes	No
152	268	Coast Live Oak	Quercus agrifolia	38"	40% - Poor	Remove Based on Conflicts with Design Plans & Condition	Yes	Yes	No
153	269	Coast Live Oak	Quercus agrifolia	12 2/5 1/5"	40% - Poor	Remove Based on Conflicts with Design Plans & Condition	Yes	Yes	No
154	270	Coast Live Oak	Quercus agrifolia	34"	20% - Critical	Remove Based on Conflicts with Design Plans & Condition	Yes	Yes	No
155	361	Coast Live Oak	Quercus agrifolia	7"	40% - Poor	Remove Based on Conflicts with Design Plans & Condition	Yes	Yes	No
156	271	Coast Live Oak	Quercus agrifolia	8"	40% - Poor	Remove Based on Conflicts with Design Plans & Condition	Yes	Yes	No
157	272	Coast Live Oak	Quercus agrifolia	15"	60% - Fair	Remove Based on Conflicts with Design Plans	Yes	Yes	No

Oak, Coast Live	ID# 151
Oak, Coast Live	Tag# 266
Height:	DBH: 13"/4"
Health: 40% - Poor

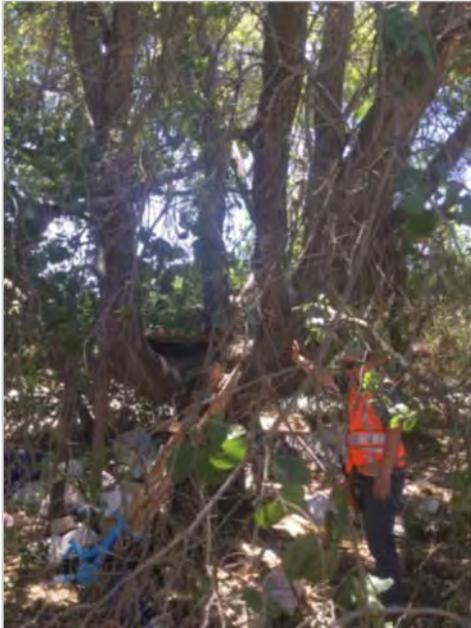
Oak, Coast Live ID# 152
Oak, Coast Live Tag# 268
Height: DBH: 38"
Health: 40% - Poor

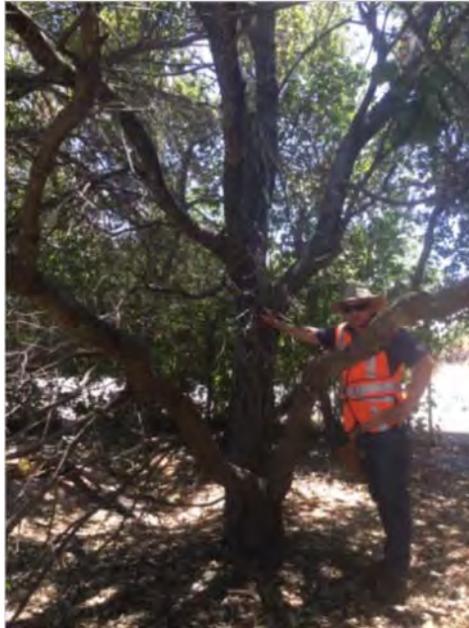
Oak, Coast Live ID# 153
Oak, Coast Live Tag# 269
Height: DBH: 12"/5"/5"
Health: 40% - Poor

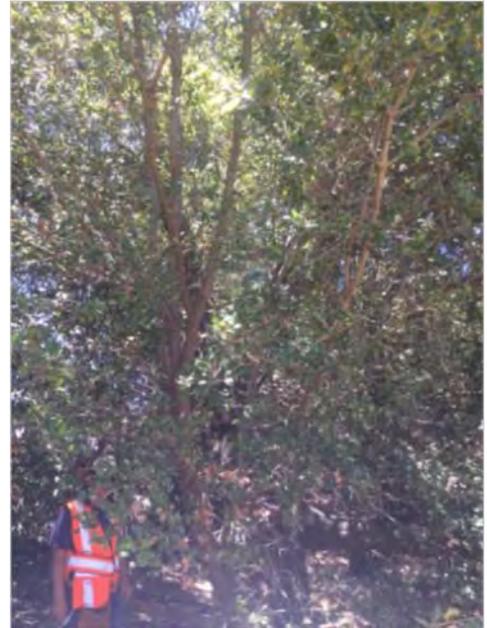
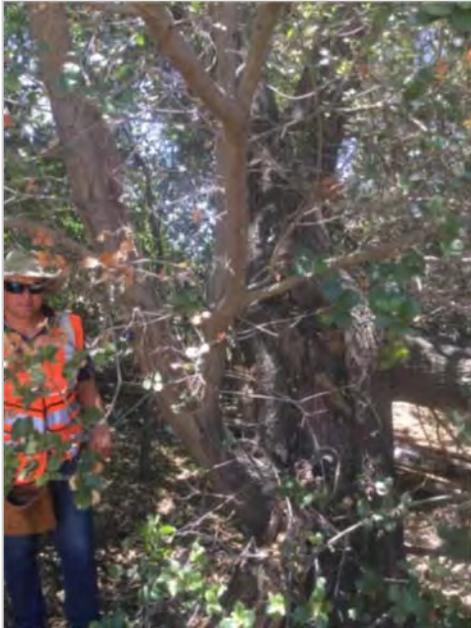
Oak, Coast Live ID# 154
Oak, Coast Live Tag# 270
Height: DBH: 34"
Health: 20% - Critical

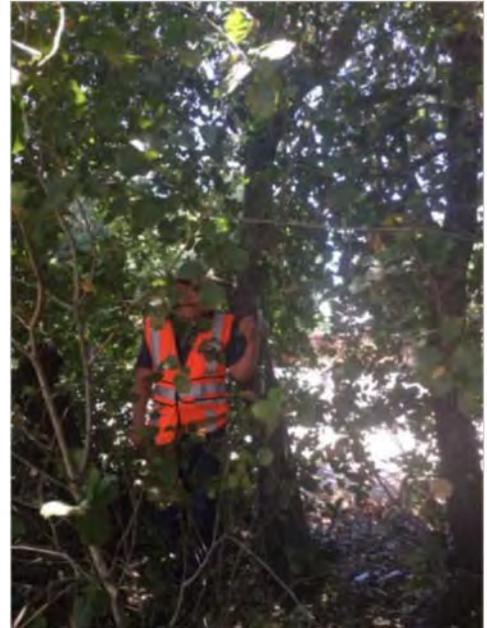
Oak, Coast Live ID# 156
Oak, Coast Live Tag# 271
Height: DBH: 8"
Health: 40% - Poor

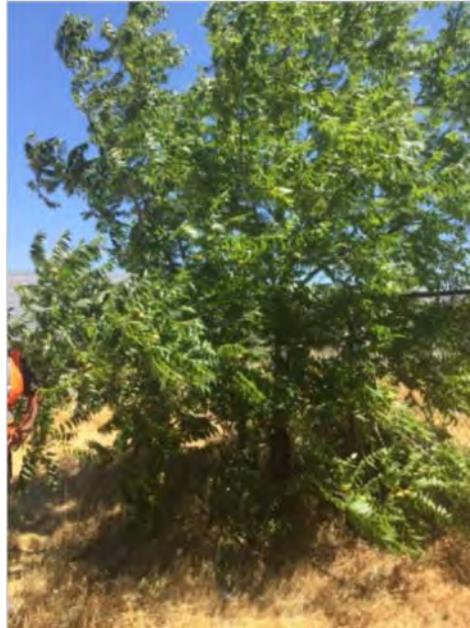
158	273	Black Walnut	Juglans nigra	7 1/4"	60% - Fair	Remove Based on Conflicts with Design Plans	No	No	No
159	277	Coast Redwood	Sequoia sempervirens	12"	60% - Fair	Remove Based on Conflicts with Design Plans & Condition	No	No	No
160	278	Coast Redwood	Sequoia sempervirens	12"	0% - Dead	Remove Based on Condition	No	No	No
161	274	Coast Live Oak	Quercus agrifolia	38"	60% - Fair	Remove Based on Conflicts with Design Plans	Yes	Yes	No

Juglans nigra ID# 158
eastern black walnut Tag# 273
Height: DBH: 7 1/4"
Health: 60% - Fair

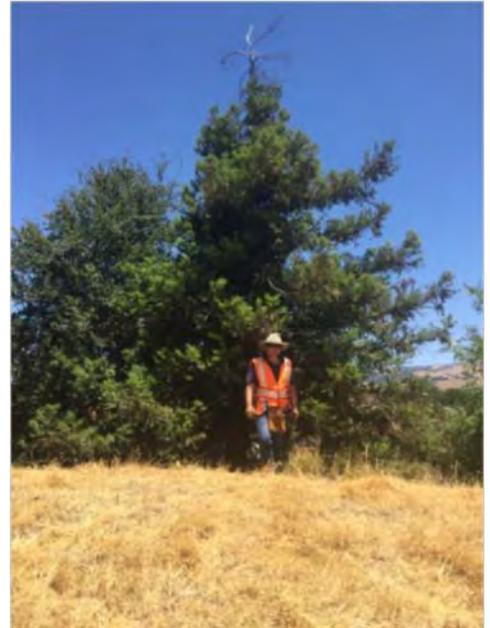
Sequoia, Giant ID# 159
Sequoia, Giant Tag# 277
Height: DBH: 12"
Health: 60% - Fair

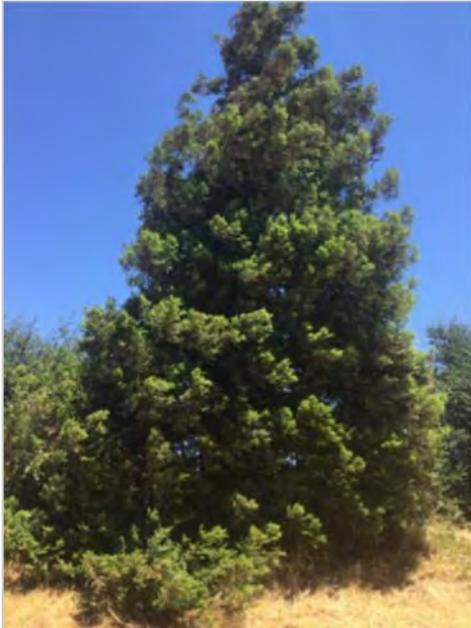
Sequoia Semperivens	ID# 160
Sequoia Semperivens	Tag# 278
Height:	DBH: 12"
Health: 0% - Dead

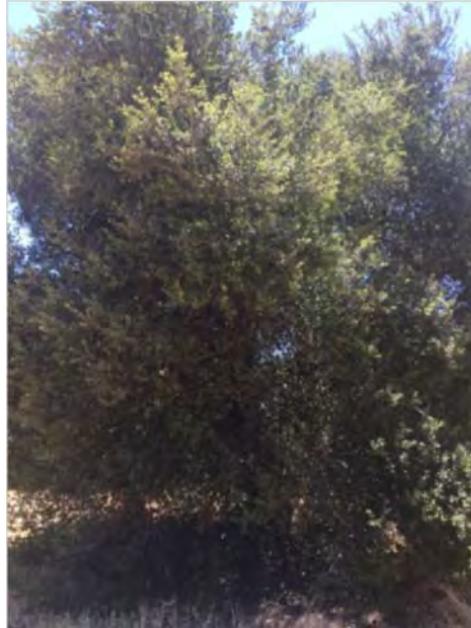
Oak, Coast Live	ID# 161
Oak, Coast Live	Tag# 274
Height:	DBH: 38"
Health: 60% - Fair

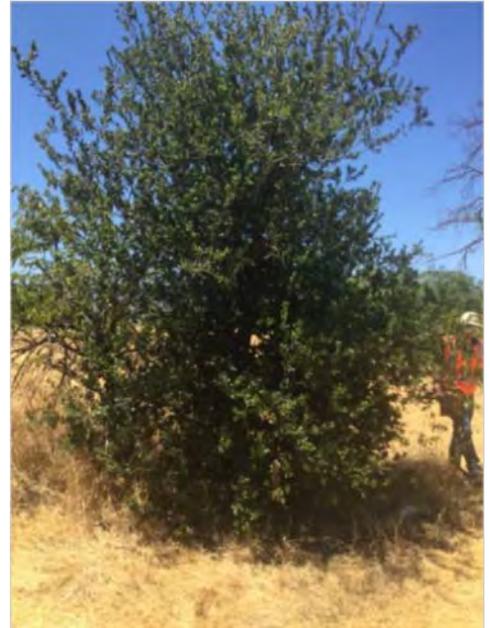
Oak, Coast Live	ID# 162
Oak, Coast Live	Tag# 275
Height:	DBH: 5"
Health: 80% - Good

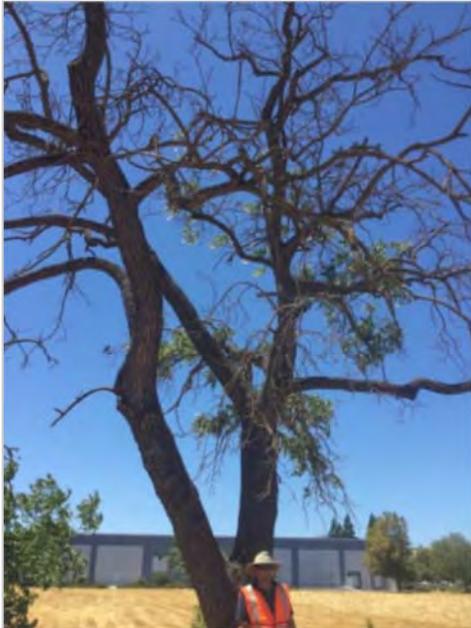
Juglans nigra ID# 163
eastern black walnut Tag# 276
Height: DBH: 27"
Health: 0% - Dead

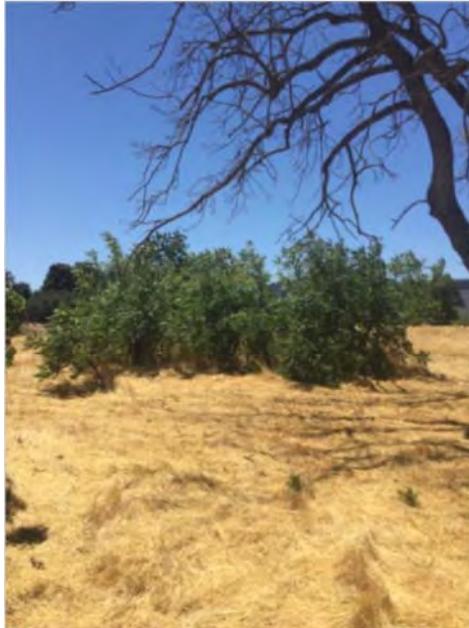
Juglans nigra ID# 164
eastern black walnut Tag# 362
Height: DBH: 5"
Health: 20% - Critical

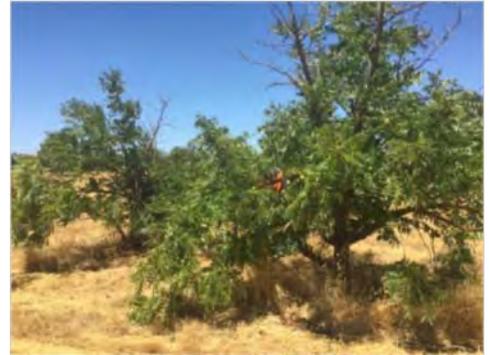
Juglans nigra ID# 164
eastern black walnut Tag# 362
Height: DBH: 5"
Health: 20% - Critical

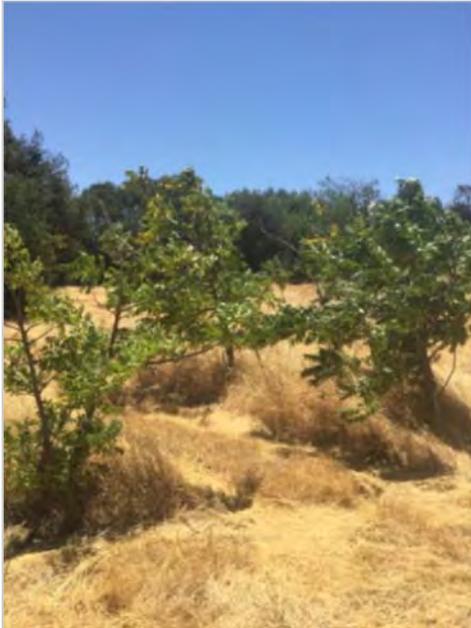
ID# 164
Tag# 362
DBH: 5"

Juglans nigra
eastern black walnut
Height:
Health: 20% - Critical

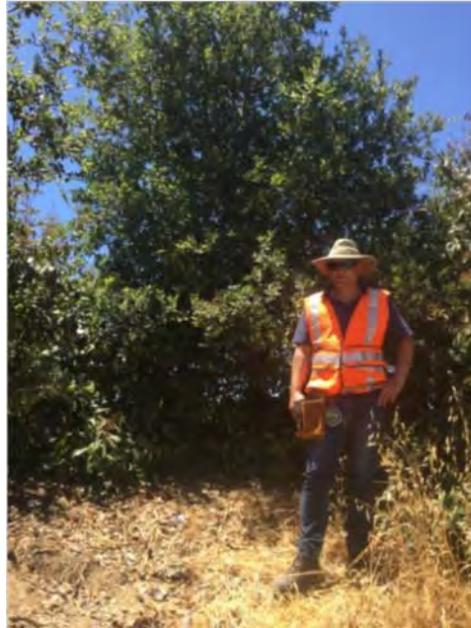
ID# 165
Tag# 280
DBH: 5"

Oak, Coast Live
Oak, Coast Live
Height:
Health: 80% - Good

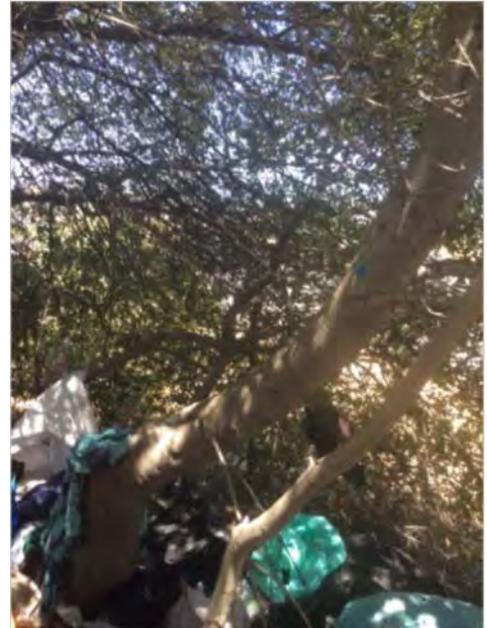
ID# 166
Tag# 281
DBH: 8"

Oak, Coast Live
Oak, Coast Live
Height:
Health: 80% - Good

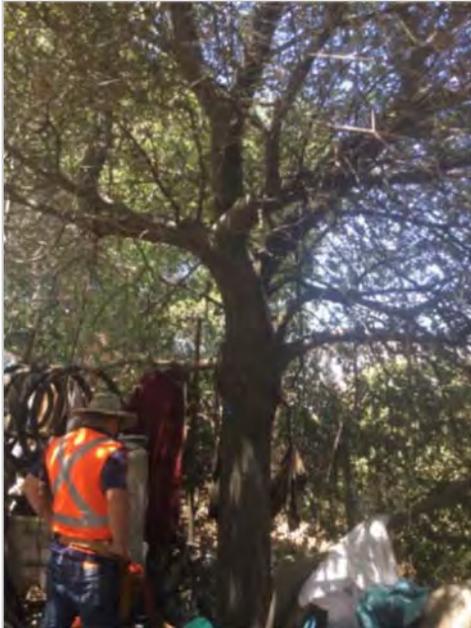
Oak, Coast Live ID# 167
Oak, Coast Live Tag# 282
Height: DBH: 12"
Health: 60% - Fair

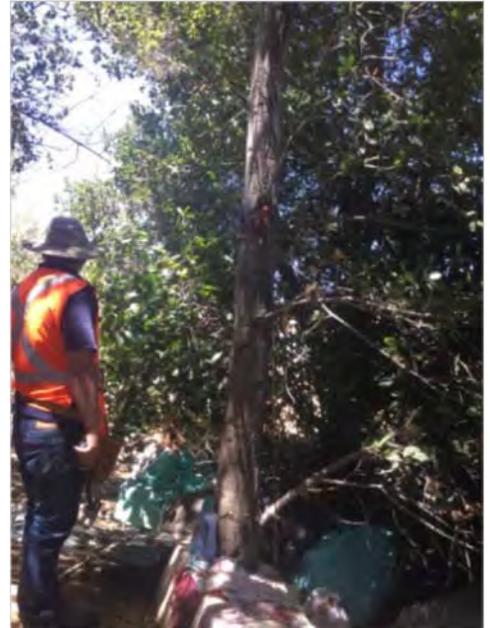
Oak, Coast Live ID# 169
Oak, Coast Live Tag# 284
Height: DBH: 8"
Health: 60% - Fair

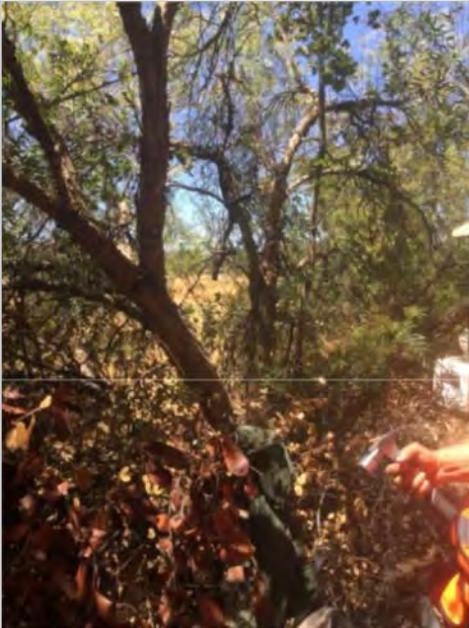
ID# 170
Tag# 284
DBH: 4"/4"/3"

Schinus molle
California pepper tree
Height:
Health: 40% - Poor

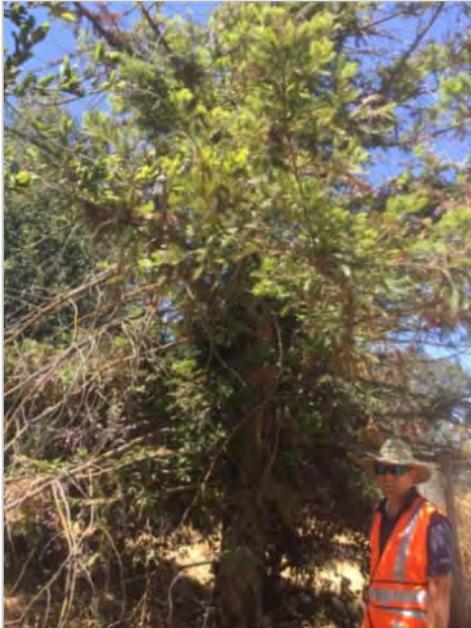
Oak, Coast Live ID# 173
Oak, Coast Live Tag# 288
Height: DBH: 12"
Health: 20% - Critical

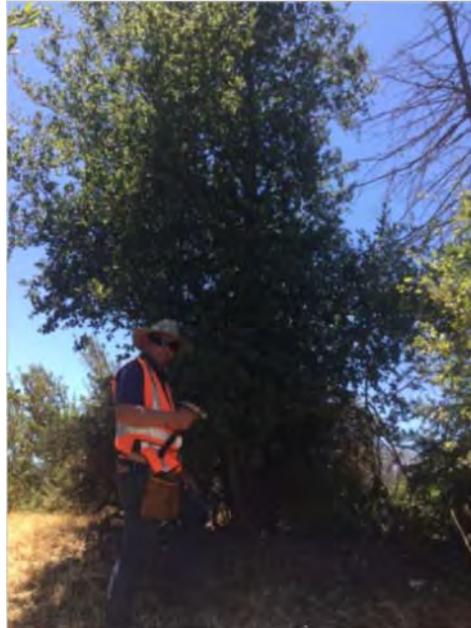
Oak, Coast Live ID# 174
Oak, Coast Live Tag# 289
Height: DBH: 8"
Health: 20% - Critical

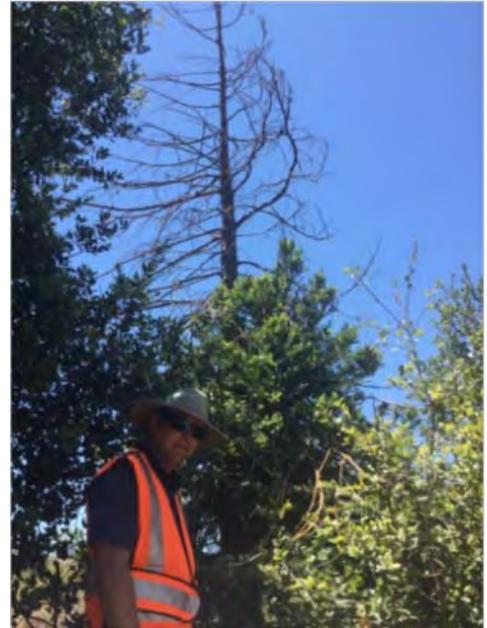
Sequoia, Giant ID# 175
Sequoia, Giant Tag# 290
Height: DBH: 9"
Health: 0% - Dead

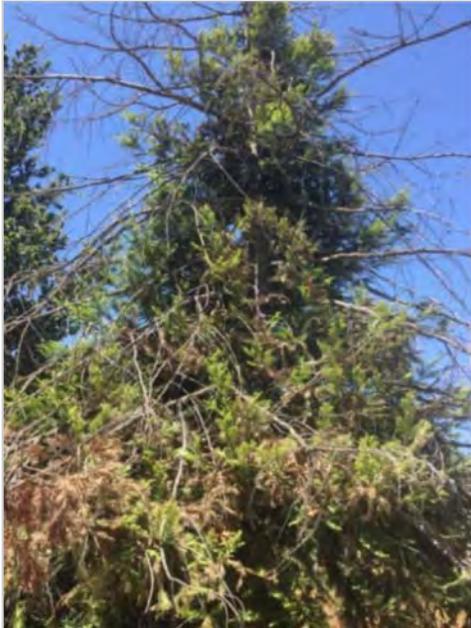
Sequoia, Giant ID# 176
Sequoia, Giant Tag# 291
Height: DBH: 13"
Health: 0% - Dead
