Appendix B
Tree Inventory & Protection Plan

**755 Jarvis Drive
Tree Inventory & Protection Plan**

755 Jarvis Drive
Morgan Hill, California

Prepared by:
Samuel Oakley
ISA Board Certified Master Arborist WE-9474B
ASCA Registered Consulting Arborist #556

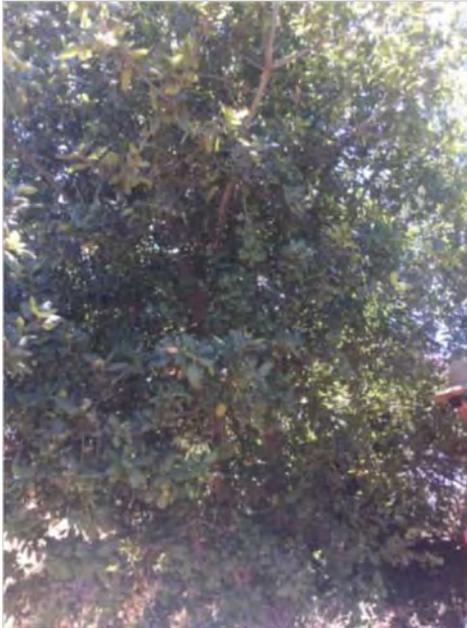
Sequoia, Giant ID# 176
Sequoia, Giant Tag# 291
Height: DBH: 13"
Health: 0% - Dead

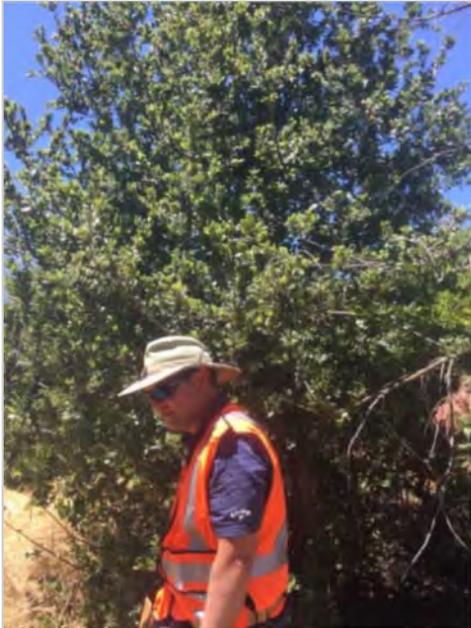
Oak, Coast Live ID# 178
Oak, Coast Live Tag# 363
Height: DBH: 6"
Health: 60% - Fair

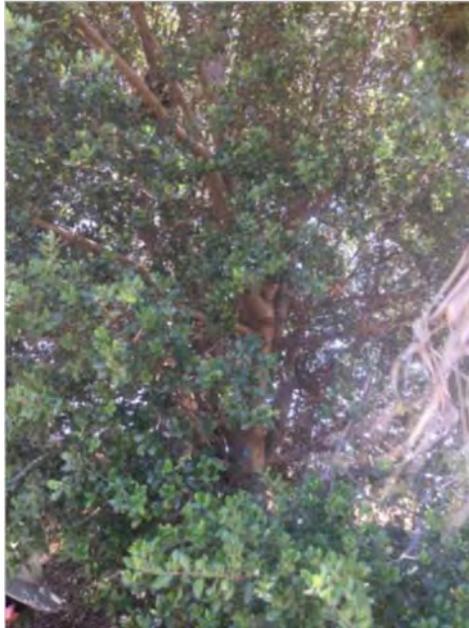
Oak, Coast Live ID# 179
Oak, Coast Live Tag# 295
Height: DBH: 12"/12"
Health: 60% - Fair

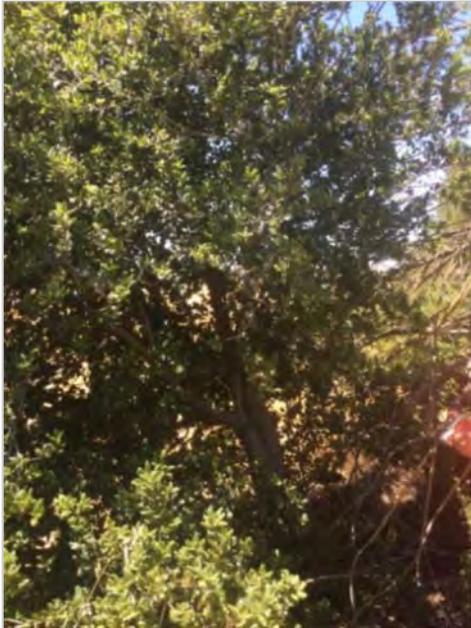
Oak, Coast Live ID# 181
Oak, Coast Live Tag# 294
Height: DBH: 12"/12"
Health: 60% - Fair

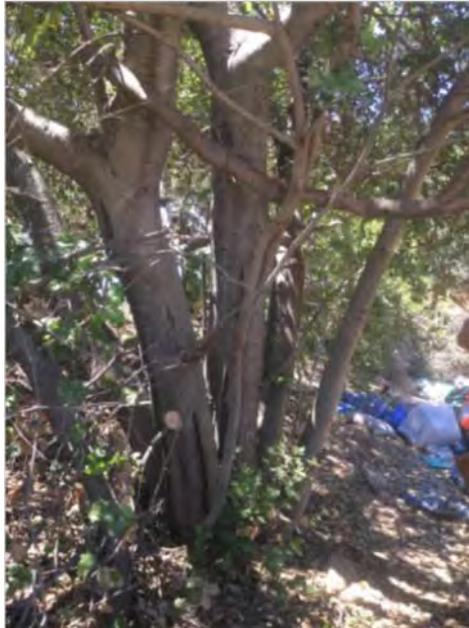
Oak, Coast Live ID# 182
Oak, Coast Live Tag# 296
Height: DBH: 12"/12...
Health: 60% - Fair

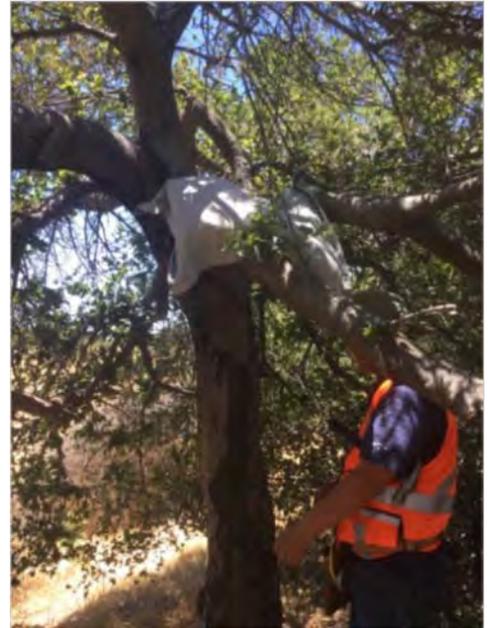
Oak, Coast Live ID# 183
Oak, Coast Live Tag# 297
Height: DBH: 10"
Health: 40% - Poor

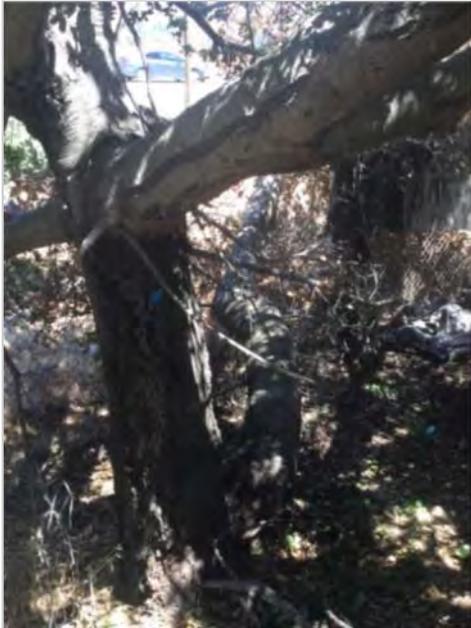
Oak, Coast Live ID# 184
 Oak, Coast Live Tag# 298
 Height: DBH: 13"/10"
 Health: 60% - Fair

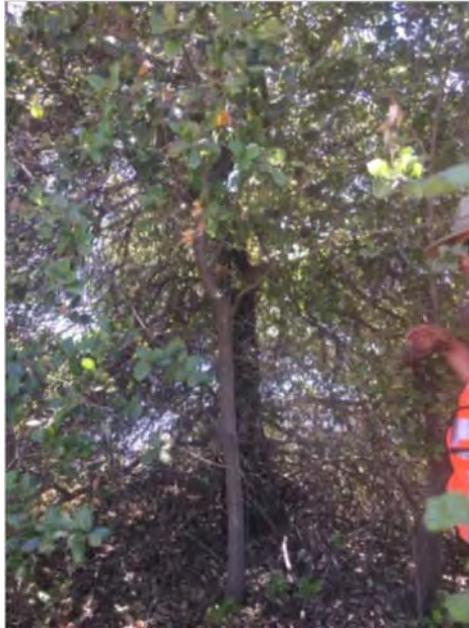
Oak, Coast Live ID# 185
 Oak, Coast Live Tag# 299
 Height: DBH: 12"
 Health: 60% - Fair

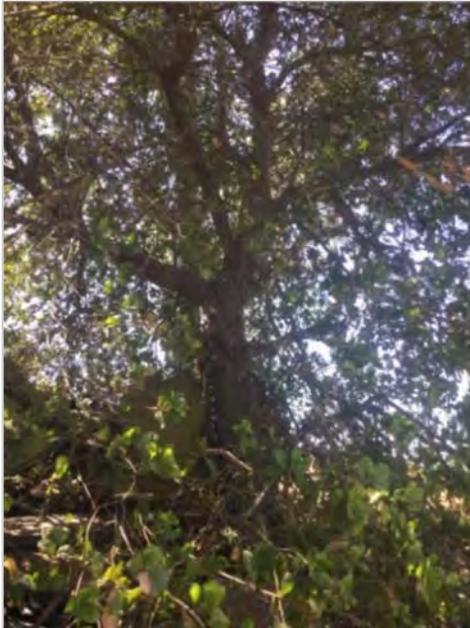
Oak, Coast Live ID# 187
Oak, Coast Live Tag# 302
Height: DBH: 14"
Health: 60% - Fair

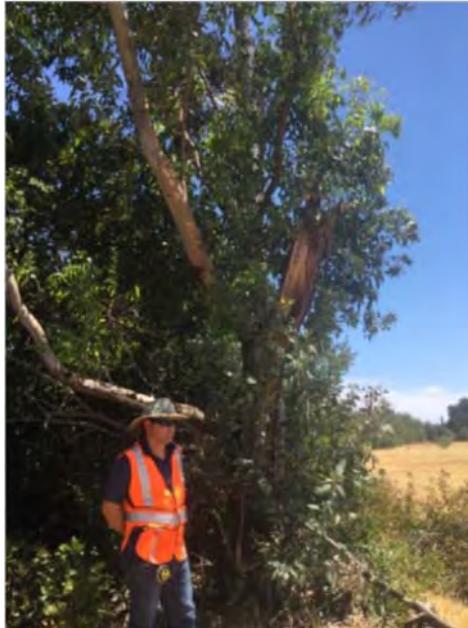
Eucalyptus ID# 188
Eucalyptus Tag# 303
Height: DBH: 32"
Health: 20% - Critical

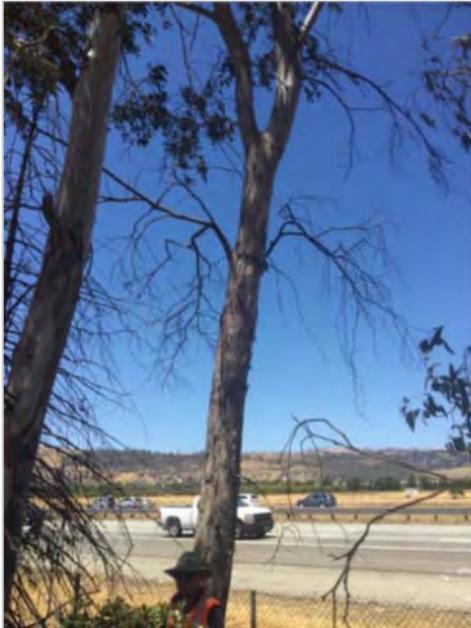
Eucalyptus ID# 190
Eucalyptus Tag# 305
Height:
Health: 40% - Poor

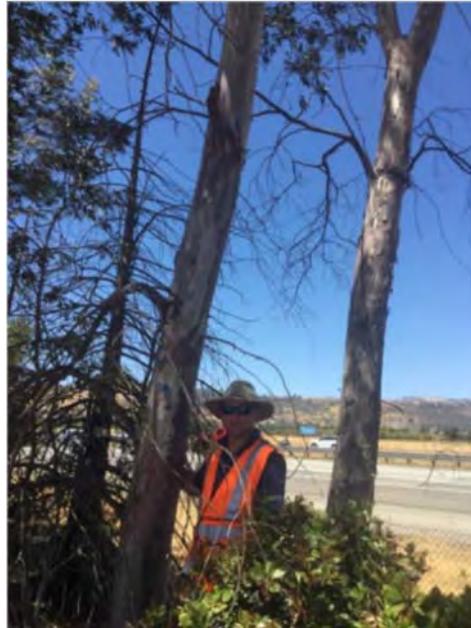
Eucalyptus ID# 191
Eucalyptus Tag# 306
Height:
Health: 40% - Poor

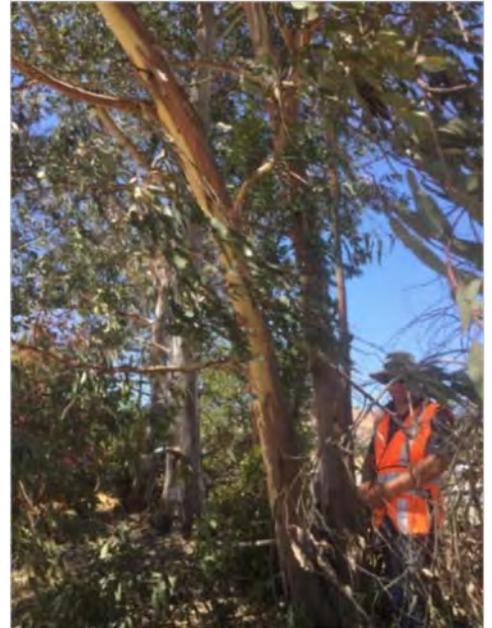
Eucalyptus ID# 192
Eucalyptus Tag# 307
Height:
Health: 40% - Poor

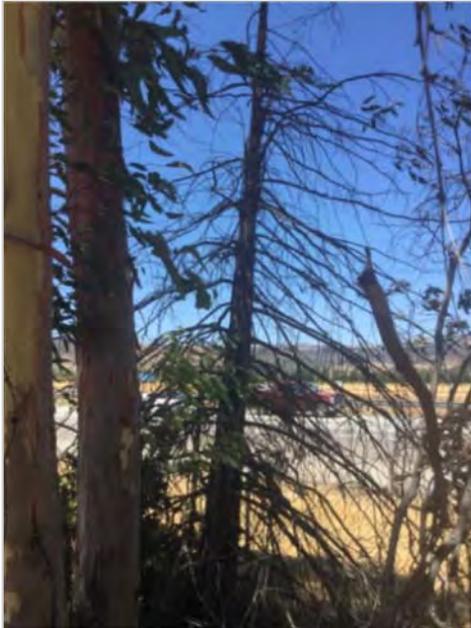
Redwood, Coast ID# 193
Redwood, Coast Tag# 308
Height:
DBH: 12"
Health: 0% - Dead

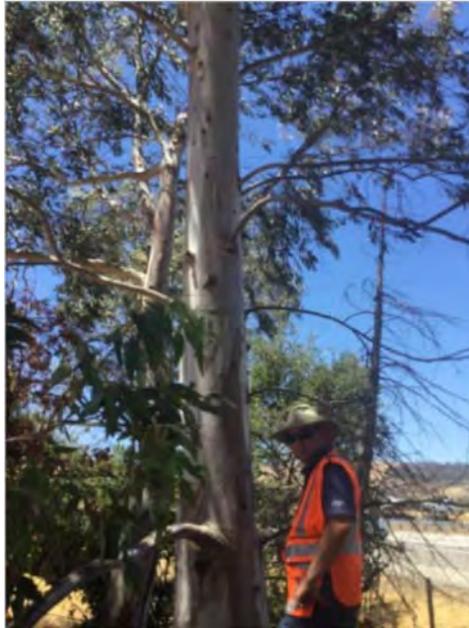
Eucalyptus ID# 194
Eucalyptus Tag# 309
Height:
DBH: 17"
Health: 40% - Poor

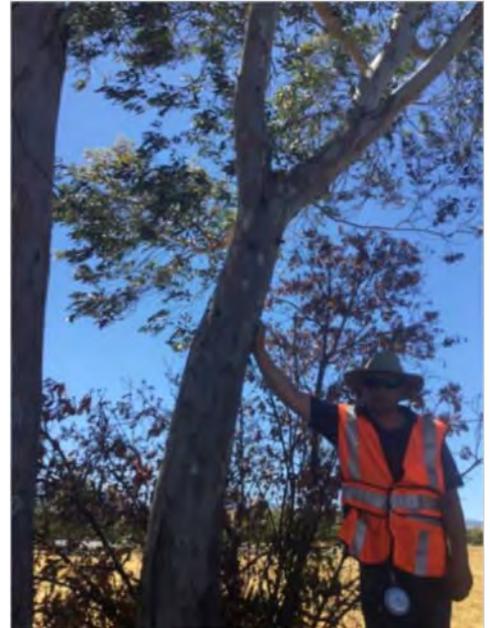
Eucalyptus ID# 195
Eucalyptus Tag# 310
Height:
DBH: 12"
Health: 40% - Poor

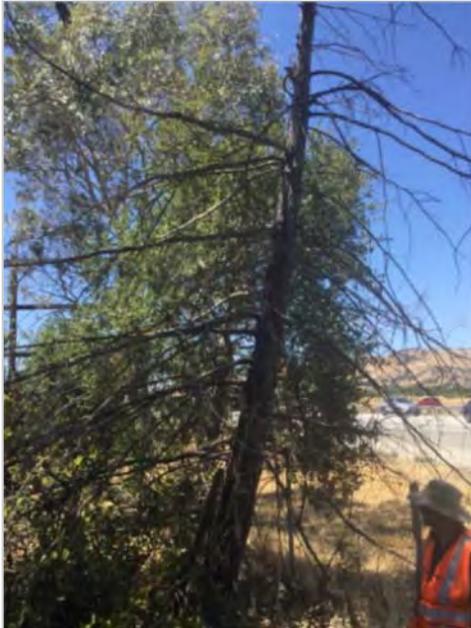
Redwood, Coast ID# 196
Redwood, Coast Tag# 311
Height:
DBH: 12"
Health: 0% - Dead

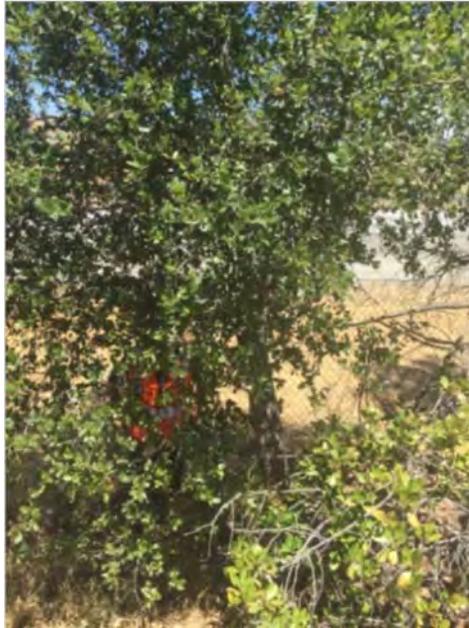
Oak, Coast Live ID# 197
Oak, Coast Live Tag# 312
Height:
DBH: 8"
Health: 60% - Fair

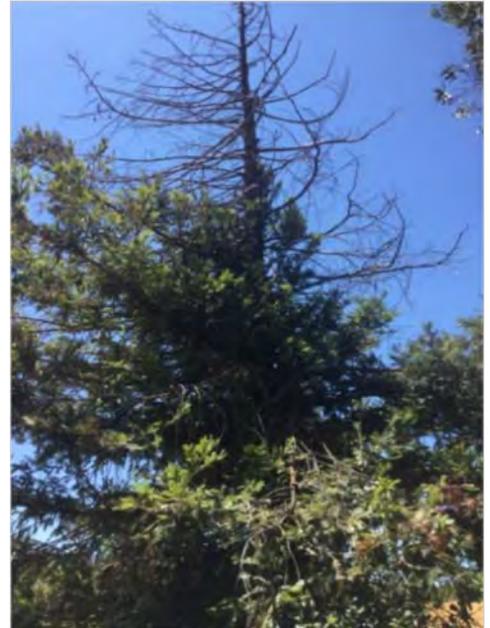
Redwood, Coast ID# 198
Redwood, Coast Tag# 313
Height:
DBH: 14"
Health: 20% - Critical

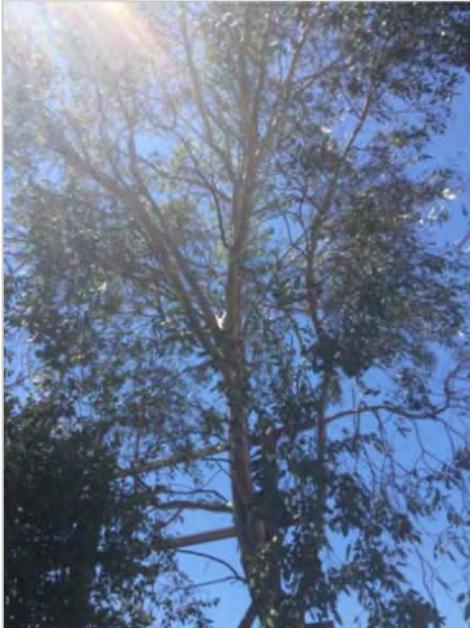
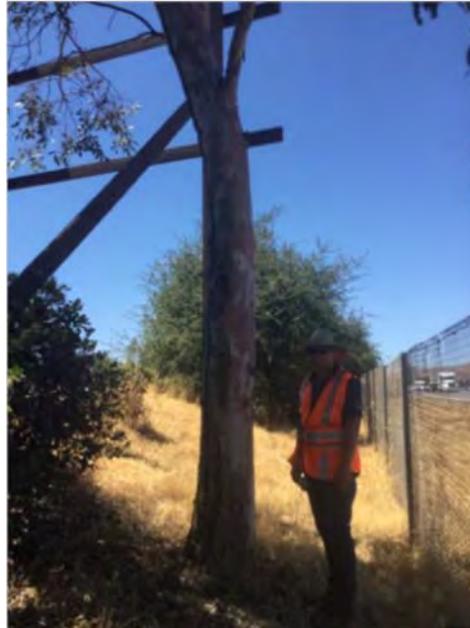
Eucalyptus ID# 199
Eucalyptus Tag# 314
Height:
DBH: 14"
Health: 40% - Poor

199	314	Eucalyptus	Eucalyptus spp.	14"	40% - Poor	Remove Based on Condition	No	Yes	No
200	315	Coast Live Oak	Quercus agrifolia	8"	80% - Good	Preserve	Yes	Yes	No
201	316	Coast Live Oak	Quercus agrifolia	9"	80% - Good	Preserve	Yes	Yes	No
202	317	Coast Live Oak	Quercus agrifolia	6"	80% - Good	Preserve	Yes	Yes	No
203	321	Black Walnut	Juglans nigra	5'5"/5'5"/4"	60% - Fair	Remove Based on Conflicts with Design Plans	No	No	No
204	318	Coast Live Oak	Quercus agrifolia	6"	80% - Good	Preserve	Yes	Yes	No
205	319	Coast Live Oak	Quercus agrifolia	6"	80% - Good	Preserve	Yes	Yes	No
206	320	Brazilian Pepper Tree	Schinus terebinthifolia	5'5'4"/3"	40% - Poor	Remove Based on Condition	No	No	No
207	322	Coast Live Oak	Quercus agrifolia	5'5"	80% - Good	Preserve	Yes	No	No
208	323	Coast Live Oak	Quercus agrifolia	5'5'5"	80% - Good	Preserve	Yes	No	No
209	325	Brazilian Pepper Tree	Schinus terebinthifolia	5'5'6"/5"	60% - Fair	Preserve	No	No	No

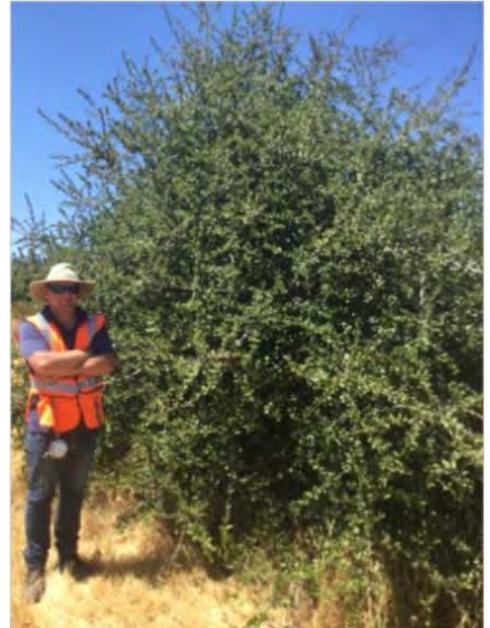
Oak, Coast Live ID# 200
Oak, Coast Live Tag# 315
Height:
DBH: 8"
Health: 80% - Good

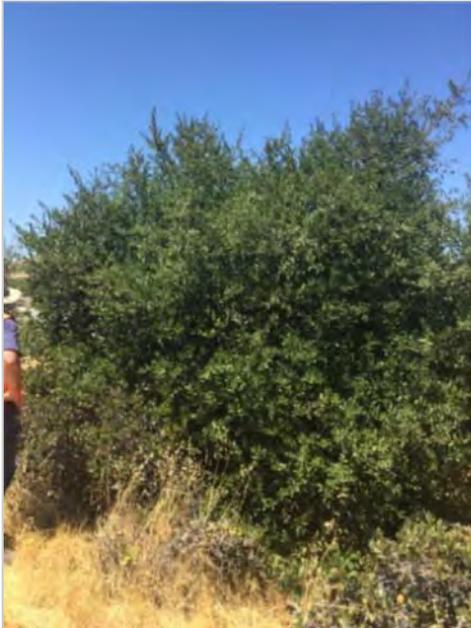
Oak, Coast Live ID# 201
Oak, Coast Live Tag# 316
Height:
DBH: 9"
Health: 80% - Good

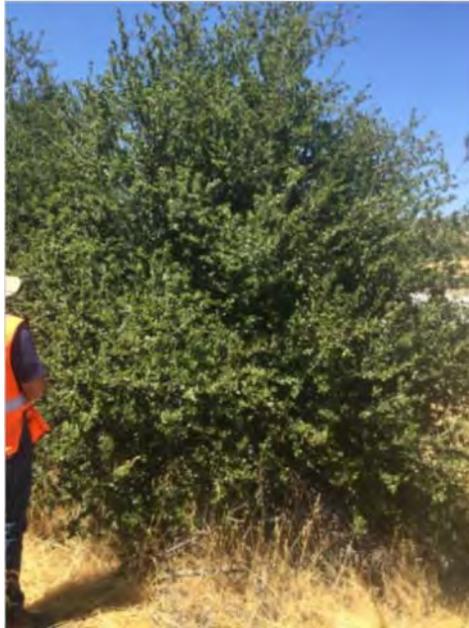
Oak, Coast Live ID# 202
Oak, Coast Live Tag# 317
Height:
DBH: 6"
Health: 80% - Good

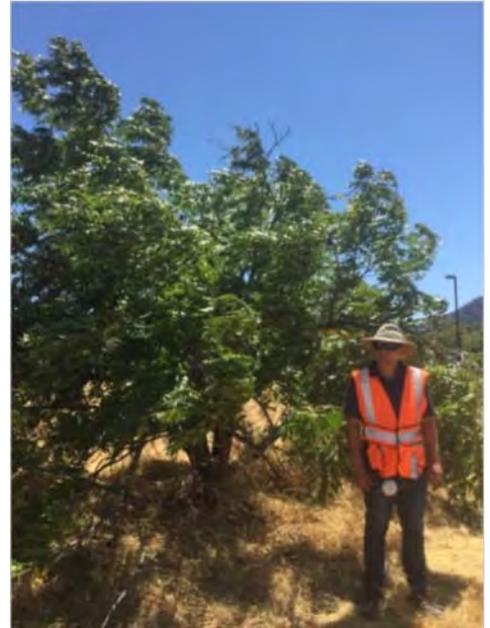
Juglans nigra ID# 203
eastern black walnut Tag# 321
Height:
DBH: 5"/5"/5...
Health: 60% - Fair

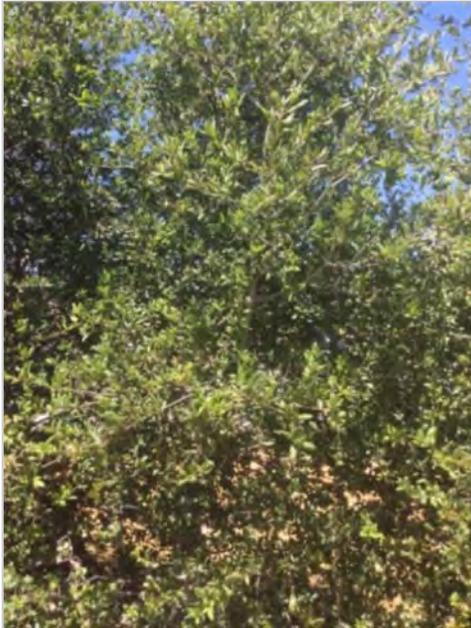
Oak, Coast Live ID# 204
Oak, Coast Live Tag# 318
Height: DBH: 6"
Health: 80% - Good

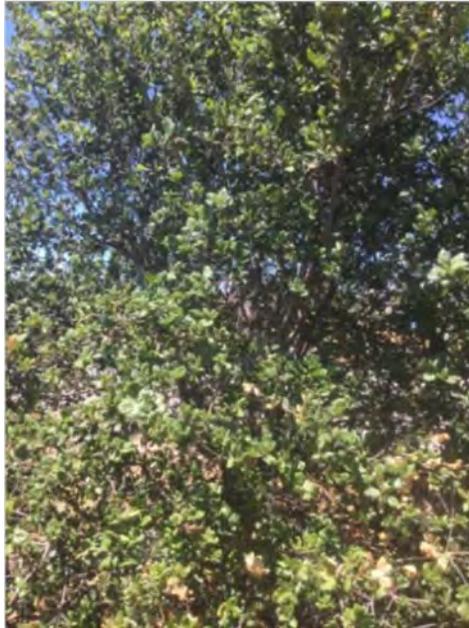
Oak, Coast Live ID# 205
Oak, Coast Live Tag# 319
Height: DBH: 6"
Health: 80% - Good

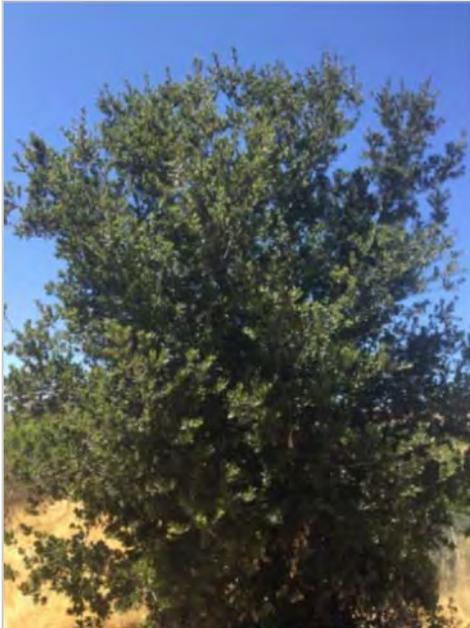
Oak, Coast Live ID# 207
 Oak, Coast Live Tag# 322
 Height: DBH: 5"/5"
 Health: 80% - Good

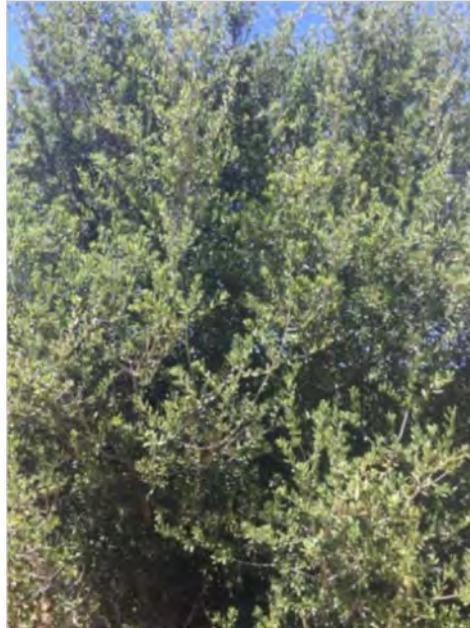
Oak, Coast Live ID# 208
 Oak, Coast Live Tag# 323
 Height: DBH: 5"/5"/5"
 Health: 80% - Good

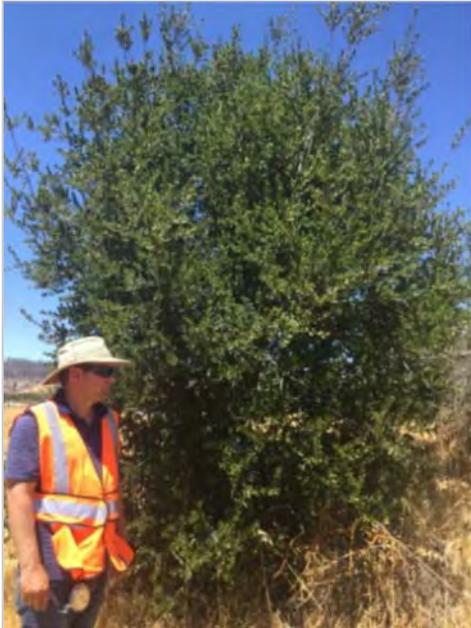
Oak, Coast Live ID# 210
 Oak, Coast Live Tag# 324
 Height: DBH: 5"/3"/3"
 Health: 80% - Good

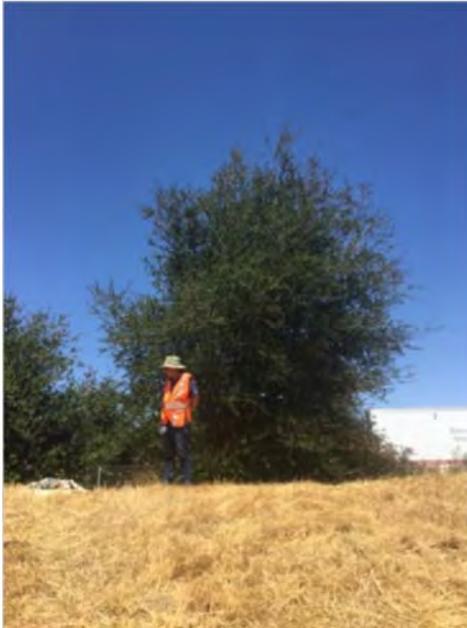
Oak, Coast Live ID# 211
 Oak, Coast Live Tag# 326
 Height: DBH: 6"/6"
 Health: 80% - Good

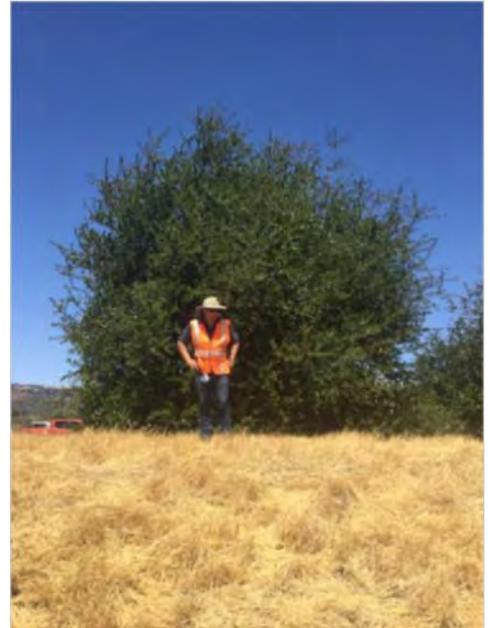
Oak, Coast Live ID# 212
 Oak, Coast Live Tag# 327
 Height: DBH: 8"/8"/8...
 Health: 80% - Good

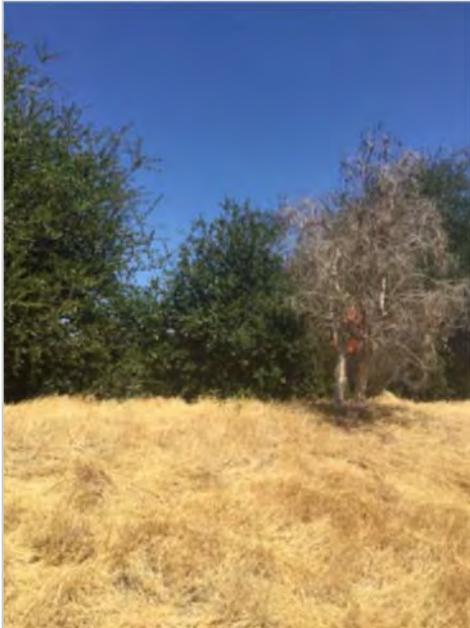
Oak, Coast Live ID# 213
Oak, Coast Live Tag# 328
Height: DBH: 5"
Health: 80% - Good

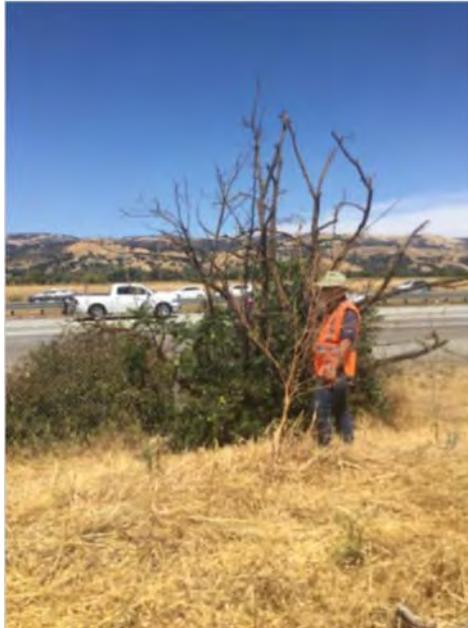
Juglans nigra ID# 214
eastern black walnut Tag# 338
Height: DBH: 6"/7"/3...
Health: 60% - Fair

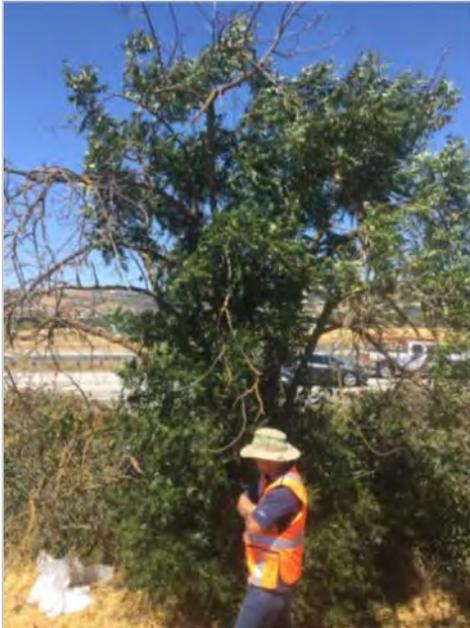
Juglans nigra ID# 216
eastern black walnut Tag# 340
Height: DBH: 11"/12"
Health: 60% - Fair

Map ID	Tag ID	Common Name	Species	DBH (inches)	Condition	Recommended Action	Indigenous Tree?	Ordinance Tree?	Street Tree?
216	340	Black Walnut	Juglans nigra	11"12"	60% - Fair	Remove Based on Conflicts with Design Plans	No	No	No
217	341	Black Walnut	Juglans nigra	12"	60% - Fair	Remove Based on Conflicts with Design Plans	No	No	No
218	336	Black Walnut	Juglans nigra	12"	20% - Critical	Remove Based on Conflicts with Design Plans & Condition	No	No	No
219	337	Fruitless Olive	Olea europaea	--	80% - Good	Remove Based on Conflicts with Design Plans	No	No	No
220	335	Fruitless Olive	Olea europaea	--	80% - Good	Remove Based on Conflicts with Design Plans	No	No	No
221	334	Black Walnut	Juglans nigra	12"	20% - Critical	Remove Based on Conflicts with Design Plans & Condition	No	No	No
222	333	Black Walnut	Juglans nigra	14"	0% - Dead	Remove Based on Conflicts with Design Plans & Condition	No	No	No
223	332	Black Walnut	Juglans nigra	8"5"5"5"13"	20% - Critical	Remove Based on Conflicts with Design Plans & Condition	No	No	No

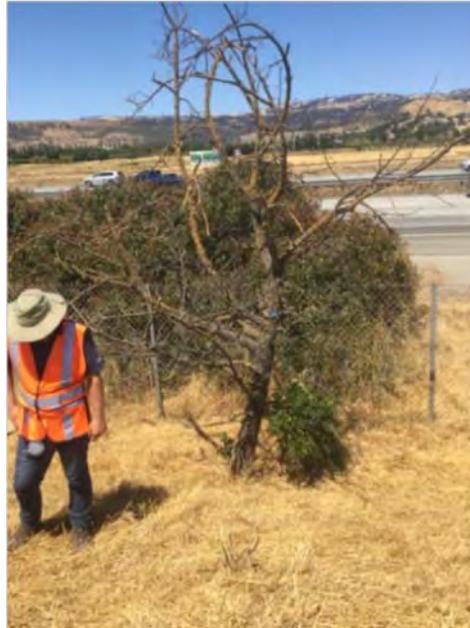
Juglans nigra ID# 217
eastern black walnut Tag# 341
Height: DBH: 12"
Health: 60% - Fair

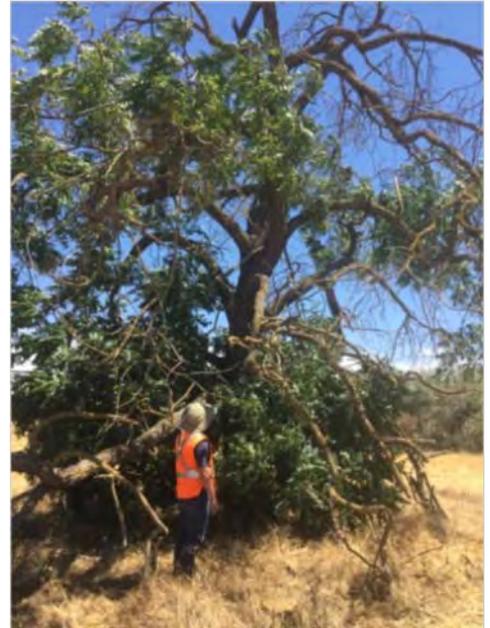
Juglans nigra ID# 218
eastern black walnut Tag# 336
Height: DBH: 12"
Health: 20% - Critical

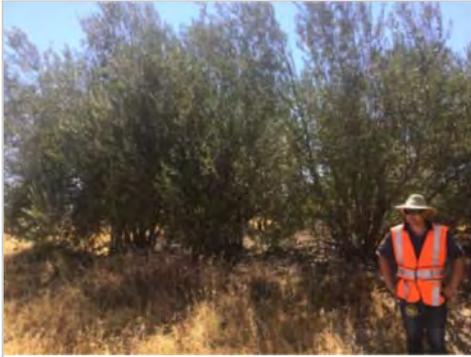
Olive ID# 219
Olive Tag# 337
Height:
Health: 80% - Good

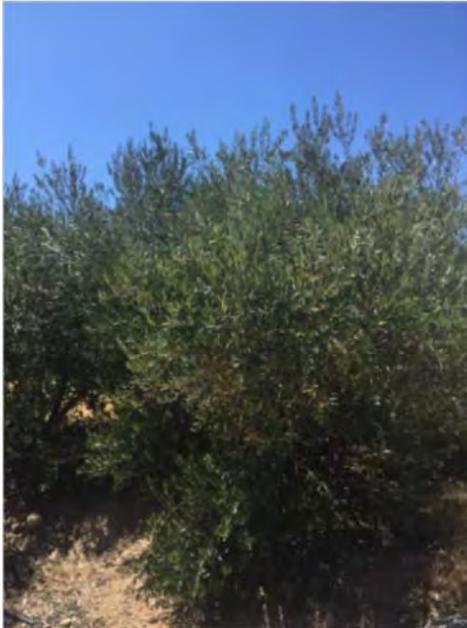
Olive ID# 219
Olive Tag# 337
Height:
Health: 80% - Good

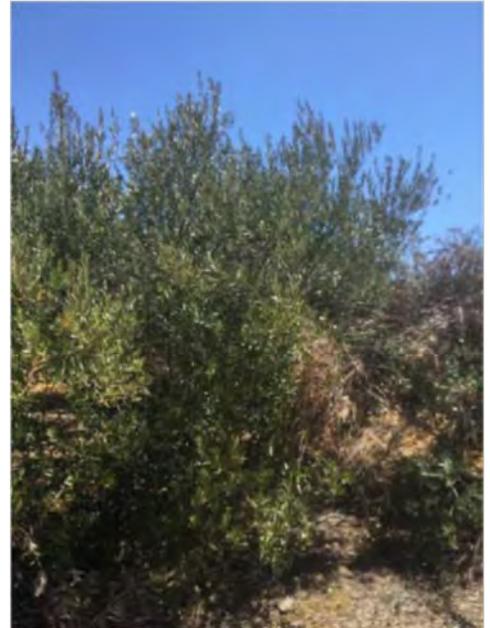
Olive ID# 220
Olive Tag# 335
Height:
Health: 80% - Good

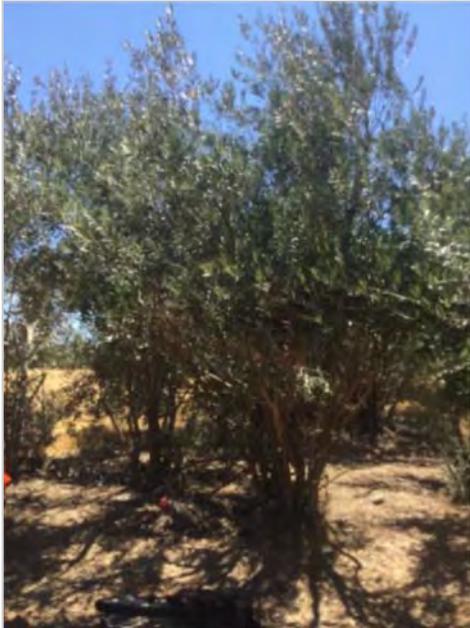
Olive ID# 220
Olive Tag# 335
Height:
Health: 80% - Good

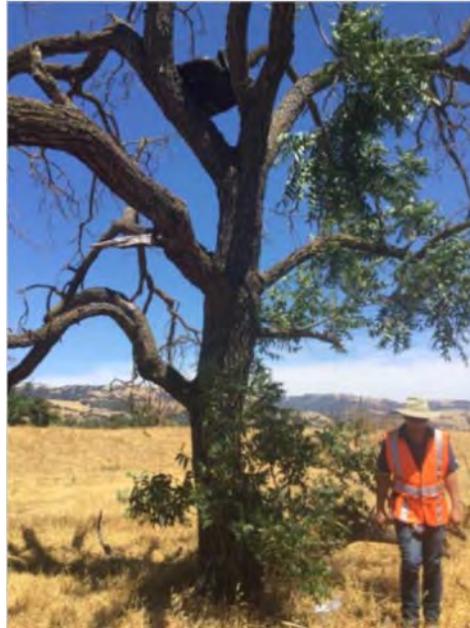
Juglans nigra ID# 221
eastern black walnut Tag# 334
Height: DBH: 12"
Health: 20% - Critical

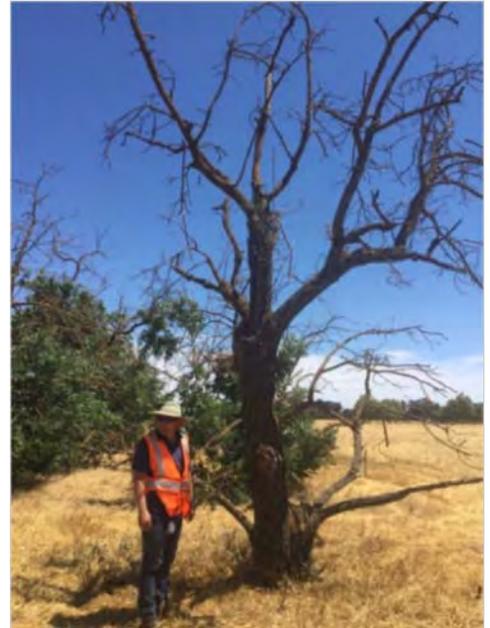
Juglans nigra ID# 222
eastern black walnut Tag# 333
Height: DBH: 14"
Health: 0% - Dead

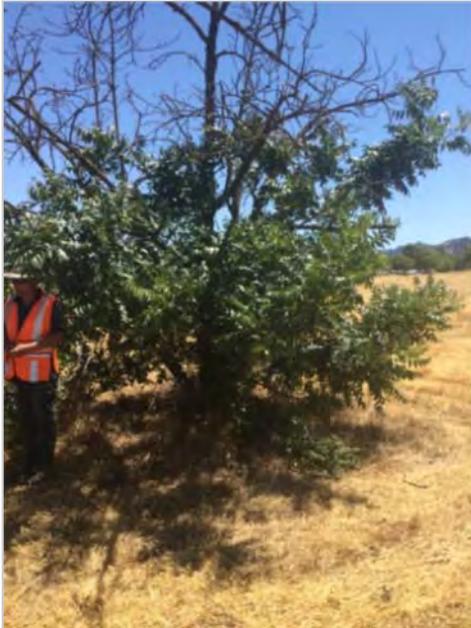
Juglans nigra ID# 223
eastern black walnut Tag# 332
Height: DBH: 8"/5"/5...
Health: 20% - Critical

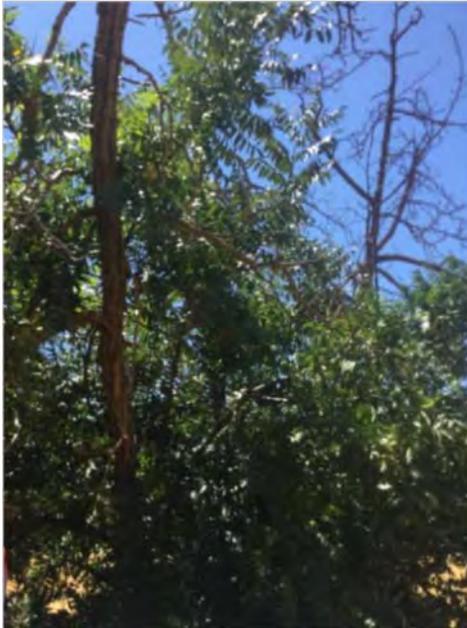
Juglans nigra ID# 224
eastern black walnut Tag# 331
Height: DBH: 6"/7"/8...
Health: 20% - Critical

224	331	Black Walnut	Juglans nigra	6"7"8"6"	20% - Critical	Remove Based on Conflicts with Design Plans & Condition	No	No	No
225	330	Black Walnut	Juglans nigra	14"	20% - Critical	Remove Based on Conflicts with Design Plans & Condition	No	No	No
226	329	Black Walnut	Juglans nigra	18"	20% - Critical	Remove Based on Conflicts with Design Plans & Condition	No	Yes	No
227	180	Sycamore	Platanus acerifolia	7"	80% - Good	Remove Based on Conflicts with Design Plans	Yes	Yes	No
228	181	Sycamore	Platanus acerifolia	7"	80% - Good	Remove Based on Conflicts with Design Plans	Yes	Yes	No
229	182	Sycamore	Platanus acerifolia	7"	80% - Good	Remove Based on Conflicts with Design Plans	Yes	Yes	No
230	183	Sycamore	Platanus acerifolia	7"	80% - Good	Remove Based on Conflicts with Design Plans	Yes	Yes	No
231	184	Sycamore	Platanus acerifolia	7"	80% - Good	Remove Based on Conflicts with Design Plans	Yes	Yes	No
232	185	Sycamore	Platanus acerifolia	7"	80% - Good	Remove Based on Conflicts with Design Plans	Yes	Yes	No

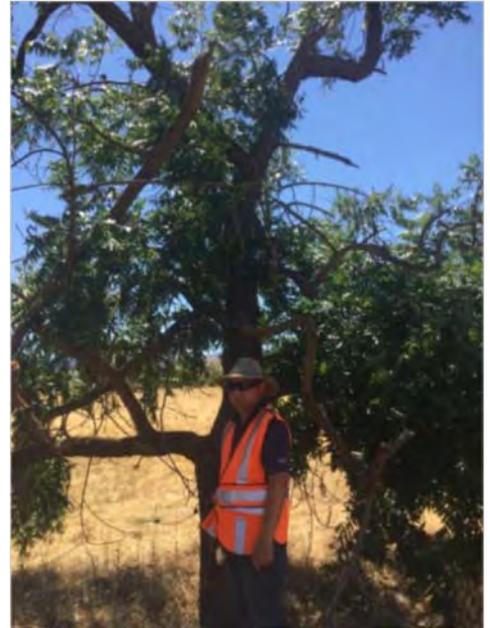
Juglans nigra ID# 225
eastern black walnut Tag# 330
Height: DBH: 14"
Health: 20% - Critical

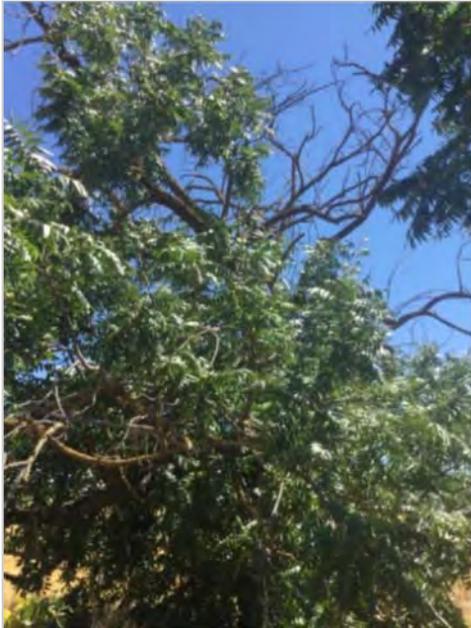
ID# 226
Tag# 329
DBH: 18"

Juglans nigra
eastern black walnut
Height:
Health: 20% - Critical

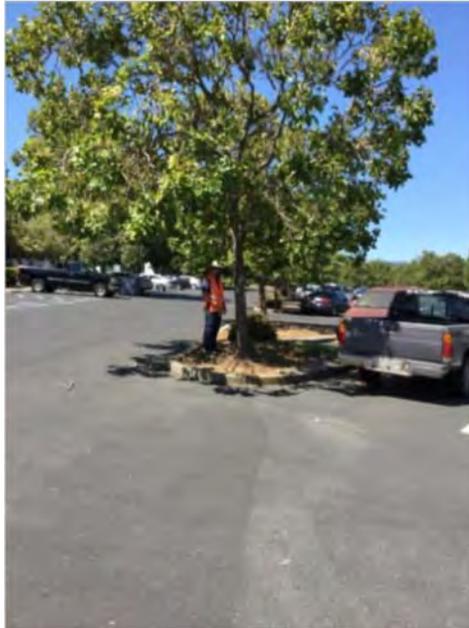
ID# 227
Tag# 180
DBH: 7"-12"

London Plane Tree
London Plane Tree
Height:
Health: 80% - Good

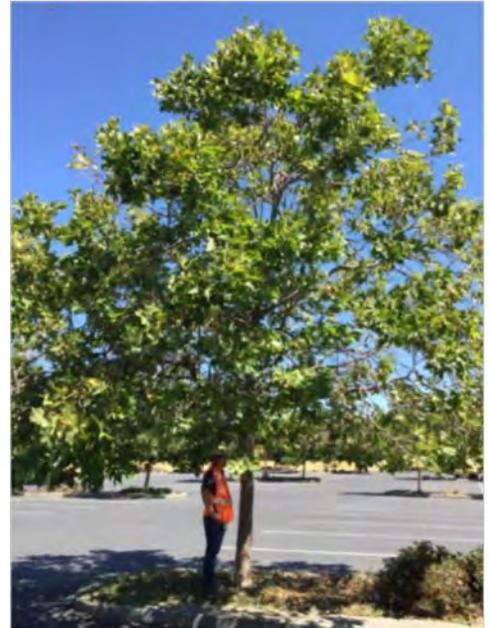
ID# 229
Tag# 182
DBH: 7"-12"

London Plane Tree
London Plane Tree
Height:
Health: 80% - Good

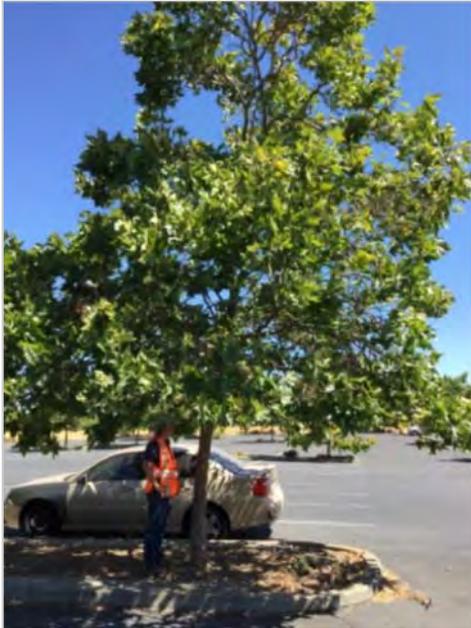
London Plane Tree ID# 230
 London Plane Tree Tag# 183
 Height: DBH: 7"-12"
 Health: 80% - Good

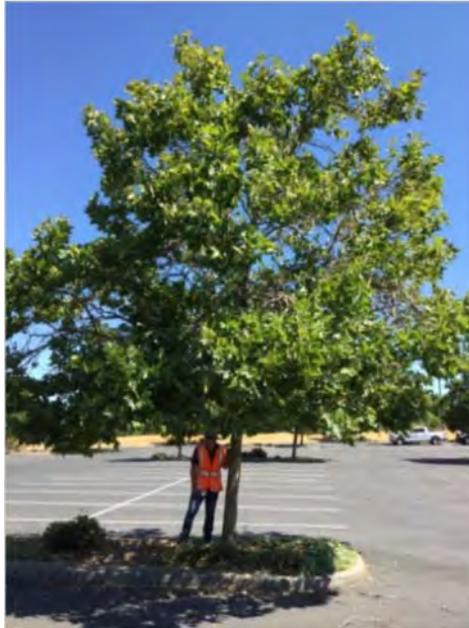
London Plane Tree ID# 231
 London Plane Tree Tag# 184
 Height: DBH: 7"-12"
 Health: 80% - Good

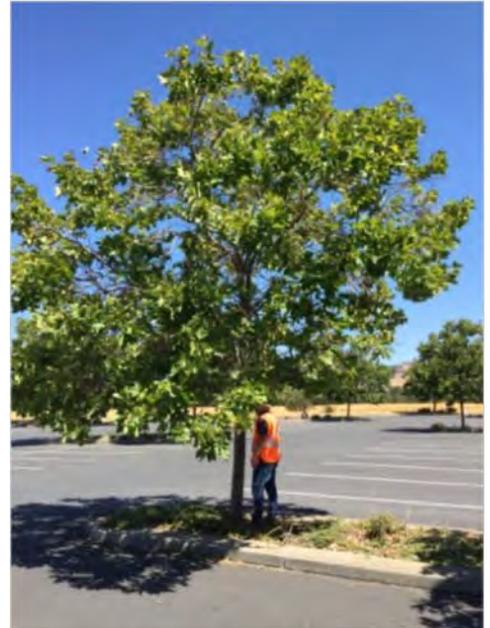
London Plane Tree ID# 232
 London Plane Tree Tag# 185
 Height: DBH: 7"-12"
 Health: 80% - Good

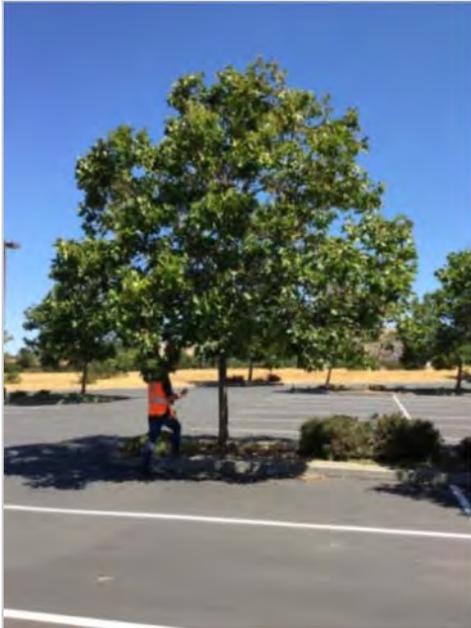
London Plane Tree ID# 233
 London Plane Tree Tag# 186
 Height: DBH: 1"-6"
 Health: 80% - Good

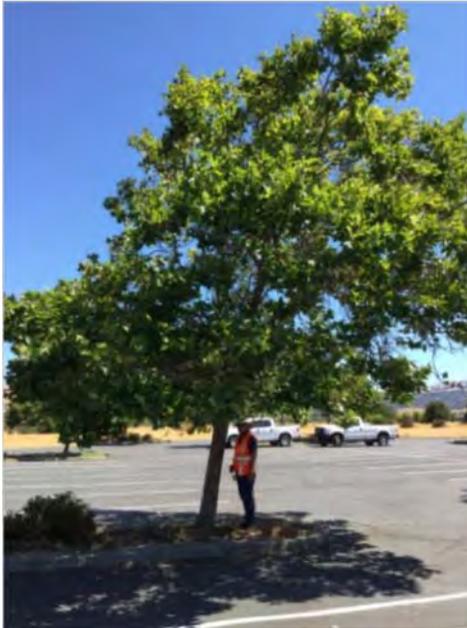
London Plane Tree ID# 234
 London Plane Tree Tag# 187
 Height: DBH: 7"-12"
 Health: 80% - Good

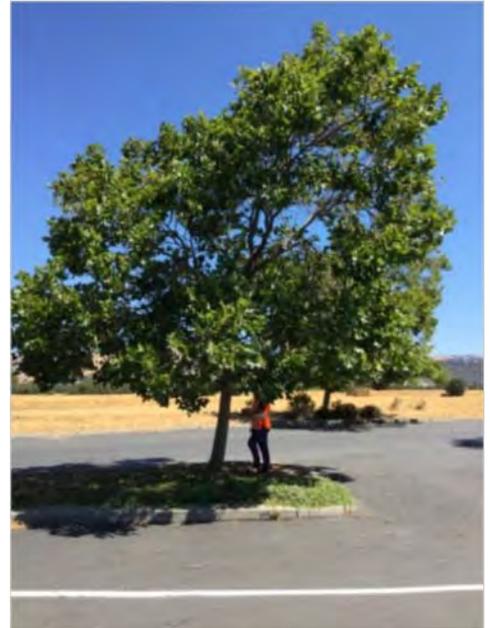
London Plane Tree ID# 235
 London Plane Tree Tag# 188
 Height: DBH: 7"-12"
 Health: 80% - Good

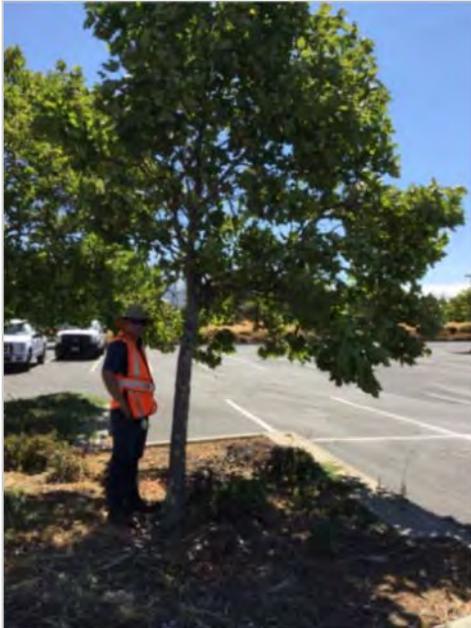
London Plane Tree ID# 236
 London Plane Tree Tag# 189
 Height: DBH: 1"-6"
 Health: 60% - Fair

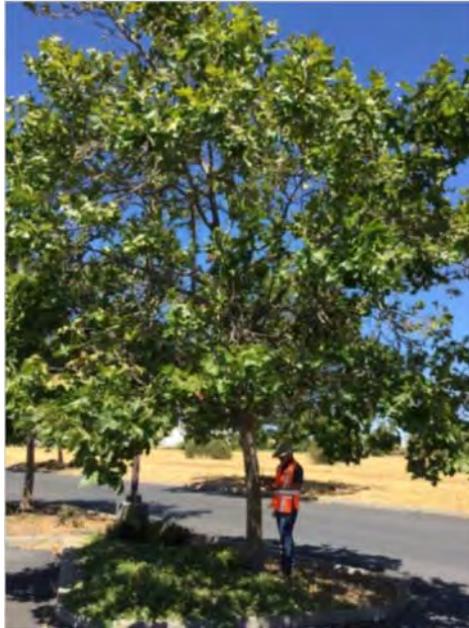
London Plane Tree ID# 237
 London Plane Tree Tag# 190
 Height: DBH: 7"-12"
 Health: 80% - Good

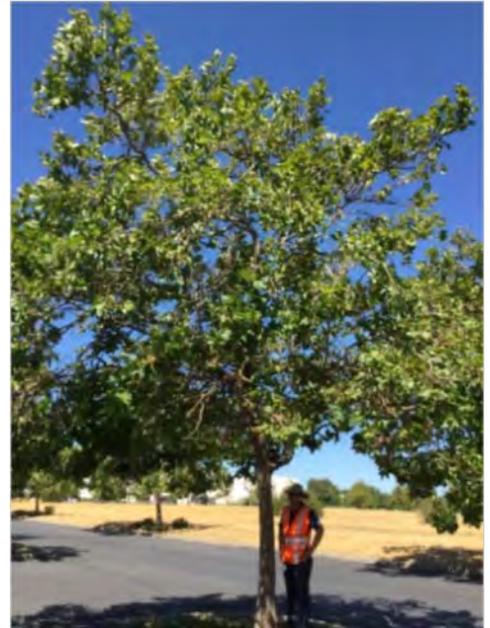
London Plane Tree ID# 238
 London Plane Tree Tag# 191
 Height: DBH: 7"-12"
 Health: 80% - Good

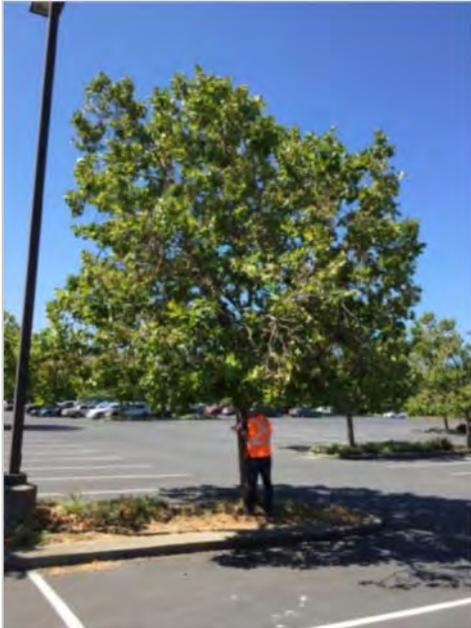
London Plane Tree ID# 239
 London Plane Tree Tag# 192
 Height: DBH: 7"-12"
 Health: 80% - Good

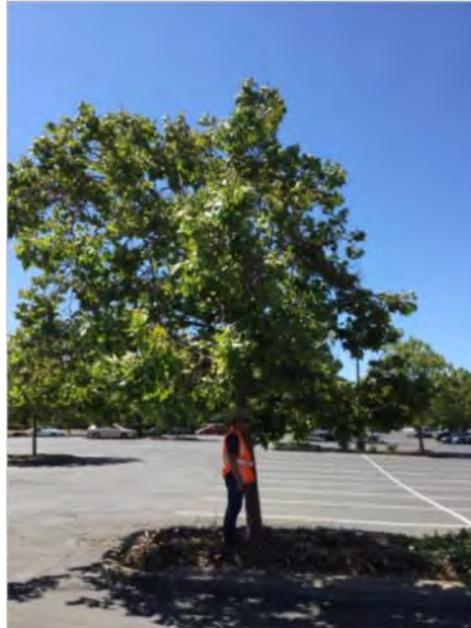
London Plane Tree ID# 240
 London Plane Tree Tag# 193
 Height: DBH: 7"-12"
 Health: 80% - Good

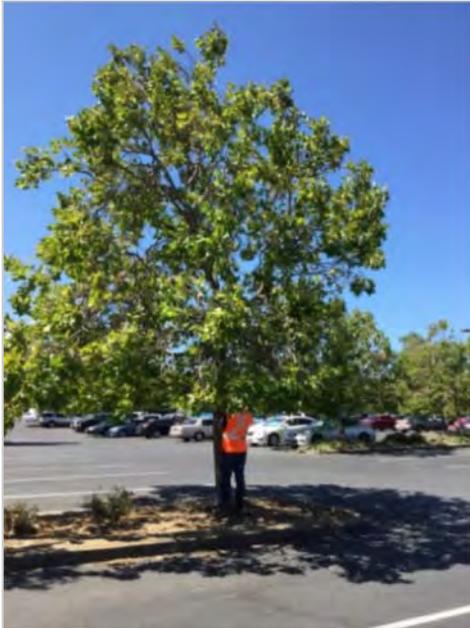
London Plane Tree ID# 242
London Plane Tree Tag# 195
Height:
Health: 80% - Good
DBH: 7"-12"

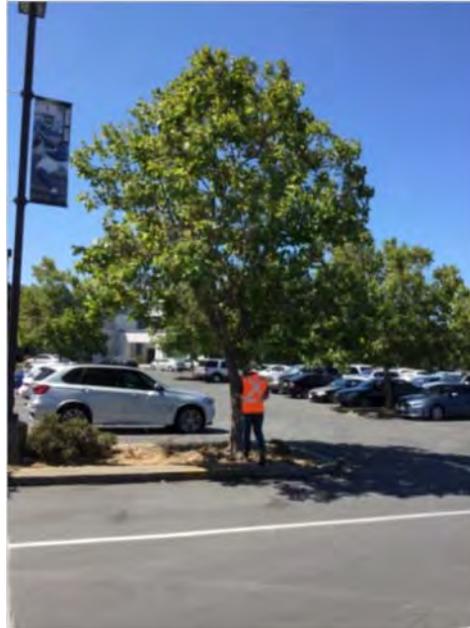
London Plane Tree ID# 243
London Plane Tree Tag# 196
Height:
Health: 80% - Good
DBH: 7"-12"

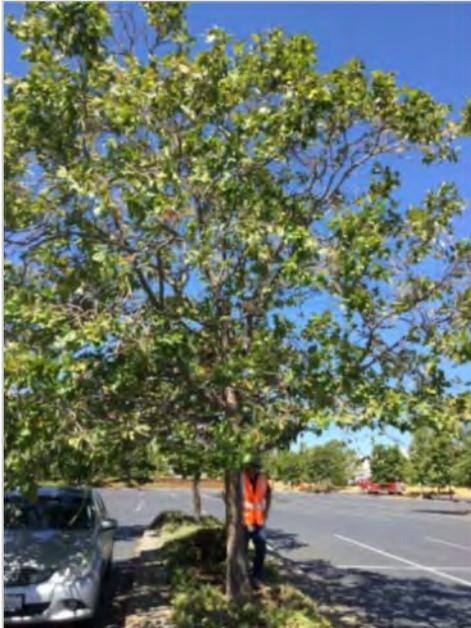
London Plane Tree ID# 245
 London Plane Tree Tag# 198
 Height: DBH: 7"-12"
 Health: 80% - Good

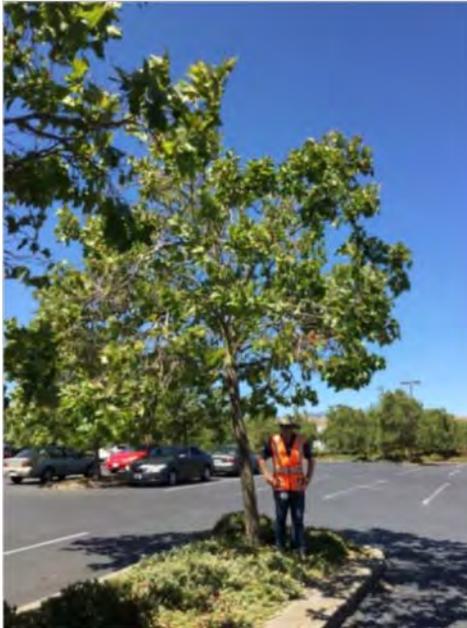
London Plane Tree ID# 246
 London Plane Tree Tag# 199
 Height: DBH: 1"-6"
 Health: 80% - Good

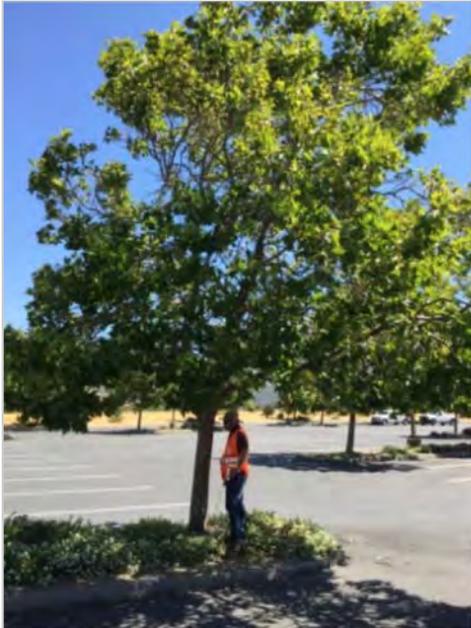
London Plane Tree ID# 248
 London Plane Tree Tag# 102
 Height: DBH: 7"-12"
 Health: 80% - Good

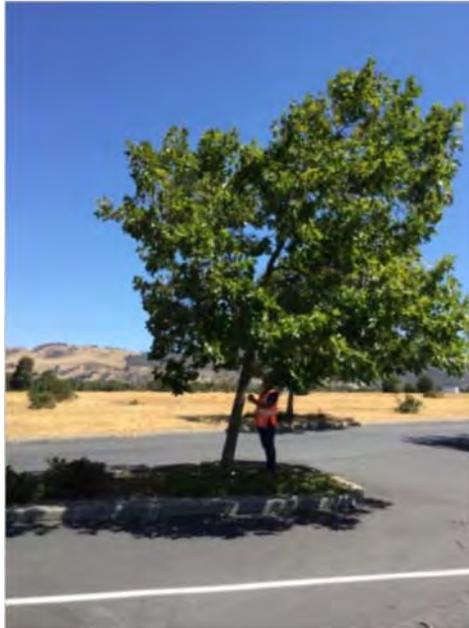
London Plane Tree ID# 249
 London Plane Tree Tag# 203
 Height: DBH: 7"-12"
 Health: 80% - Good

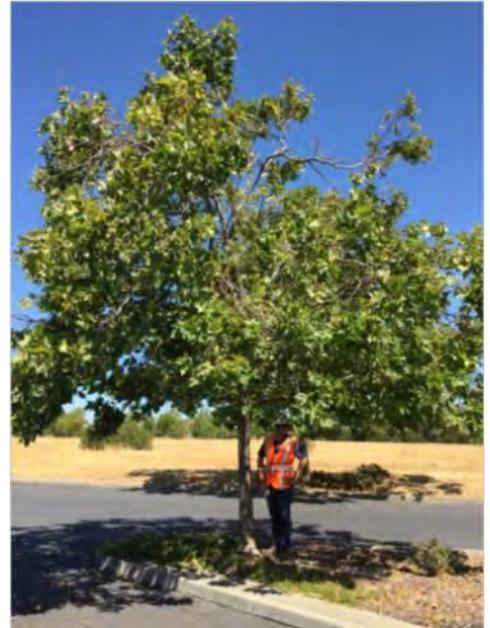
London Plane Tree ID# 250
 London Plane Tree Tag# 204
 Height: DBH: 7"-12"
 Health: 80% - Good

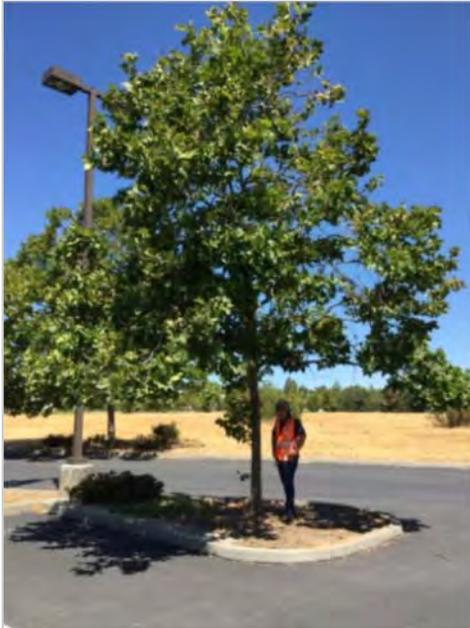
London Plane Tree ID# 251
London Plane Tree Tag# 205
Height:
Health: 80% - Good
DBH: 7"-12"

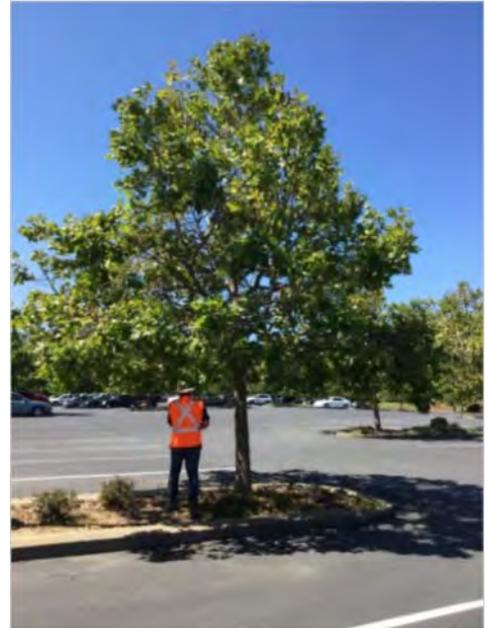
London Plane Tree ID# 253
London Plane Tree Tag# 207
Height:
Health: 80% - Good
DBH: 7"-12"
