Appendix B
Tree Inventory & Protection Plan

**755 Jarvis Drive
Tree Inventory & Protection Plan**

755 Jarvis Drive
Morgan Hill, California

Prepared by:
Samuel Oakley
ISA Board Certified Master Arborist WE-9474B
ASCA Registered Consulting Arborist #556

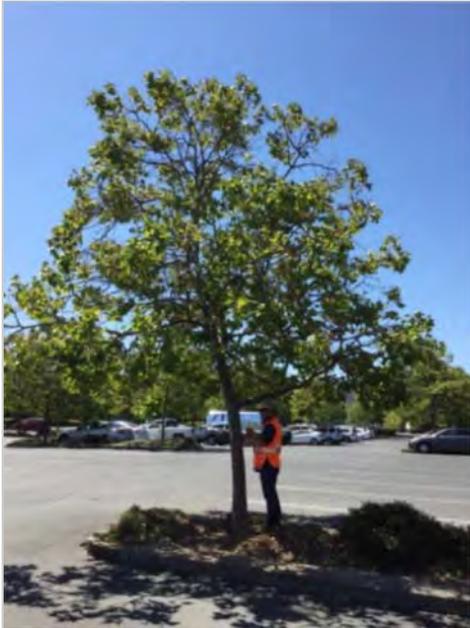
London Plane Tree ID# 254
 London Plane Tree Tag# 208
 Height: DBH: 7"-12"
 Health: 80% - Good

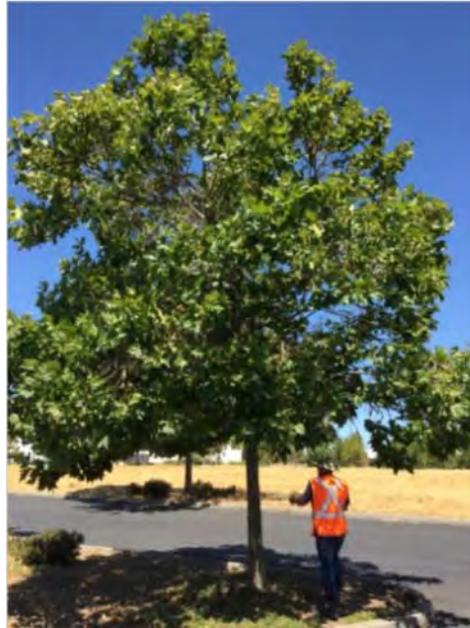
London Plane Tree ID# 255
 London Plane Tree Tag# 209
 Height: DBH: 7"-12"
 Health: 80% - Good

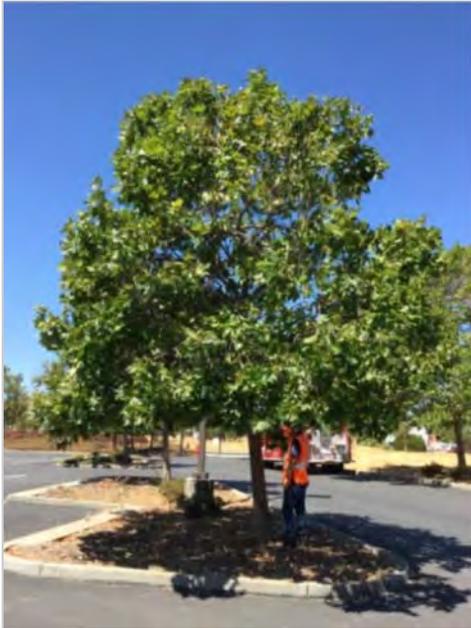
London Plane Tree ID# 257
London Plane Tree Tag# 211
Height: DBH: 7"-12"
Health: 80% - Good

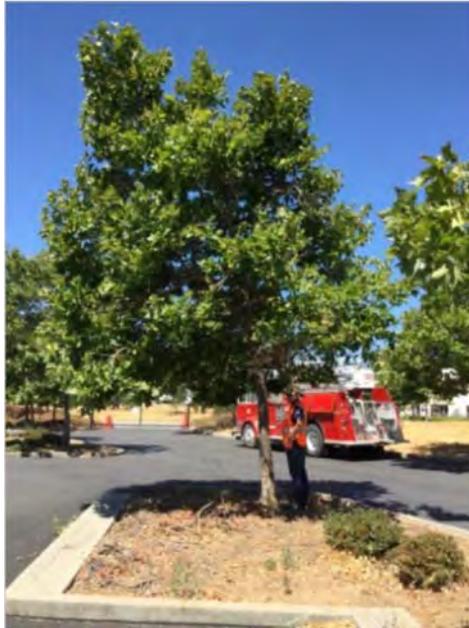
London Plane Tree ID# 258
London Plane Tree Tag# 212
Height: DBH: 1"-6"
Health: 80% - Good

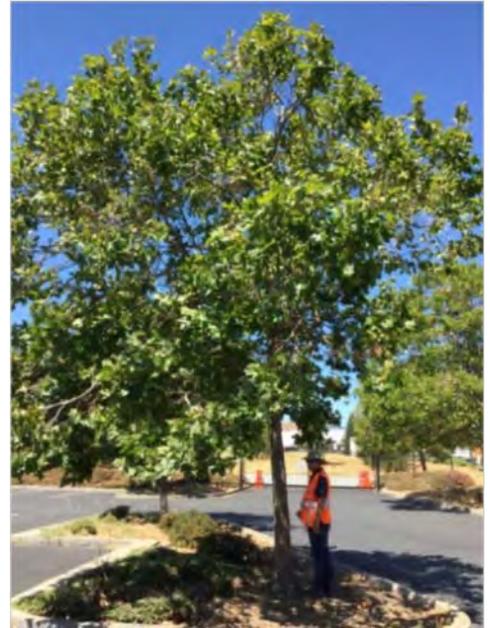
London Plane Tree ID# 259
London Plane Tree Tag# 213
Height: DBH: 7"-12"
Health: 80% - Good

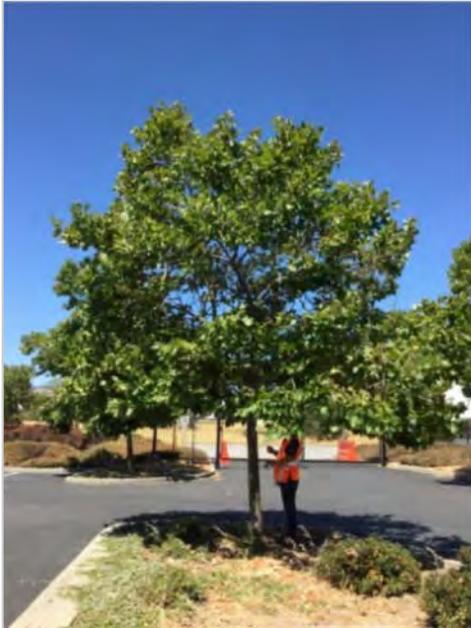
London Plane Tree ID# 260
 London Plane Tree Tag# 214
 Height: DBH: 1"-6"
 Health: 80% - Good

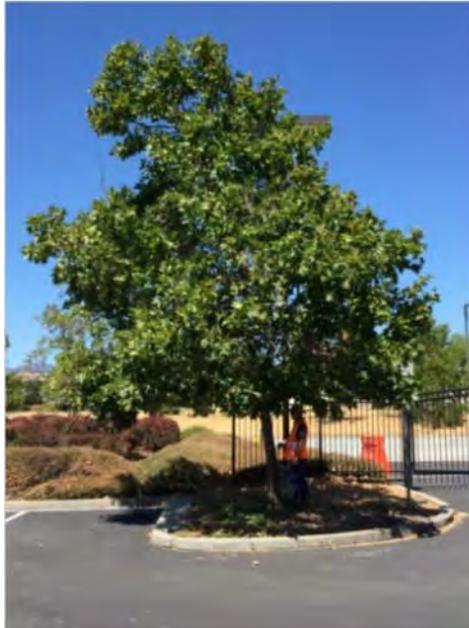
London Plane Tree ID# 261
 London Plane Tree Tag# 215
 Height: DBH: 7"-12"
 Health: 80% - Good
